# HILL TOP HOUSE HOTEL

## HISTORIC RESOURCES PLAN

HARPERS FERRY, WV

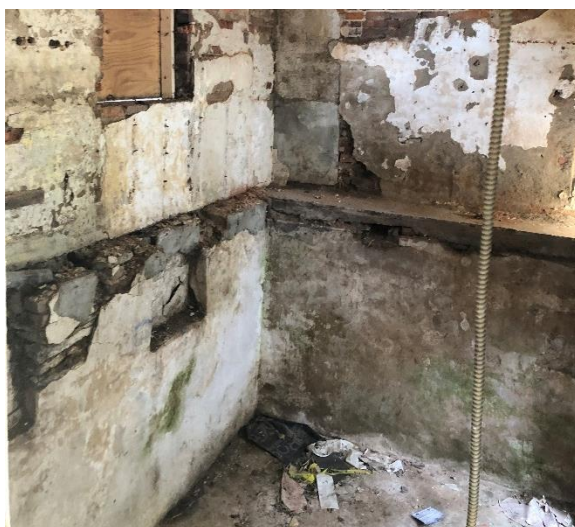
Missing floor framing in rear wing (Mills Group 2018).

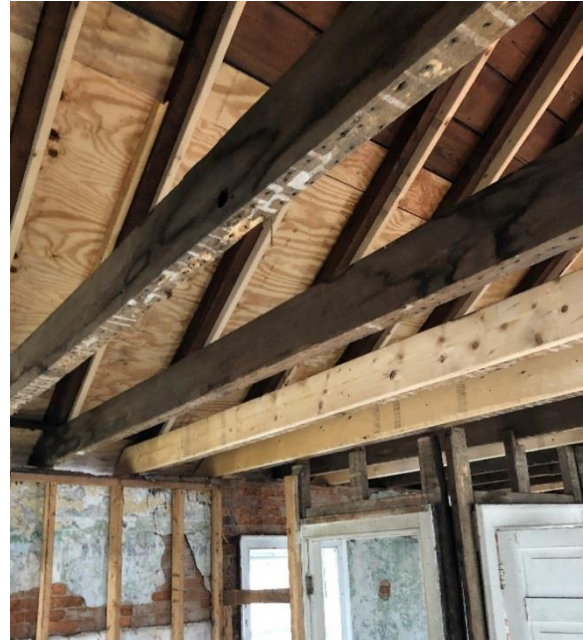
View of north-facing replaced roof decking, sistered rafters, and replaced ceiling joists (Mills Group 2018).

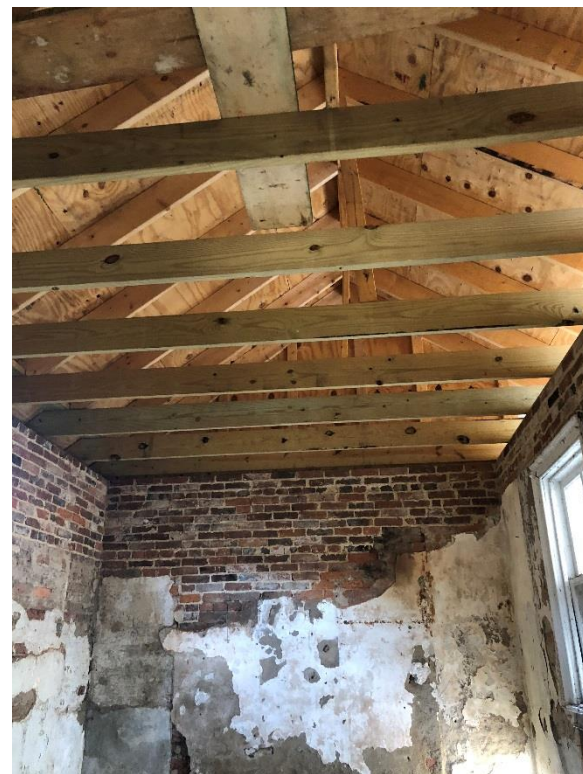
View of replaced roof framing and decking in rear wing (Mills Group 2018).

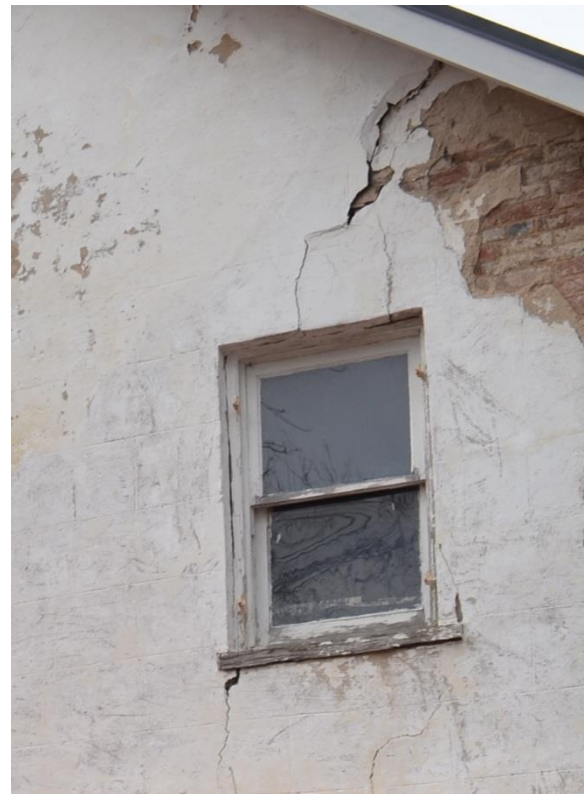
Cracking observed above second floor north window on east elevation (Mills Group 2018).

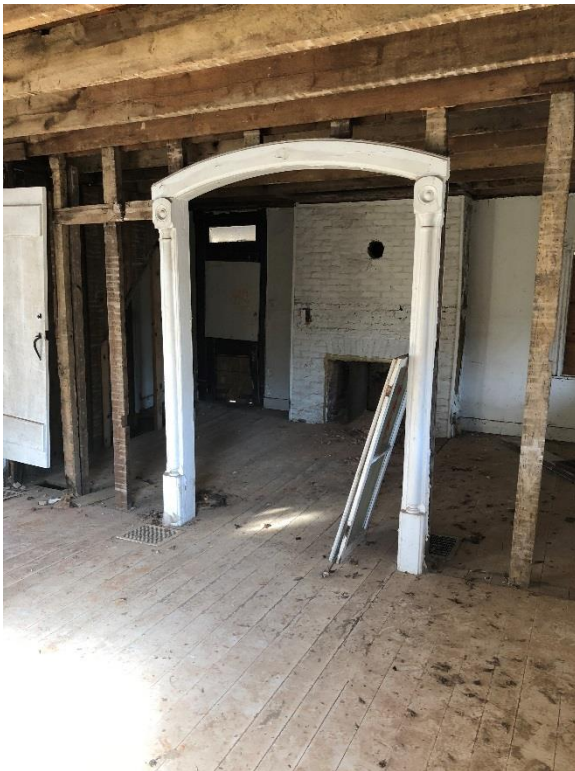
Existing interior door trim; clean, repair, prime and paint all elements scheduled to remain (Mills Group 2018).

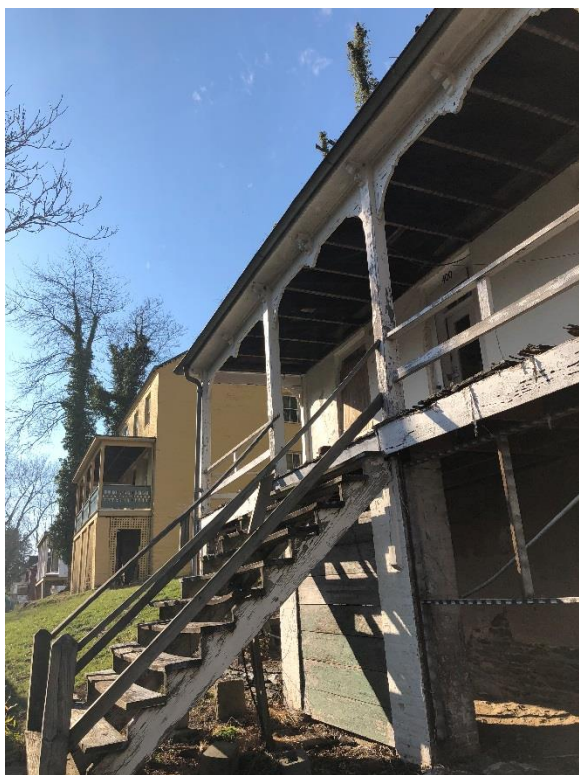
View of missing wood sheathing between masonry porch piers (Mills Group 2018).

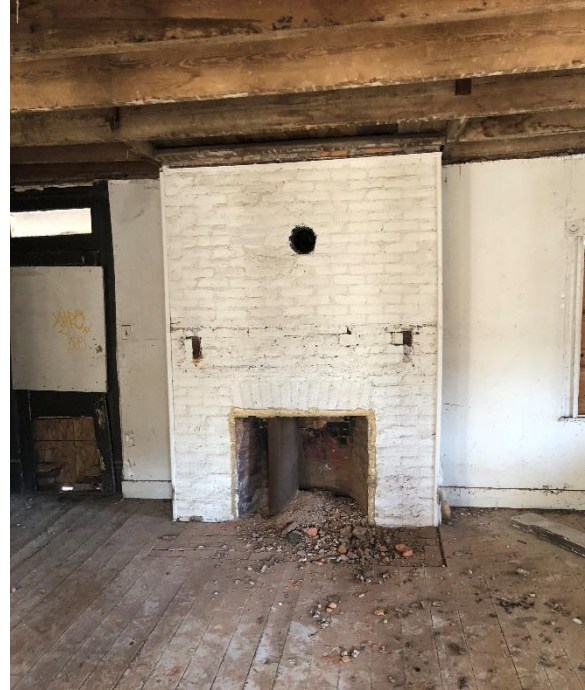
View of missing mantle at east fireplace on first floor; replicate west fireplace mantle for installation (Mills Group 2018).

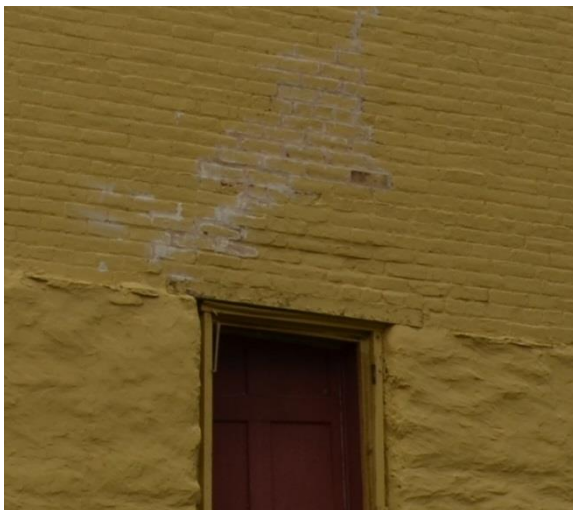
Evidence of bulging and cracking above basement door on east elevation (Mills Group 2018).

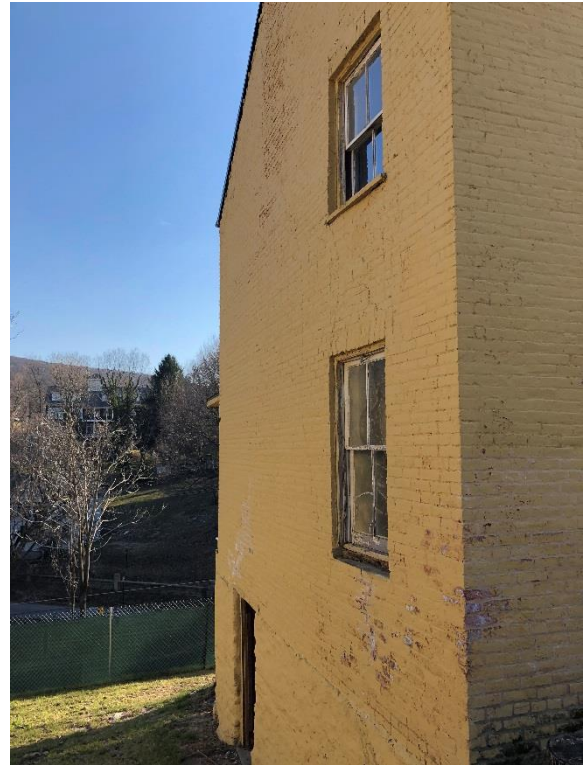
Bulging evident along east wall of main building (Mills Group 2018).

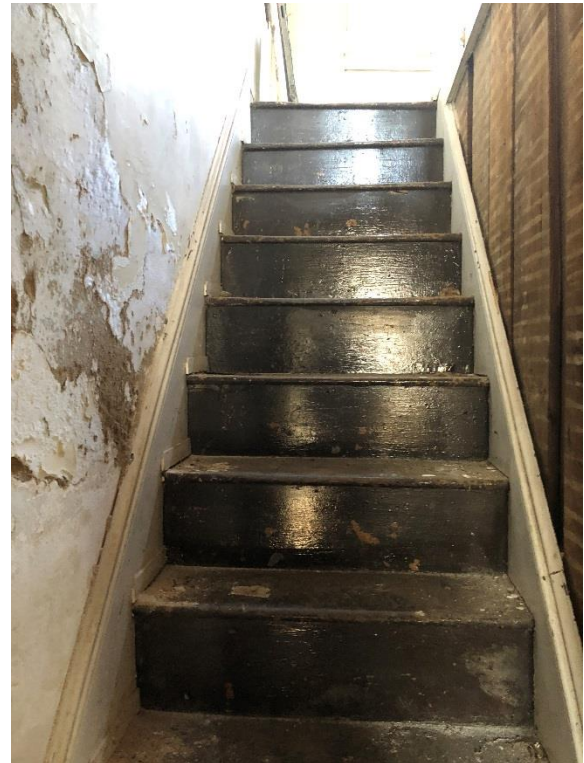
Plaster deterioration along north wall adjacent to stairs (Mills Group 2018).

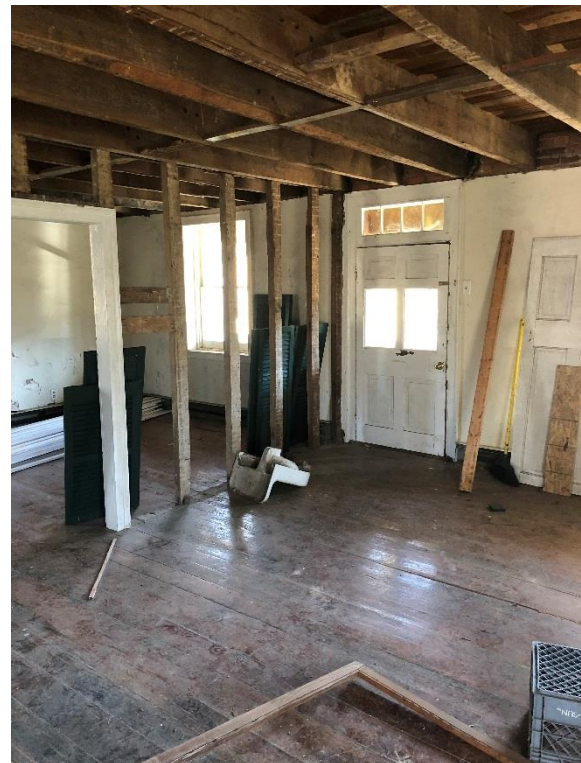
Interior framing with plaster and lath removed (Mills Group 2018).

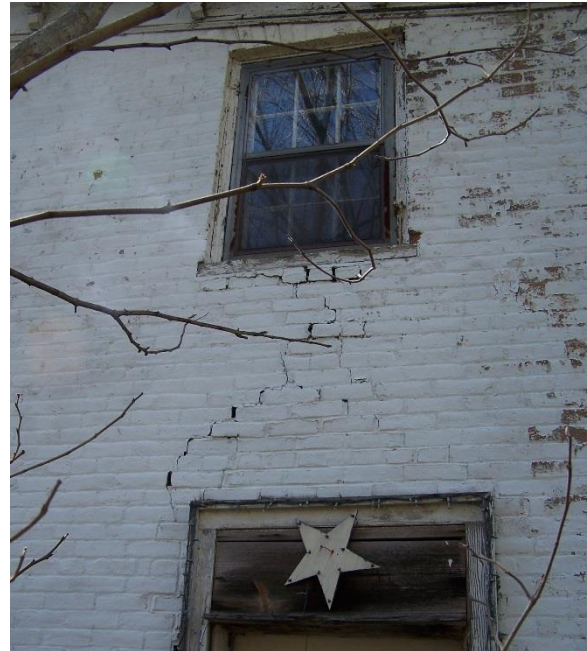
Masonry opening added at east elevation. Note crack in mortar joints above door (Oehrlein & Associates, 2008).

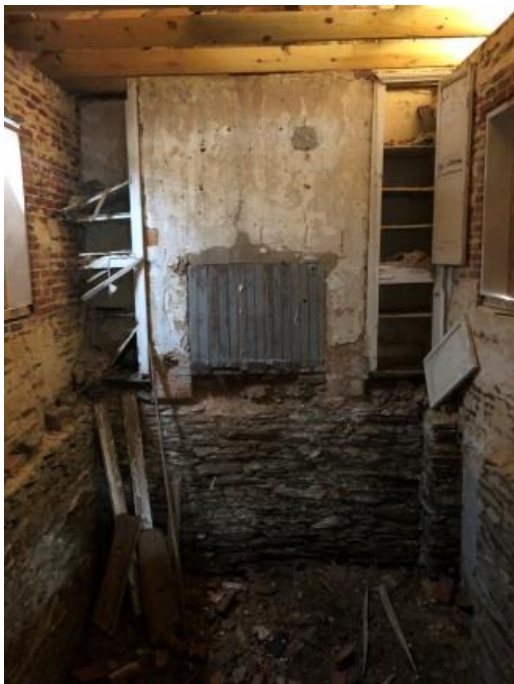
View of missing floor framing in rear wing (Mills Group 2018).

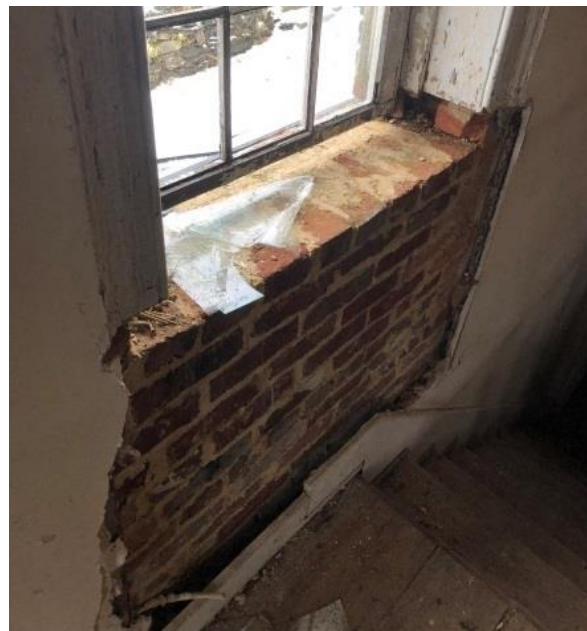
Plaster deterioration under north window, second level (Mills Group 2018).

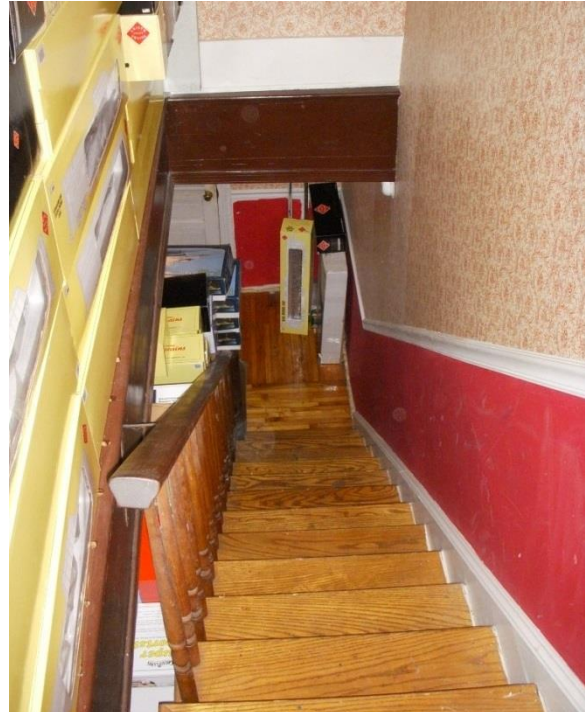
View looking from the second floor down to the first floor in the east unit. Note the missing guardrail on the left side of the photo (Oehrlein & Associates, 2008).

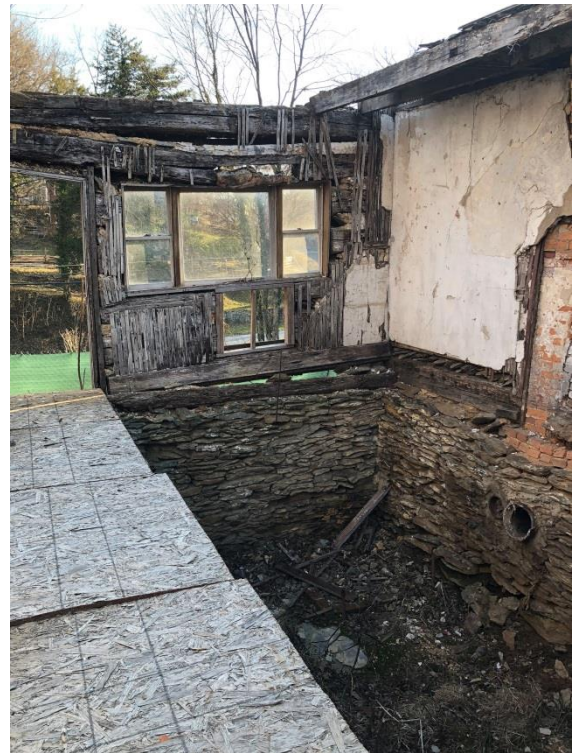
View of deteriorated picture window opening, West Unit log building (Mills Group, 2018).

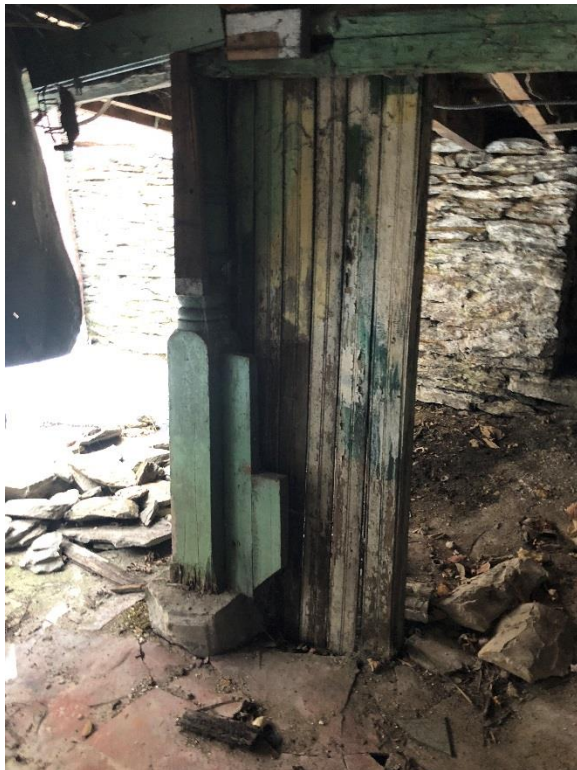
View of single post currently supporting West Unit floor framing (Mills Group 2018).

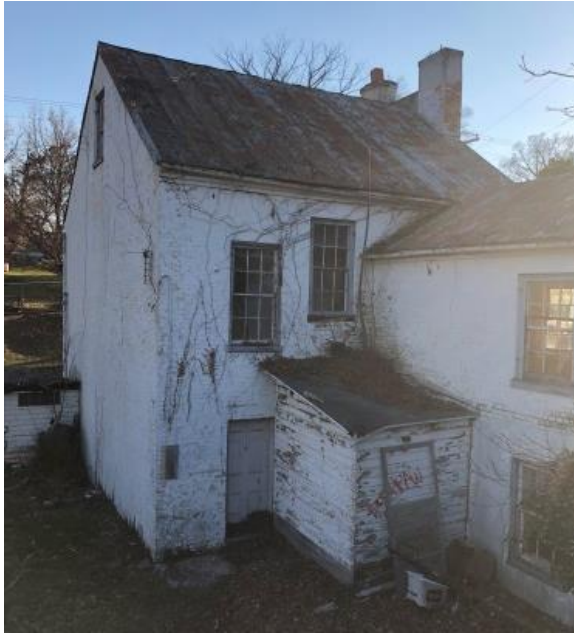
View of deteriorated rear frame addition (Mills Group, 2018).

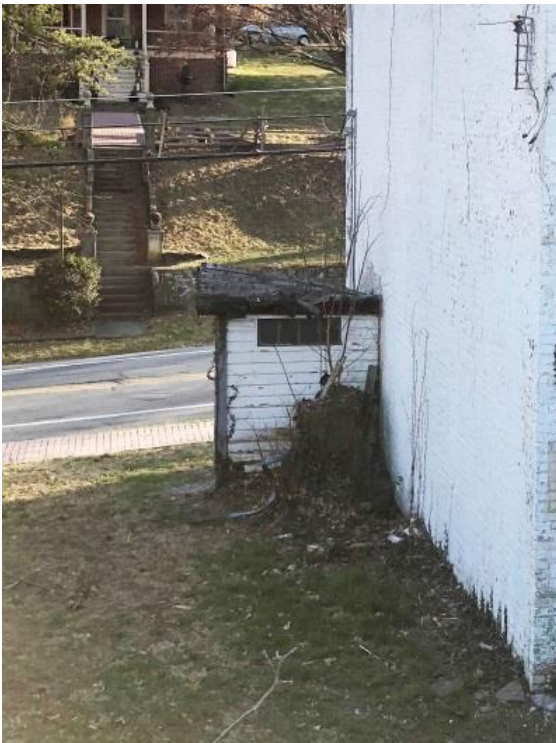
View of deteriorated frame basement access addition (Mills Group, 2018).

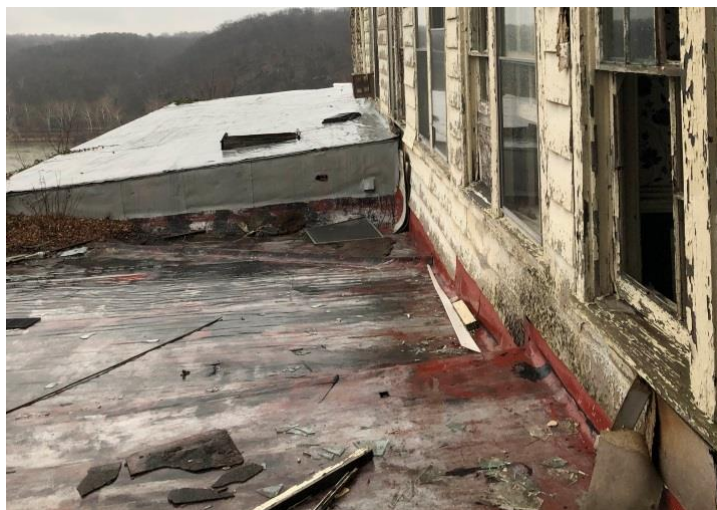
Detail view of deteriorating flat seam metal roofing (Mills Group, 2018).

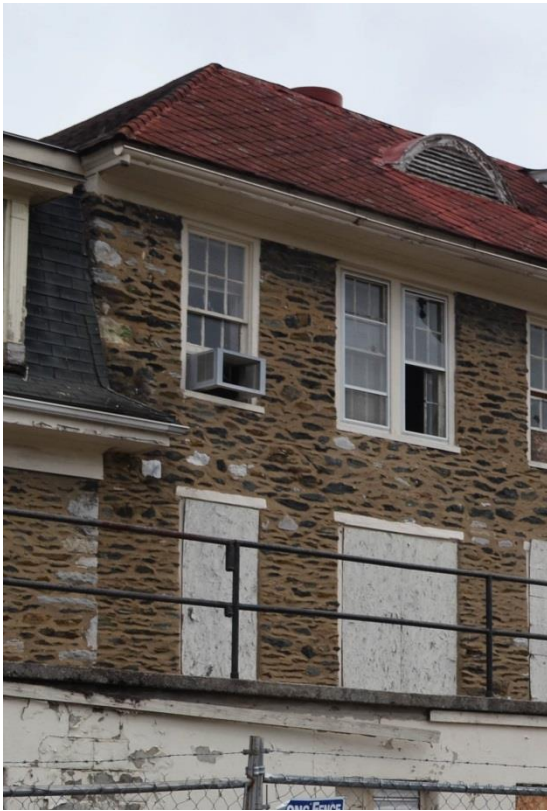
Wood windows and missing windows at stone and frame walls (Mills Group, 2018).
