HARPERS FERRY WATER WORKS

EVALUATION AND FEASIBILITY STUDY

**WATER TREATMENT FACILITY AND
DISTRIBUTION SYSTEM UPGRADES**

NOVEMBER 2013

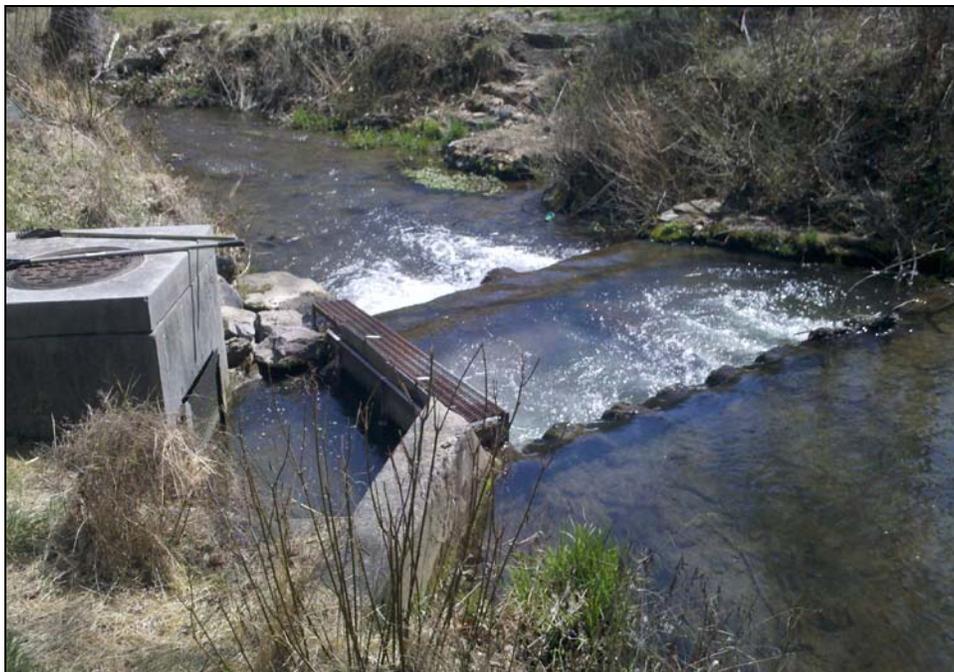
Photo 1: Elk Run Intake Structure

Elk Run/Town Spring Raw Water Intakes - The existing intake and screen on Elk Run has been in service since approximately 1985 and appears to be in good working order. The existing debris screens do not show signs of corrosion and cleaning tools are present at the intake to remove any obstructions within the screens. It was reported that the operators perform a daily inspection of the intake site. It is our opinion that no upgrades/modifications will be required to this intake.

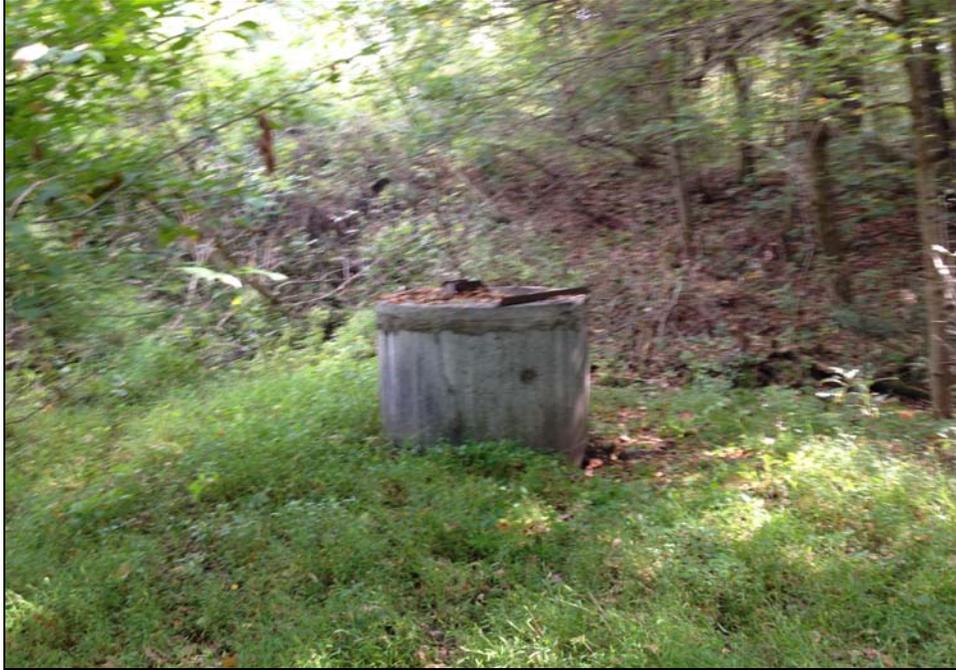
Photo 2: Existing Town Spring Intake

In addition to the Elk Run intake, raw water is provided to the treatment facility from the Harpers Ferry Town Spring. The raw water at the Town Spring is collected by a precast concrete circular intake and is conveyed by gravity to an existing wet well where it is combined with raw water from the Elk Run Intake. The estimated average amount of flow from this spring is 85 gpm, however; at the time of the site visit for this report the flow was zero (0) gpm. Due to the minimal amount of water collected at this intake and fluctuations in the amount of flow generated by the spring, the Town Spring should not be considered a viable source of raw water. It would be helpful to know the amount of flow that is entering the wet well from the Town Spring, thus Harpers Ferry Water Works may want to consider adding a flow meter to this line.

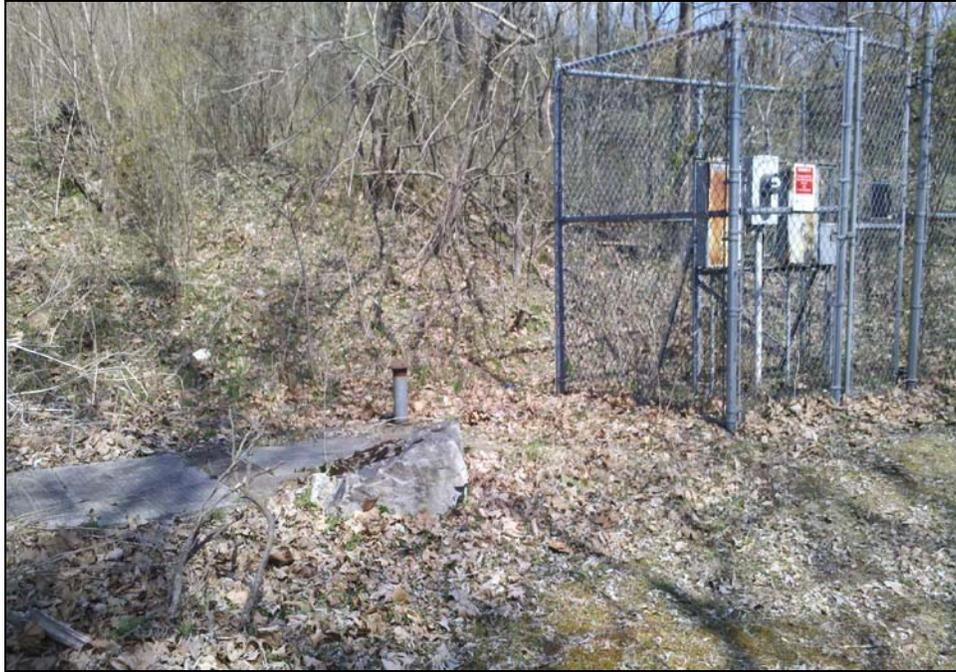
Photo 3: Raw Water Wet Well and Pump Controls

Raw Water Pumping - Raw water is pumped to the existing treatment facility from an existing concrete wet well. The existing wet well consists of dual 10 HP Fairbanks Morse submersible pumps rated at 350 gpm. The pump controls are currently exposed to the elements and are showing signs of rust and corrosion. The wet well and pump controls are currently located within the 100-year flood elevation. Operators verified that this low lying area is prone to flooding.

It is recommended that the submersible pumps be replaced with more efficient vertical turbine pumps with variable frequency drives (VFDs). Vertical turbine pumps are more energy efficient for this application and should require smaller pump motors to operate under the same design conditions as the submersible pumps. VFDs will aid in pump efficiency and offer better flow control to the treatment facility. A new submerged pressure transducer should be installed in the wet well to measure level for pump control.

A new concrete wet well with masonry building structure is recommended at the existing intake location. The building will provide additional security, keep the equipment above the floodplain and provide a temperature controlled environment that will prolong the life of the equipment.

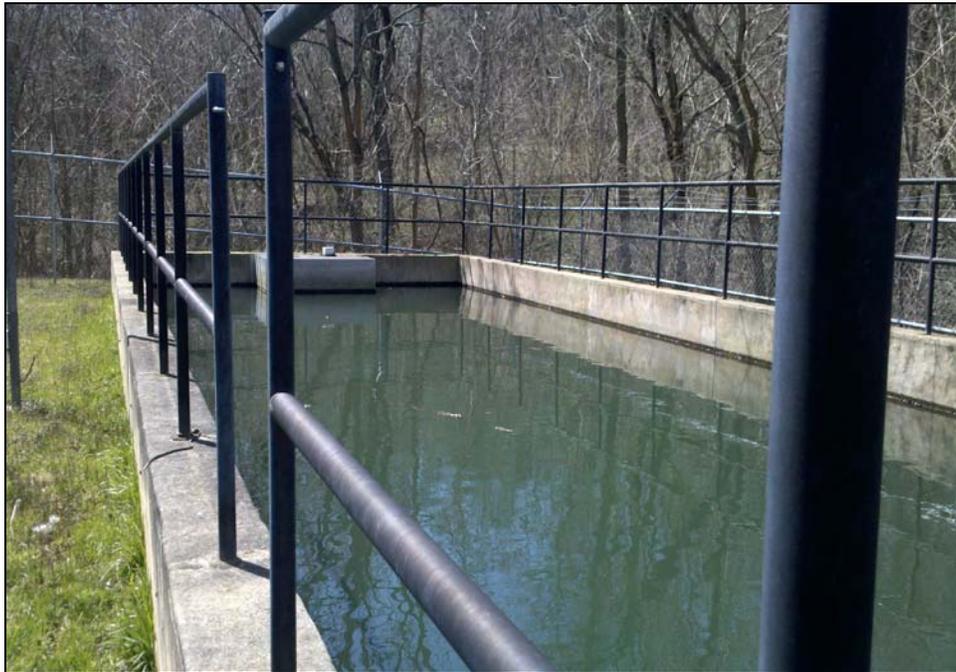
Photo 5 - Pre-Sedimentation Basin

Pre-Sedimentation Basin - An existing 77,000 gallon concrete pre-sedimentation basin is located 300 feet south of the existing treatment facility. At the treatment plant capacity rate of 350 gpm, an approximate detention time of 220 minutes (3.67 hours) is achieved in the basin. This detention time is within the 2-4 hour range as required by WV BPH.

Furthermore, without the use of an oxidant before the sedimentation basin, the soluble forms of metals such as iron, manganese and aluminum cannot be settled or filtered. These metals will pass through the filters and then be oxidized in the clearwell when subjected to chlorine. This can lead to increases in these secondary contaminants in the finish water which can cause health problems and unwanted staining, color, taste or odor.

It is recommended that a precast concrete vault be placed between the raw water intake building and the pre-sedimentation basin to accommodate chemical injections, a new raw water flow meter and an in-line static mixer.

Alterations to the existing pre-sedimentation basin are also recommended. These alterations include the addition of flocculation mixing basins and flocculation mixers. Sluice gates and baffle walls should be included in the new flocculation basin with a minimum detention time of 30 minutes as recommended by WV BPH. The flocculation basins should be designed to provide redundancy in both equipment and detention time.

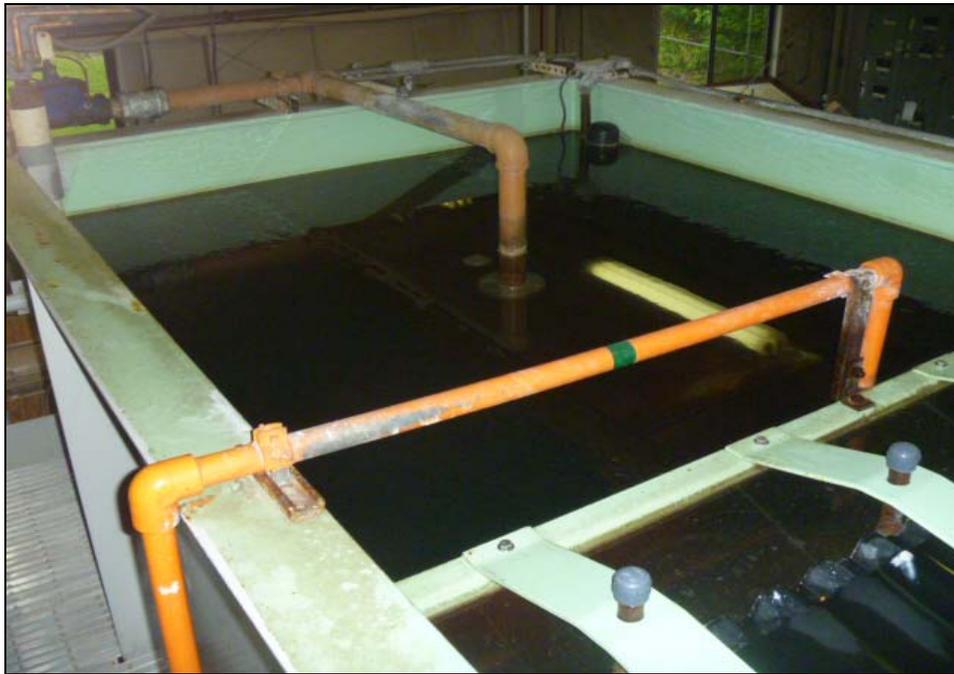
Photo 7 - Packaged Mixed Media Filter

The packaged filter modules have been in continuous use for nearly 30 years since the treatment plant was constructed in 1985. The filter modules have reached or are near the end of their effective service life. It is our opinion that these filter modules should be replaced. Refer to the Water Treatment Facility Upgrade Alternatives Evaluation located in this report for additional information regarding the filter system options.

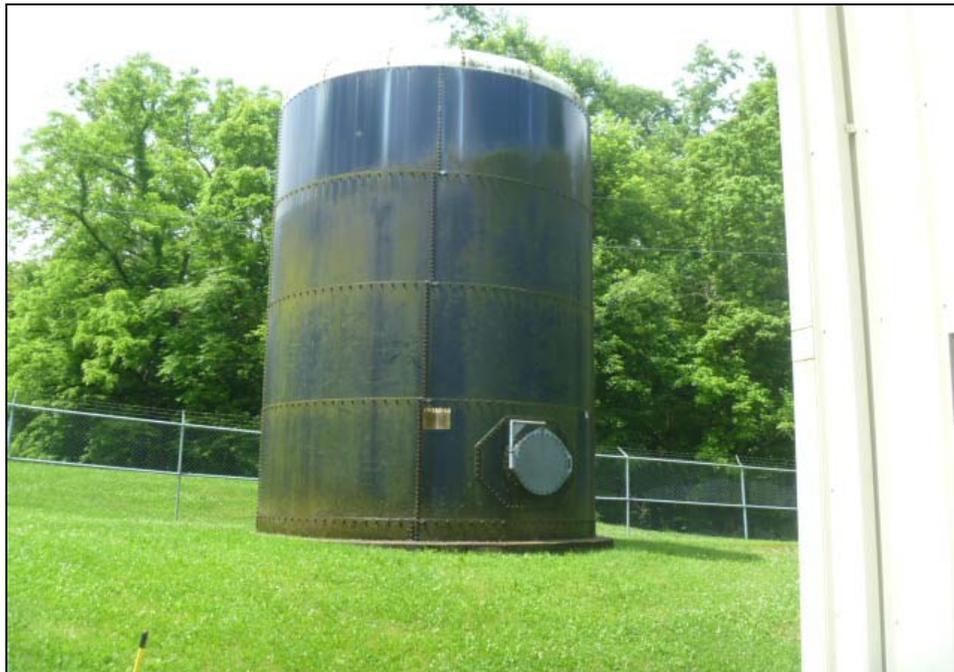
Photo 8 - Glass-Lined Ground Level Clearwell (21,000 Gallon)

Finish Water Clearwell - The filtered water is conveyed to a 21,000 gallon above grade glass-lined clearwell via filtrate pumps. Most recent LT2 testing results require a minimum 2-log deactivation of filtered water prior to distribution. Removal/deactivation of *Giardia* cysts is currently performed in the packaged filters and clearwell prior to the water being pumped into the public water distribution system. Dual HACH CL17 online chlorine residual analyzers continually monitor and record the residual chlorine levels in the finish water. If the residual chlorine drops below 1.0 mg/L, an alarm is sounded and an autodial system is engaged to notify the operators. If the residual chlorine drops below 0.5 mg/L, the facility is shut down.

This log reduction value is dangerously close to a minimum 3.0-log inactivation if the system falls into a "future" Bin 2 classification. In fact, a slight decrease in chlorine concentration and/or increase in pH, results in an inactivation less than that which would be required. Also, during current filter backwashing, water is extracted from the clearwell which decreases the log inactivation. The existing clearwell (0.15-log) is significantly undersized per WV BPH requirements. The clearwell should be designed for a minimum 1.0-log removal at worst case water quality conditions. Additionally, 3.0-log reduction should be obtained independently of the filtration units in the event of emergency or if the filtration units need to be taken offline. This would not be possible with the current treatment plant processes and configuration. However, this would be accomplished by placing a new precast concrete vault between the wet well and the pre-sedimentation basin for chlorine injection into the raw water, as recommended earlier in the report. This would allow additional contact time to occur in the new flocculation tanks and sedimentation basin. Please be advised that pending the results of any future Stage 2-Disinfection By-Product Rule Testing, Harpers Ferry Water Works could be required to provide a minimum of 4.0-log inactivation of *Giardia*.

A new 120,000 (+/-) gallon above grade clearwell should be provided adjacent to the existing clearwell in order to create increased contact time for log deactivation prior to finish water being pumped to the distribution system. This new clearwell volume will provide a minimum of 1.0-log removal at worst case water quality conditions. This tank should possess an internal mixing system to increase the baffling factor and thus increasing the effective volume (0.3 minimum). The most economical tank of this size is a bolted or welded stainless steel ground level tank. Stainless steel tanks require minimal upkeep and have long service-lives. Please note that it is not being recommended to construct a concrete baffled clearwell below grade due to the presence of a nearby septic drain field which could potentially contaminate the finish water.

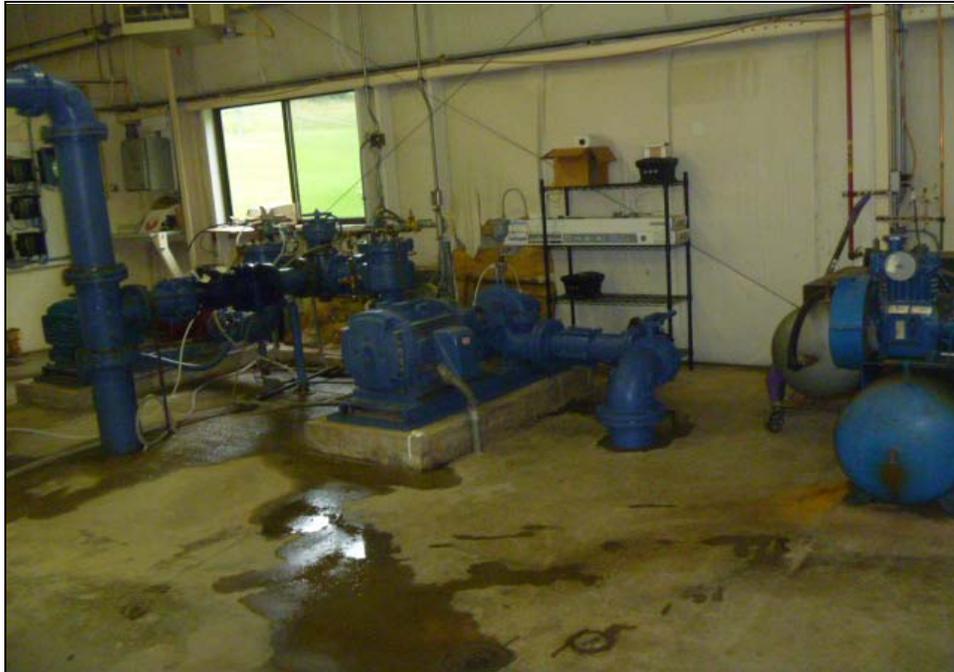
Photo 10 - Finish Water Pumps and Piping

Finish Water Pumps and Piping - The finish water is pumped to the existing distribution system by two (2) 75 HP Allis Chalmers split case centrifugal pumps rated at 200 gpm each and a total dynamic head (TDH) rating of 410 feet. The flow from the clearwell is metered by a newly installed and calibrated 6-inch Badger turbine meter. The pumps are controlled manually at the treatment facility based upon the water storage tank levels located in Bolivar Heights.

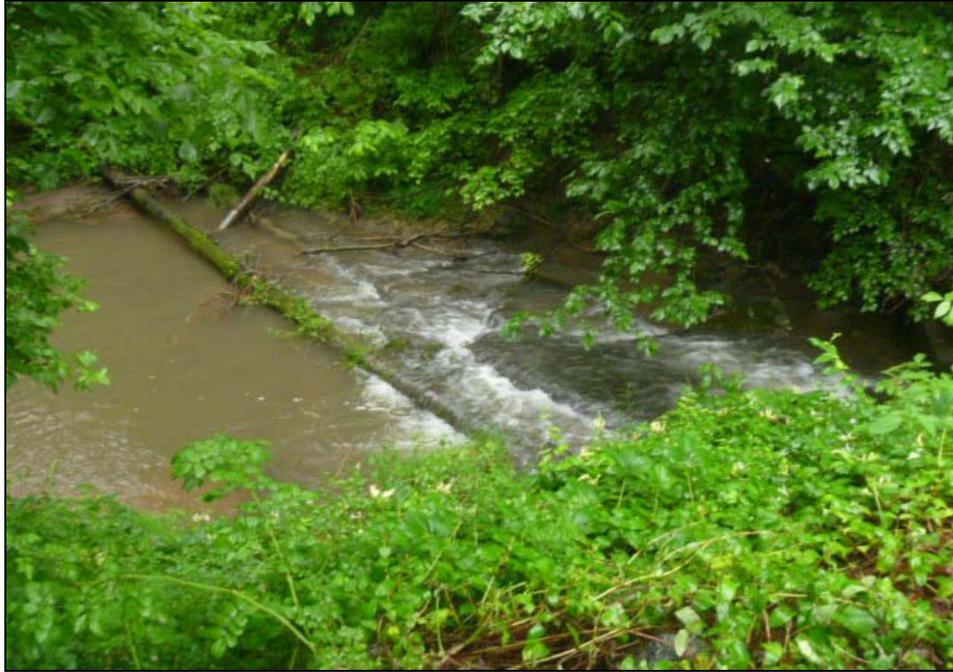
Photo 11 - Exposed 8-inch Distribution System Pipe in Elk Run

There is an existing 8-inch cast iron waterline that exits the treatment facility, crosses beneath Bakerton Road and lies exposed in Elk Run (see below) before it extends to the storage tanks. This section of pipe needs replaced with a new ductile iron pipe that is bored beneath Bakerton Road and Elk Run.

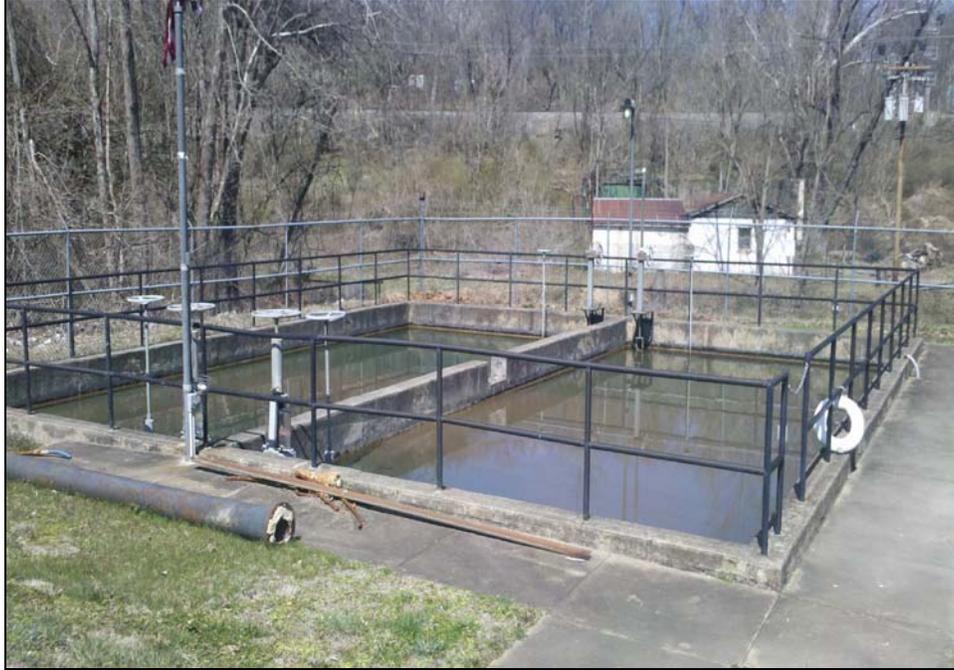
Photo 12 - Backwash Holding Tanks

Backwash Holding Tanks - Backwash effluent is discharged to two (2) concrete holding tanks located 50 feet north of the existing treatment facility. The solids are held in this tank while the effluent is discharged (via gravity decanting) to an approved NPDES discharge location on Elk Run. The tanks appear to be in good condition and consist of approximately 50,000 gallons of storage per tank for a total of 100,000 gallons.

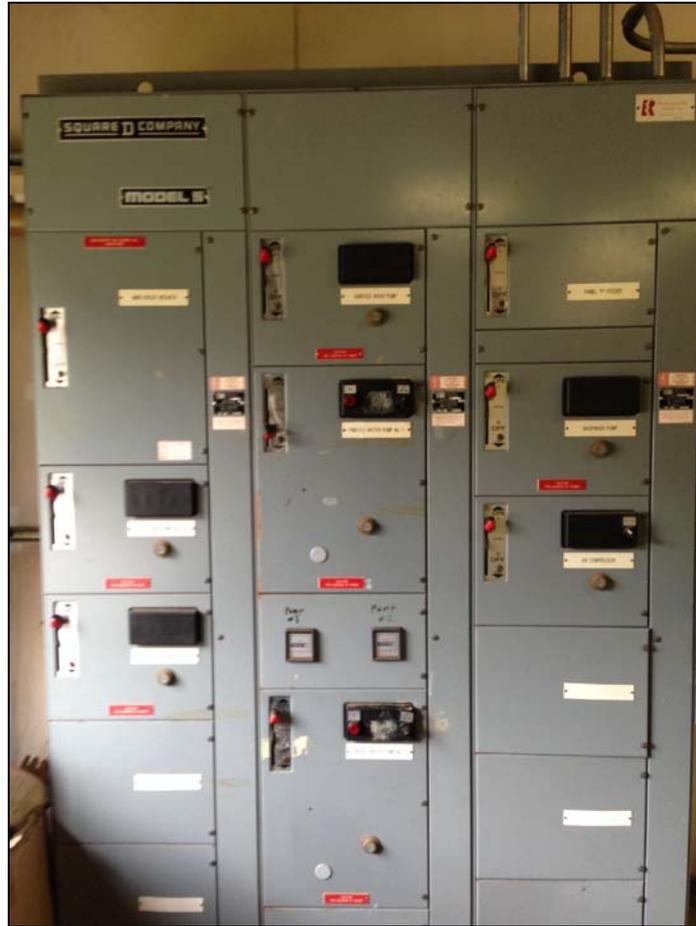
Photo 13 - Plant Motor Control Center

The existing facility currently lacks an emergency generator or other secondary source of power. It was reported by the operators that several power failures and surges take place each year, causing disruption of the treatment process, major alarms, equipment failures and manual restarting of the facility. To ensure system reliability, a new emergency generator and automatic transfer switch should be provided which has sufficient capacity for all necessary process electrical loads.

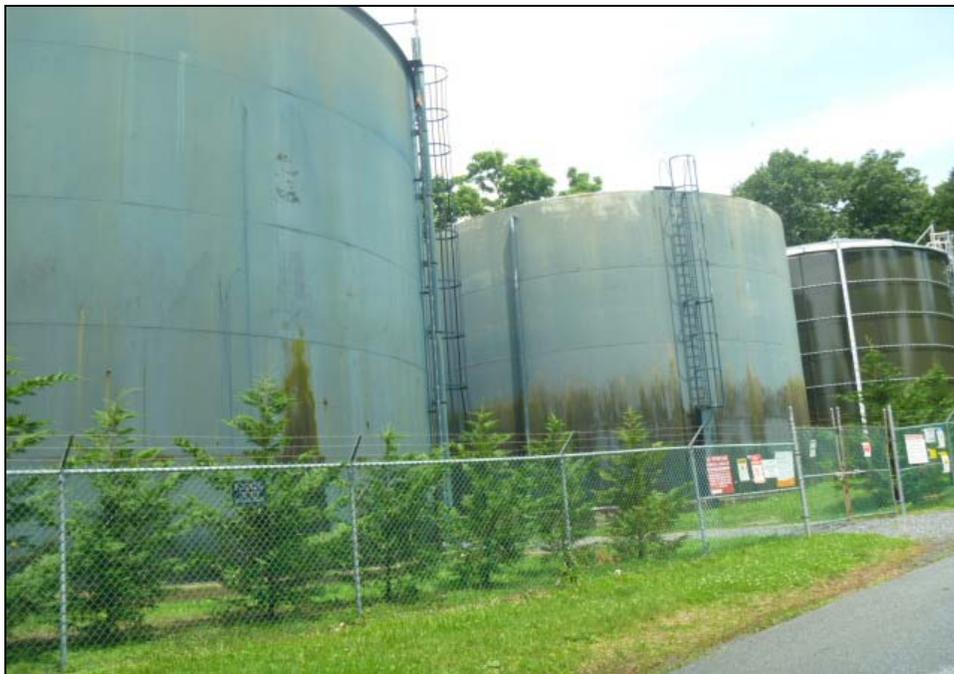
Photo 14 - Finish Water Storage Tanks

Tank inspections for these tanks were performed in September 2012 by the Pittsburg Tank & Tower Maintenance Company. The inspections indicated significant signs of wear including deteriorating sealant around the perimeter of the base of the tanks and at the roof/shell connections, inadequate safety signage, inadequate access to the roof hatch and missing fall protection rail on the tank roofs. Additional external deficiencies include the omission of frost proof drain valves, lack of an air break in the overflow drains and frost-proof pressure vents.

The interior of the tanks are beginning to show signs of corrosion on both the roof and the liner. In addition to this corrosion, sediment and debris has collected at the bottom of each tank. The exterior coatings of the tanks also show signs of rust and deterioration.

Finish Water Storage - The three (3) existing water storage tanks are considered adequate based on the WV BPH finish water storage and ISO fire flow criteria. The tanks provide 1,019,000 gallons or 4.13 days of storage.

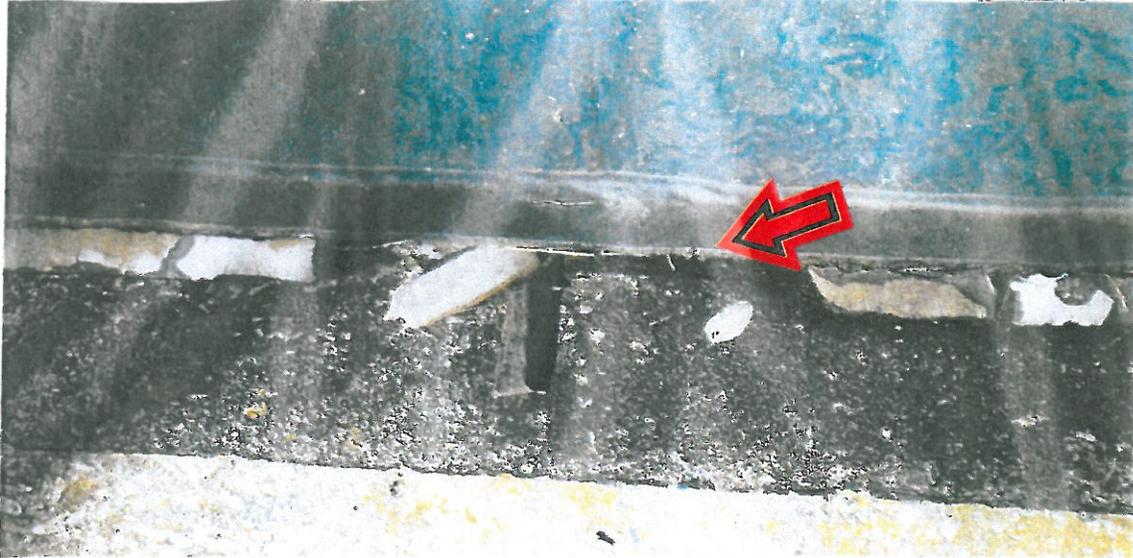
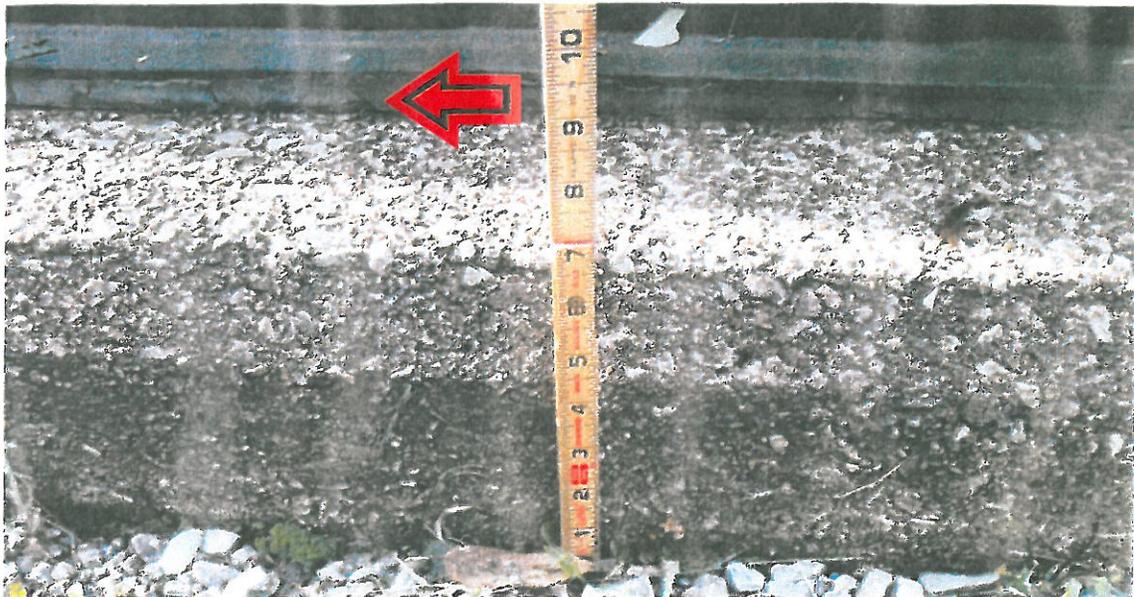
Photos show the condition of the foundation. We recommend removing damaged grout, then re-grouting and re-caulking around the base of the tank to foundation connection to prevent water from entering under the tank and sealing the foundation with a sealant.

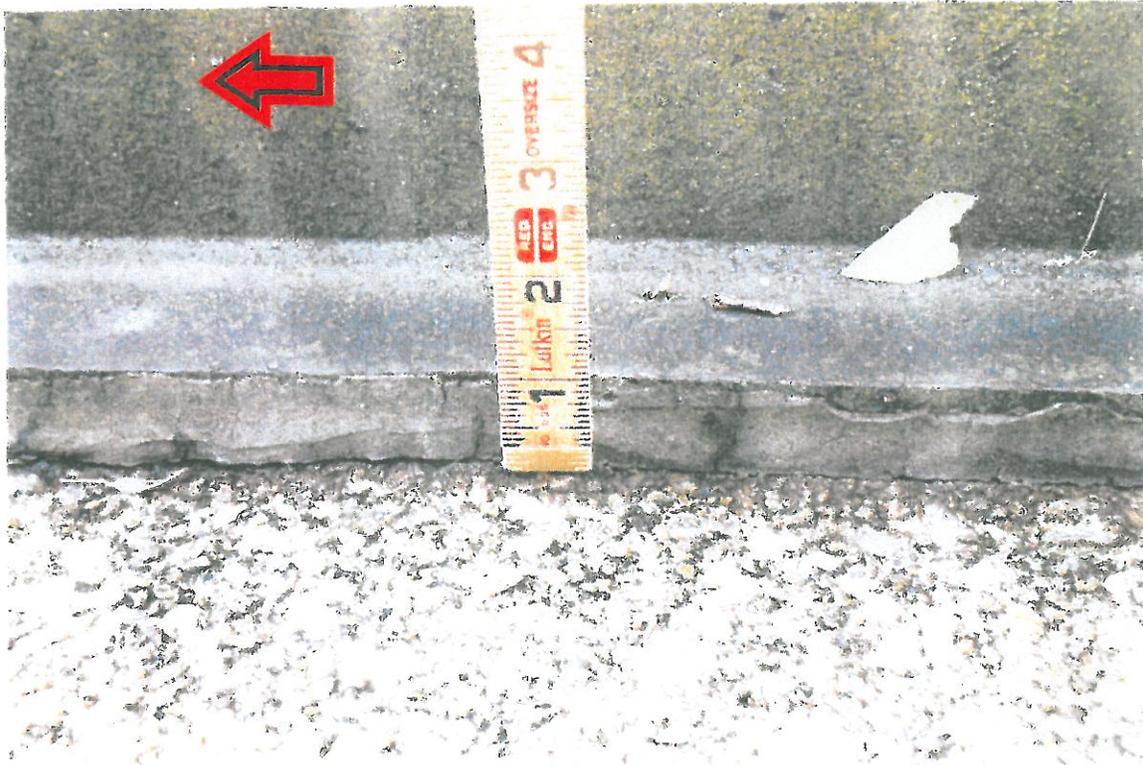
Photo shows the condition of the shell. Currently there is no drain valve. We recommend installing a frost proof drain valve near the shell-to-floor connection, complete with locking device to prevent unauthorized draining of the tank and a splash pad to direct water away from the foundation.

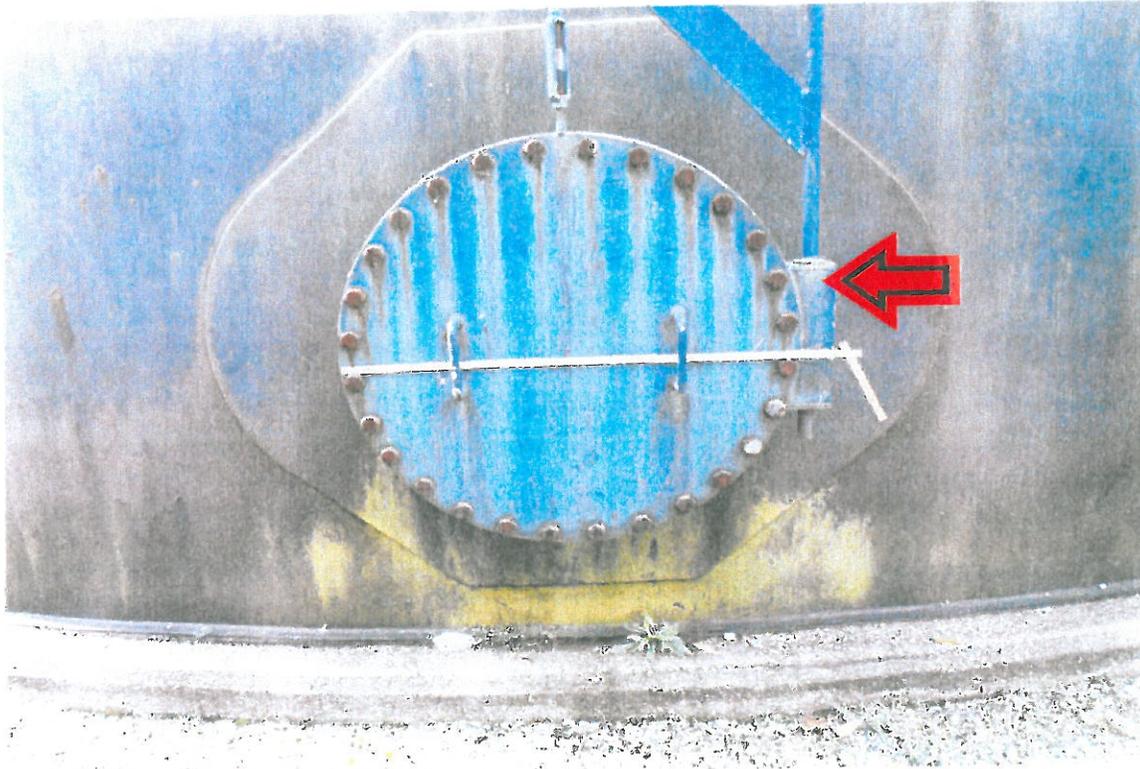
Photo shows the condition of the existing 30" primary shell manway. The manway is in compliance with **AWWA D 100-11 Shell manholes 7.4.4.**

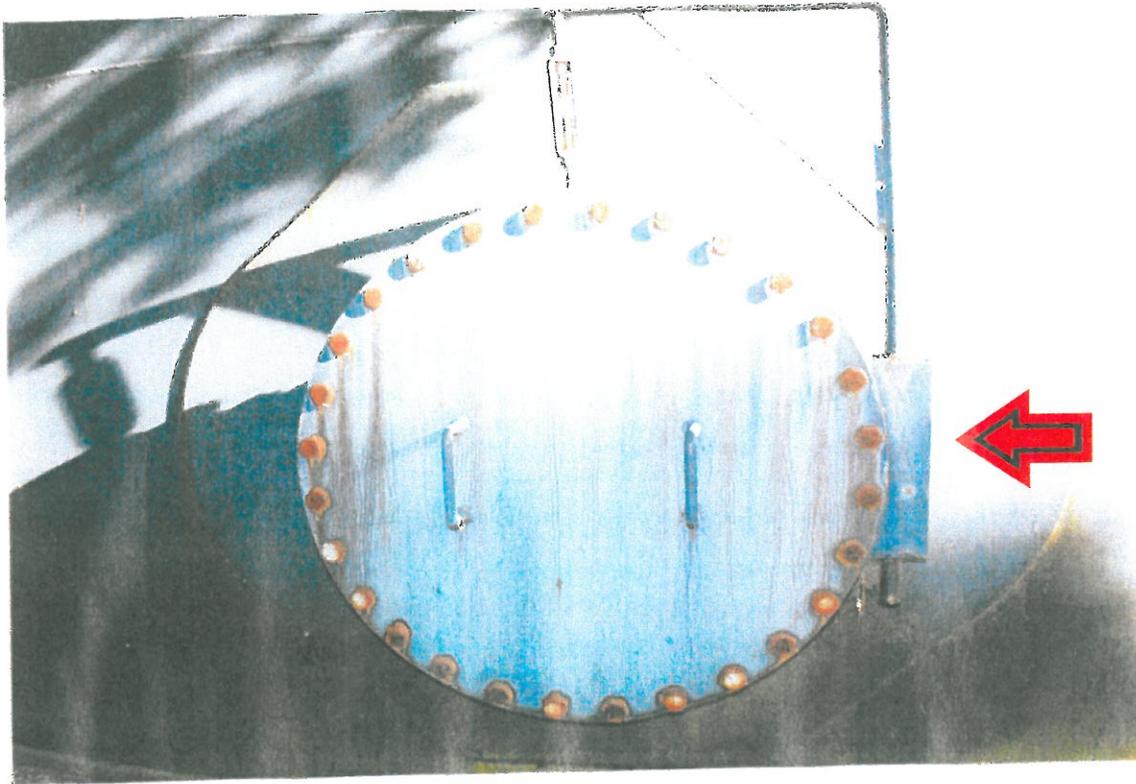
Photo shows the condition of the existing 30" secondary shell manway. The manway is in compliance with **AWWA D 100-11 Shell manholes 7.4.4.**

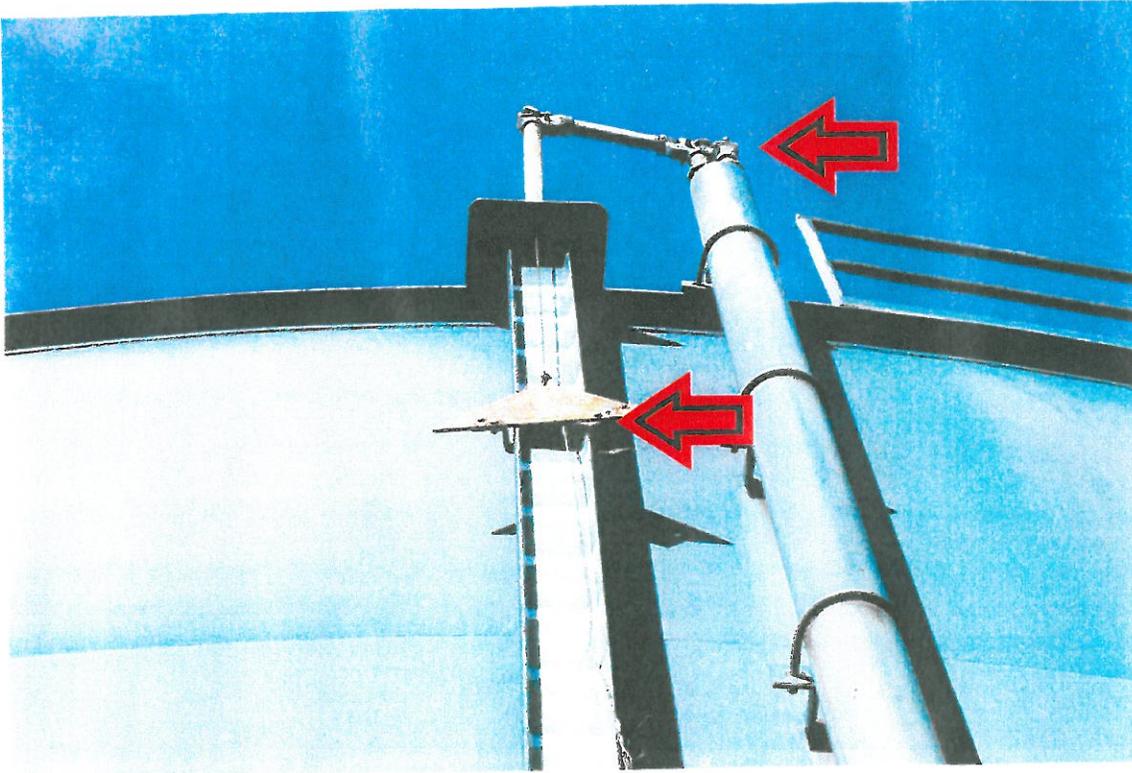
Photo shows the condition of the liquid level indicator. We recommend cleaning and lubricating all moving parts on the liquid level indicator for preventative maintenance, adjusting and calibrating the unit.

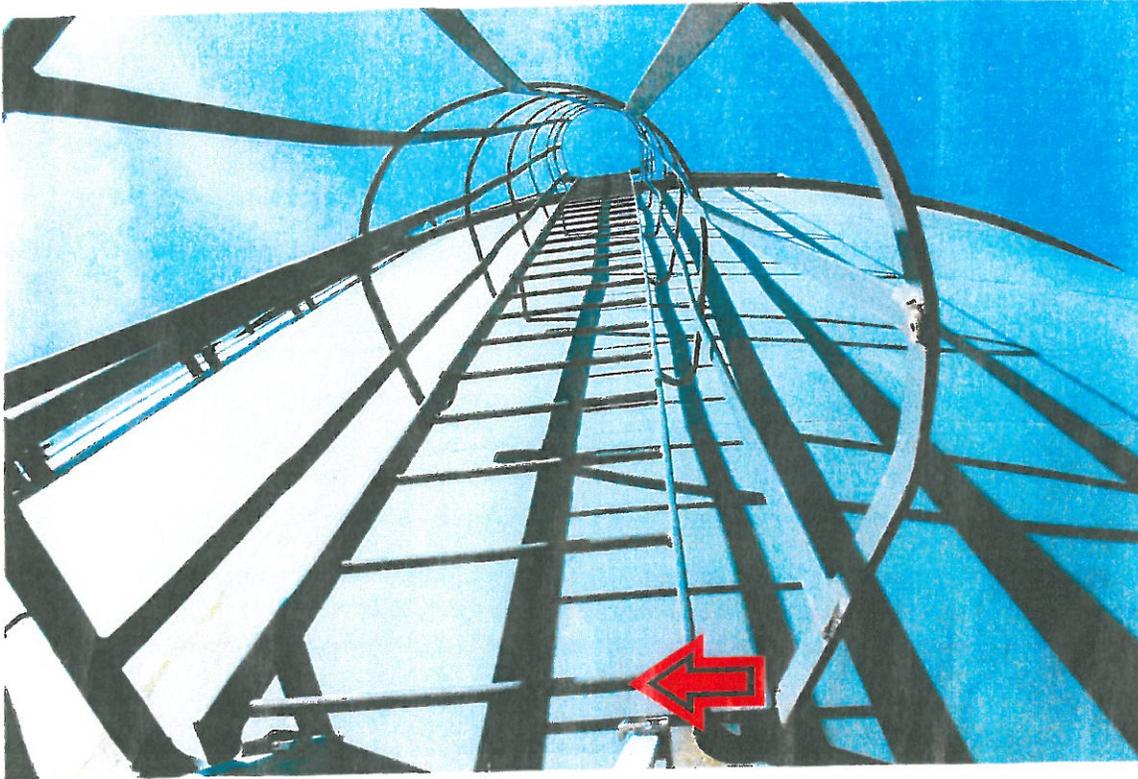
Shell access ladder in above photo is not equipped with anti-skid rungs. **OSHA 29 CFR 1926.1050-1060** states: "Rungs must be corrugated, knurled, dimpled, coated with skid-resistant material or treated to minimize slipping". We recommend installing an **OSHA** approved shell access ladder complete with standoffs every 10' on center, a cable type ladder safety device, a lockable ladder guard to prevent unauthorized access and posting a **Fall Protection Required** sign.

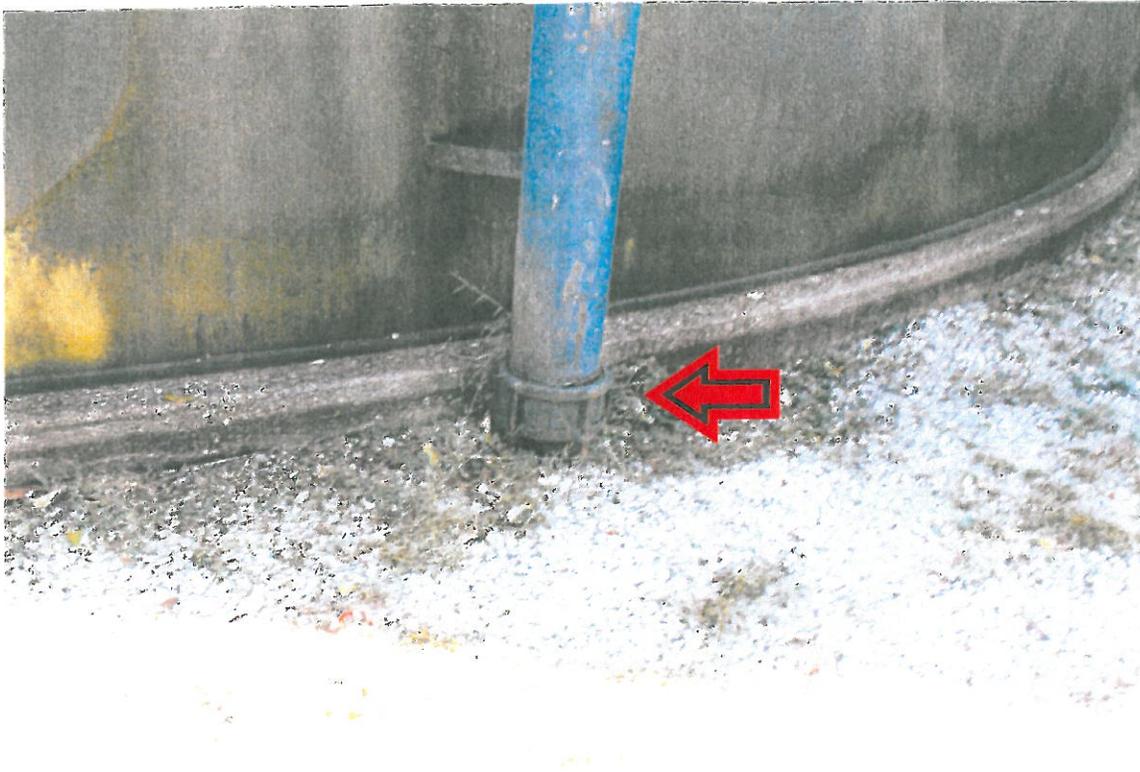
Photo shows the condition of the overflow pipe. We recommend disconnecting the pipe from the underground drain then installing an air break complete with an [AWWA D100-11 7.3: Overflow](#), approved flapper valve and screen to prevent the ingress of contaminants into the water supply.

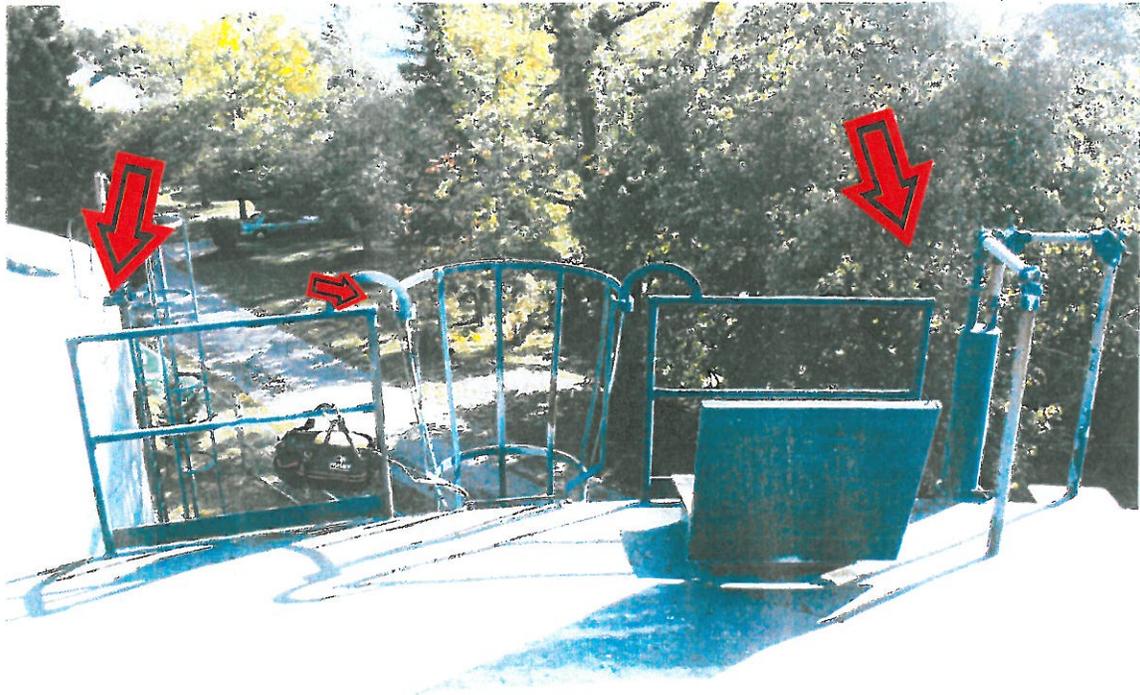
Photo shows the tank roof is not equipped with a required fall protection system. **OSHA 29 CFR 1910.23(a)(1)** requires fall protection on the edges of all walking, working surfaces. The tank is equipped with handrails to the right and left of the access ladder. **OSHA 1910.23 Subpart c** requires fall protection to encompass all walking, working surfaces. We recommend extending the handrails around the circumference of the tank roof, complete with a toeboard, an intermediate rail and a stainless steel gate chain at the junction of the shell-to-roof access ladder and tank roof.

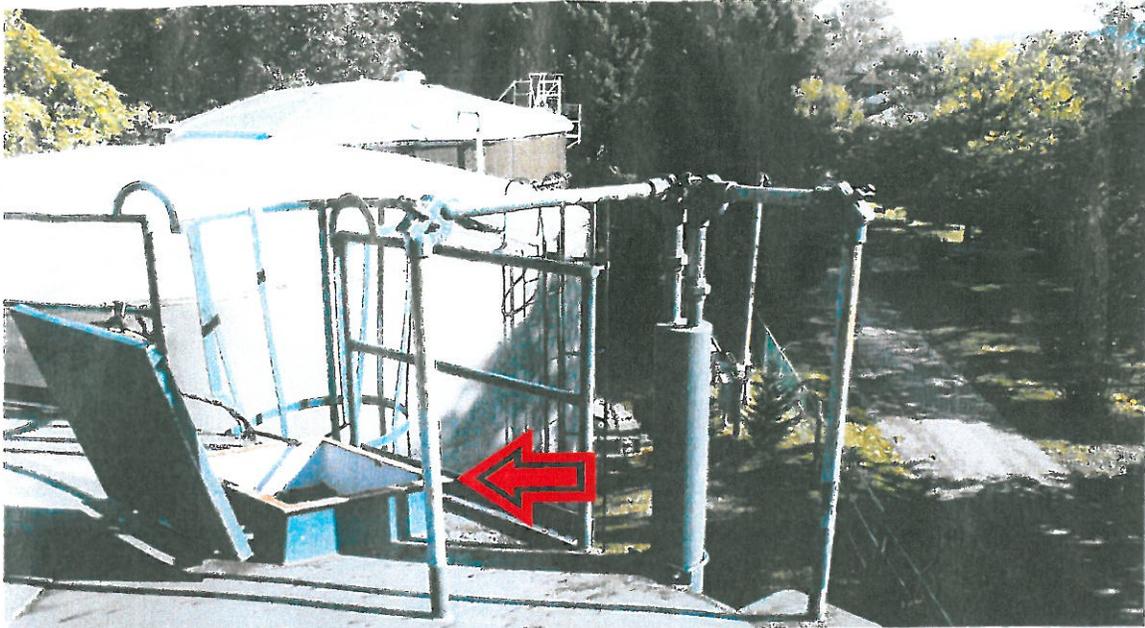
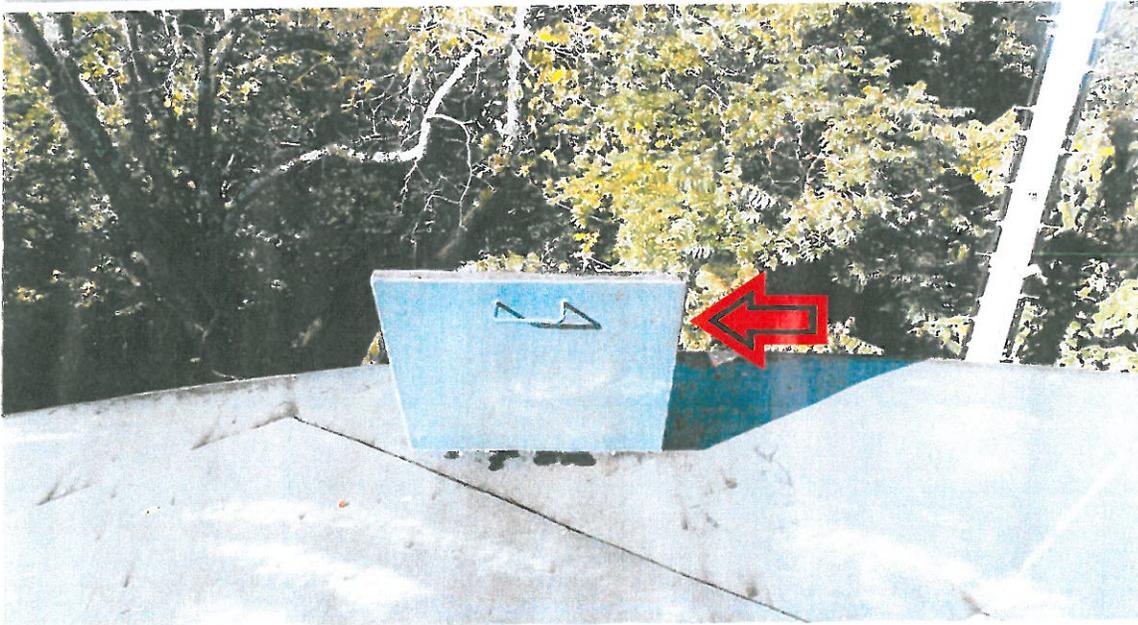
Photos show the condition of the roof manways. Roof openings on this tank require the following to be in compliance with **TSS 7.0.8.2, AWWA D100-11, 7.4.3:**
Roof openings.

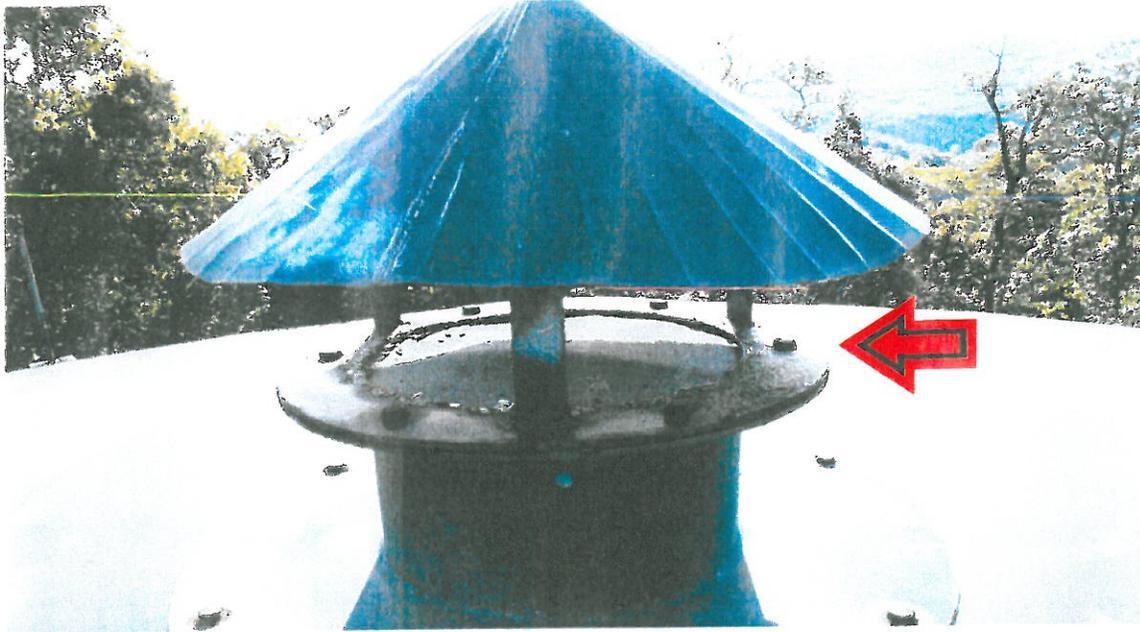
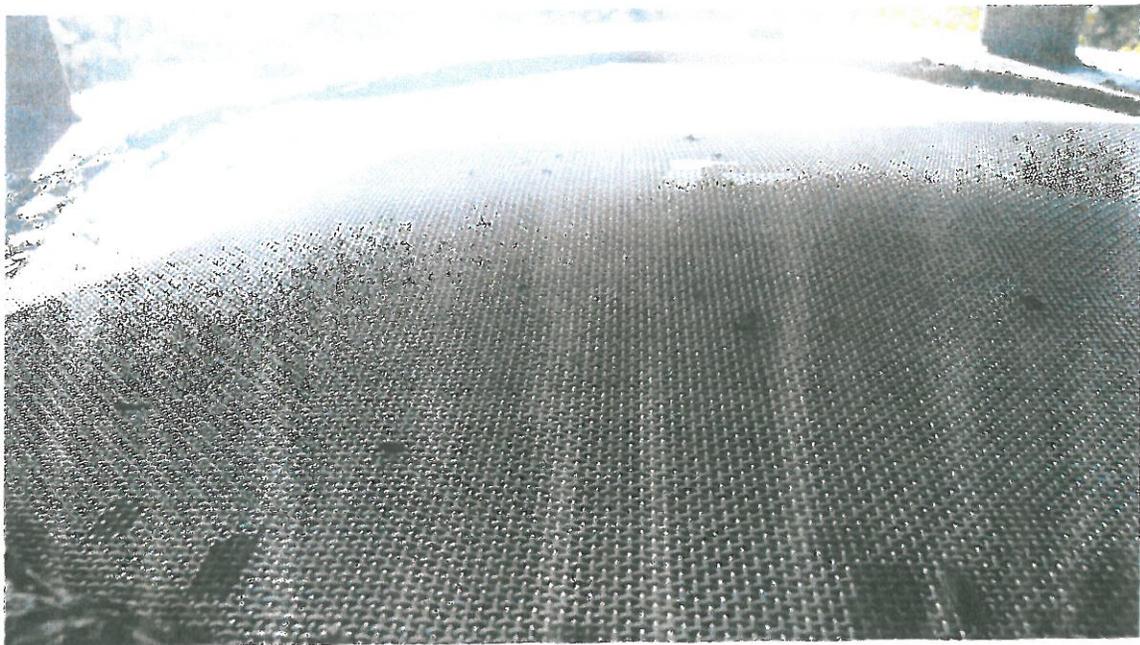
Photos show the condition of the existing roof vent and screen. **AWWA D100-11, 7.5.2** requires a vacuum/pressure device on all vents that require an insect proof screen. This vent is allowing the ingress of rain and wind-borne contaminants into the water system. **An improperly vented tank may cause external pressure to act on the tank which can cause buckling even at low pressure differential.** We recommend replacing the existing roof vent with a vacuum-pressure, frost proof vent and screen.

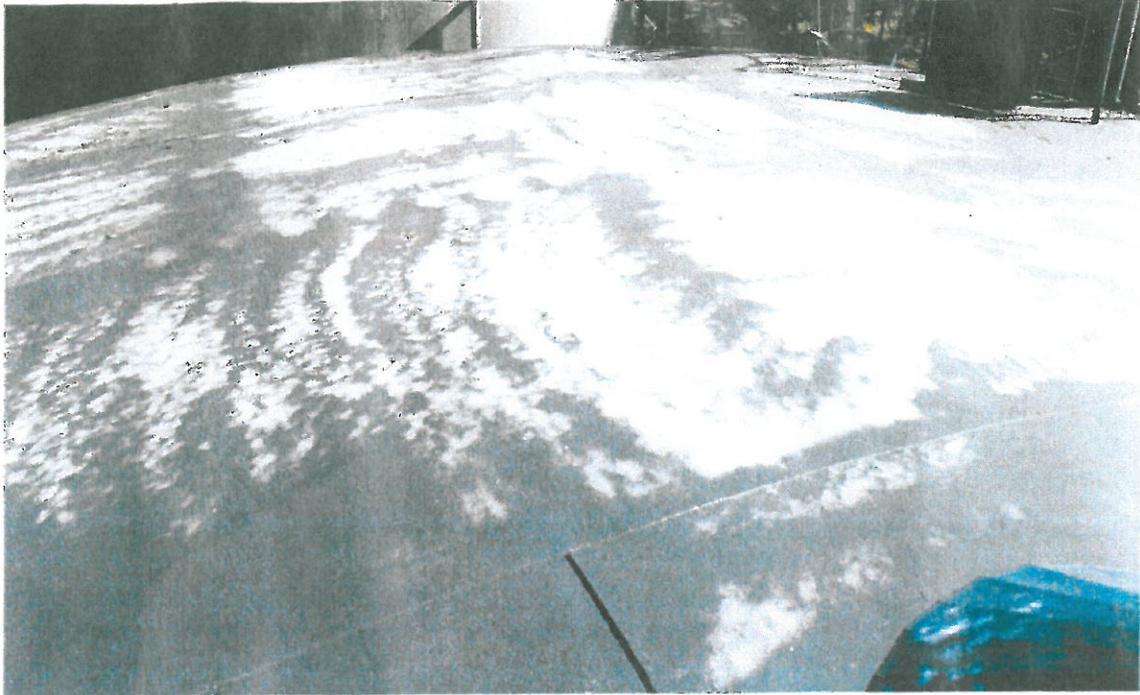
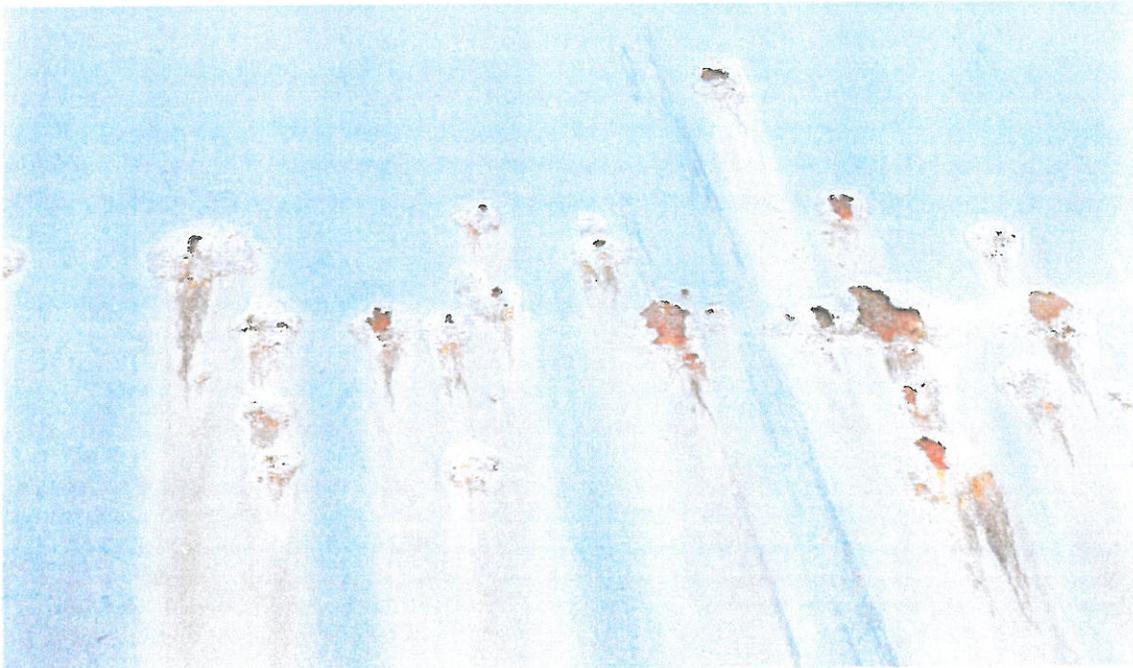
Photos show the tank exterior coating system. We recommend pressure washing the tank exterior with biodegradable detergent injection (minimum 3,500 psi at 3.0 gpm) then remove all loose rust and scale with wire brushes and hand scrapers in accordance with SSPC#2 (hand tool cleaning), spot prime and apply one (1) finish coat of alkyd enamel.
