HARPERS FERRY WATER WORKS

EVALUATION AND FEASIBILITY STUDY

**WATER TREATMENT FACILITY AND
DISTRIBUTION SYSTEM UPGRADES**

NOVEMBER 2013

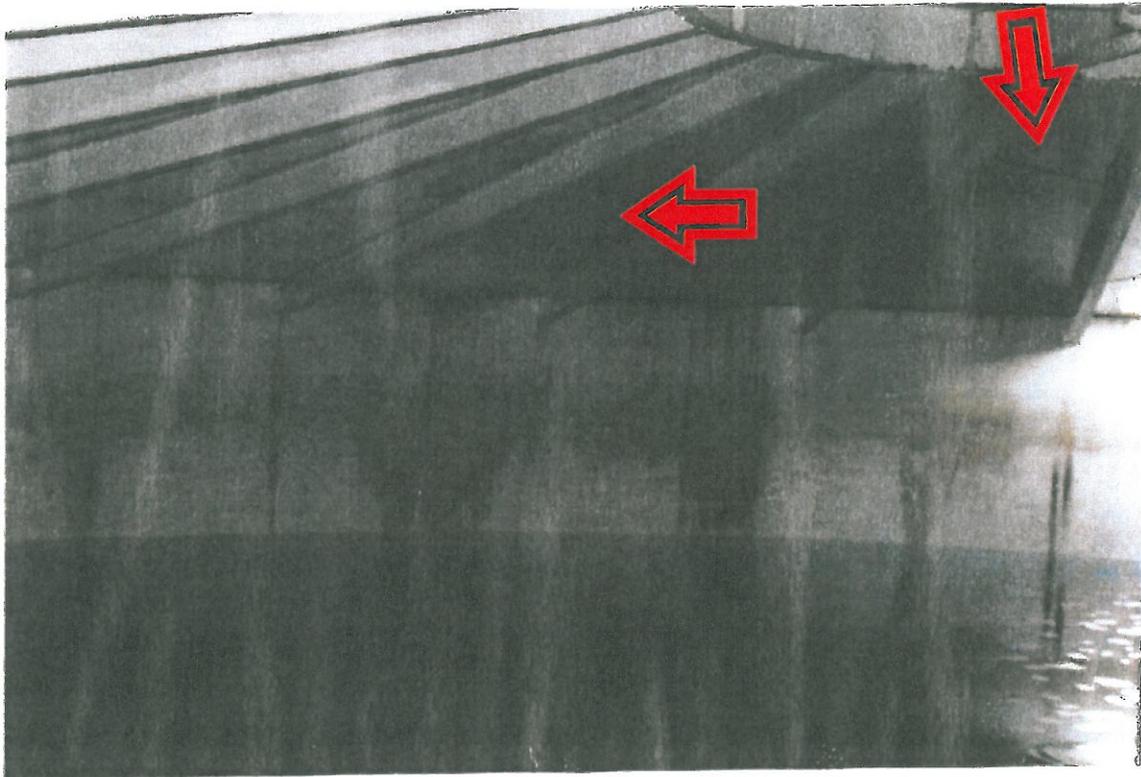
Photo shows the condition of the interior roof. Notice the rust forming at the roof lap seams. We recommend, seam sealing all un-welded interior roof lap seams with Sika-Flex 1A to prevent failure of a new interior liner.

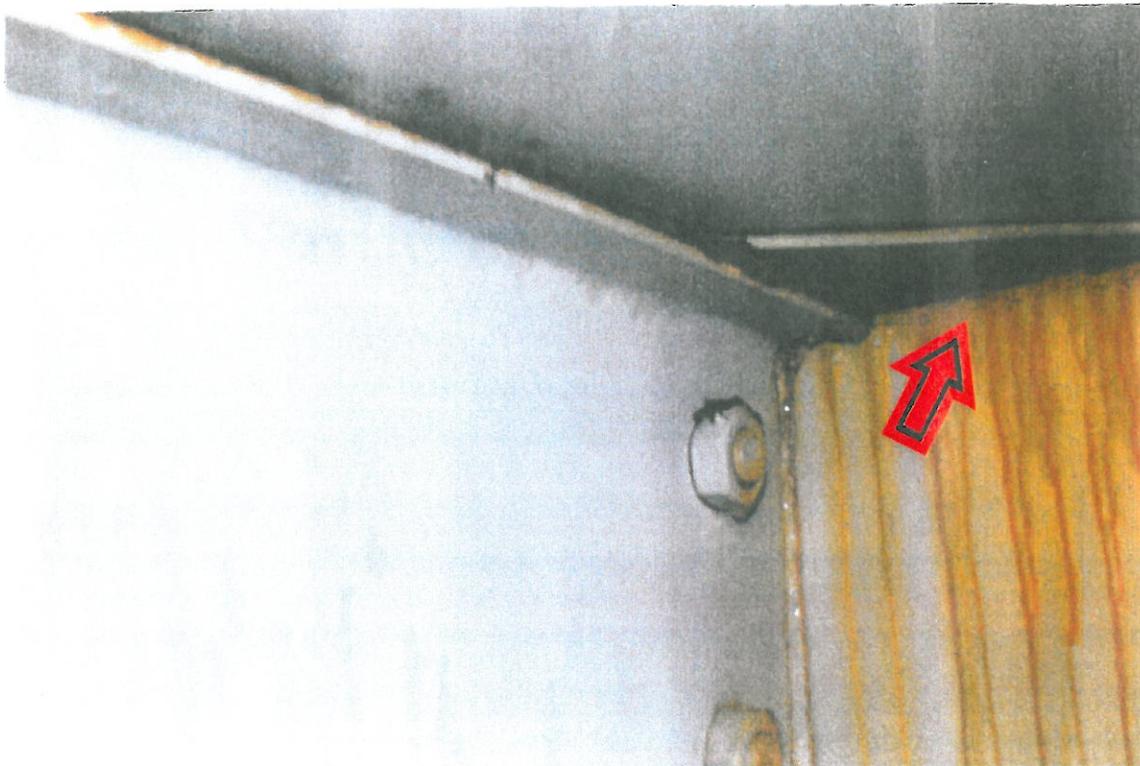
Photo shows the condition of the interior roof-to-rim angle connection. Notice the rust forming in the crevice between the roof and rim angle. We recommend seam sealing the roof to rim angle with Sika-flex 1A to prevent failure of a new interior liner.

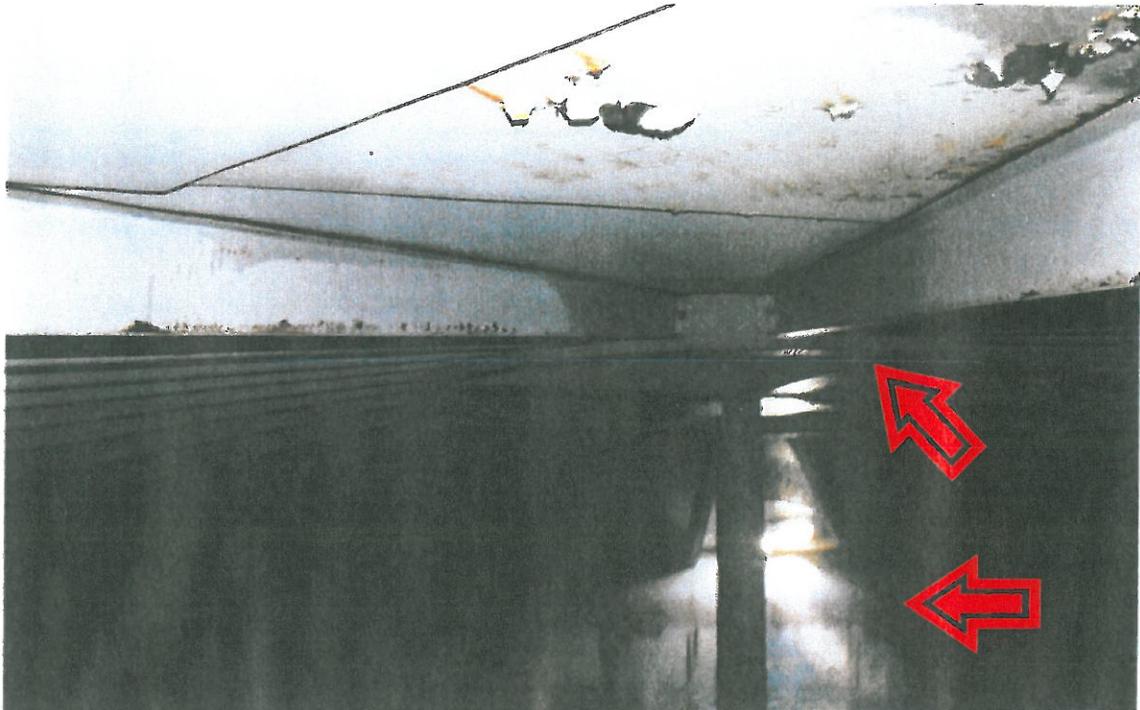
Photo shows the condition of the rafter-to-support column and rafter-to-shell connections. We recommend rewelding the rafter-to-support column and rafter-to-shell connections to reinforce.

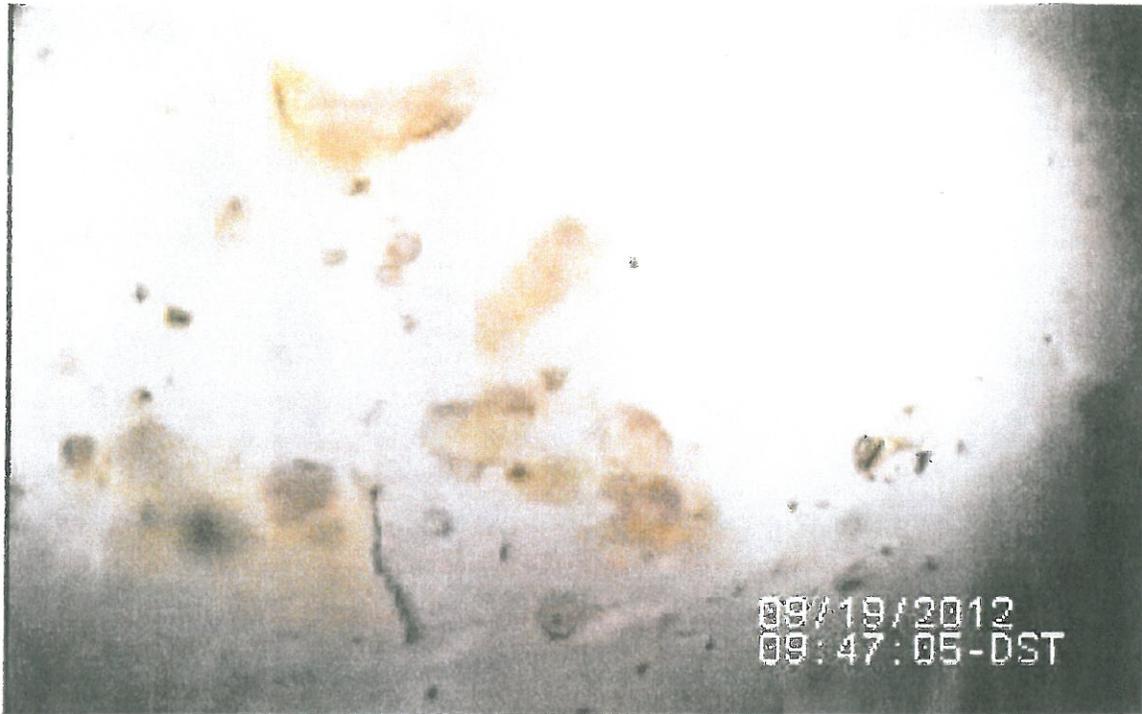
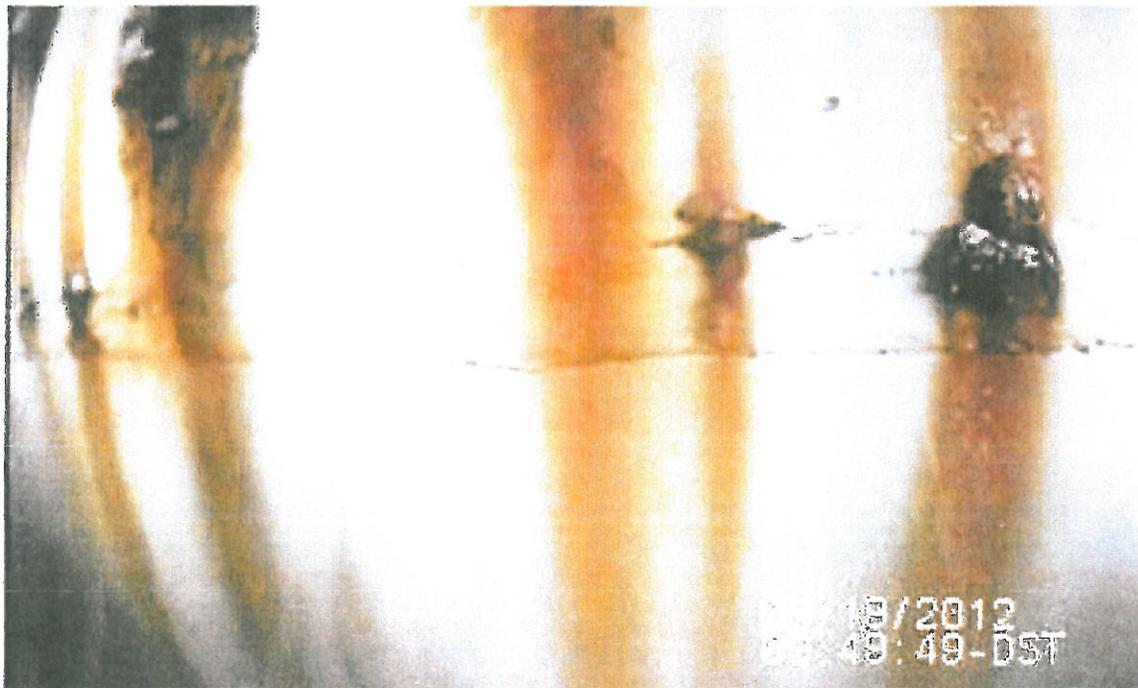
Photos show the condition of the interior liner. We recommend sandblasting all rusted and abraded areas of the tank interior to an SSPC #10 (near white blast) condition, brushblast all remaining areas, stripe coating all seams and welds, then applying an epoxy liner to achieve 8-10 mils of dry film thickness.

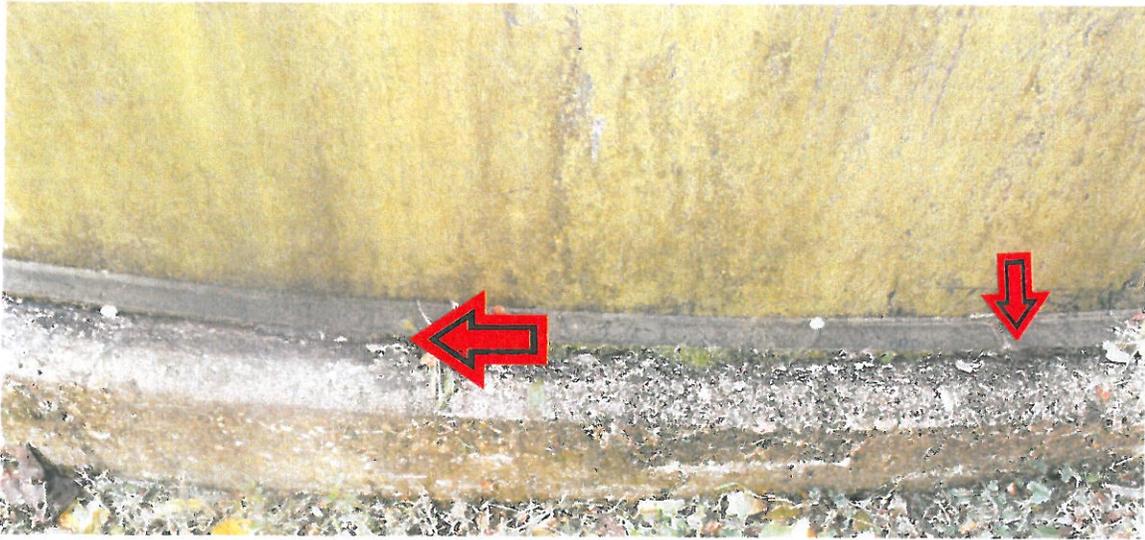
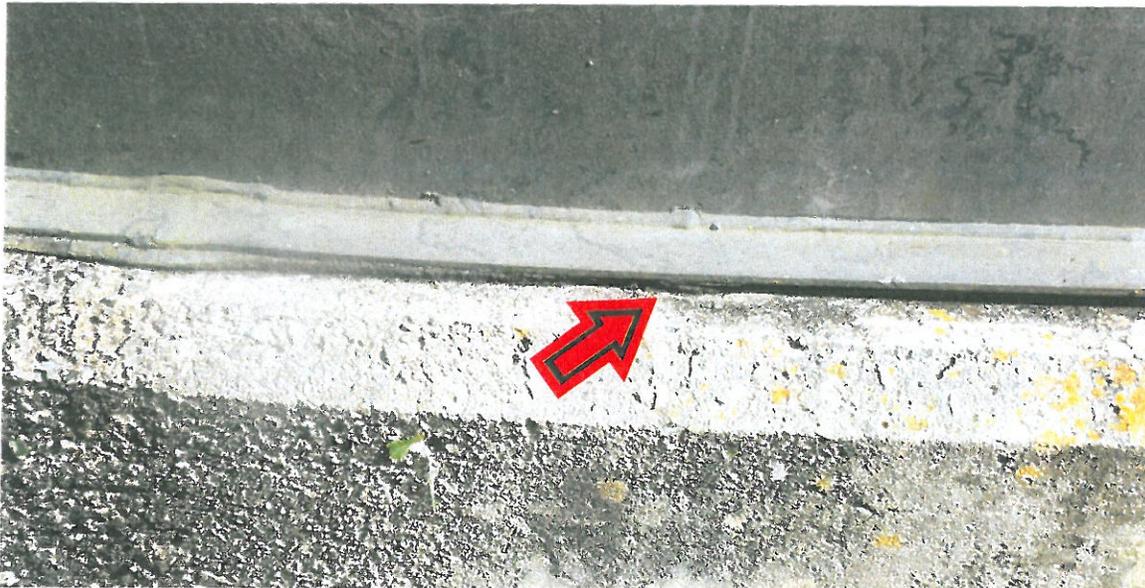
Photos show the condition of the foundation. We recommend removing deteriorated caulk and debris from the tank to foundation connection, then re-caulking around the base of the tank to foundation connection to prevent water from entering under the tank and sealing the foundation with a sealant.

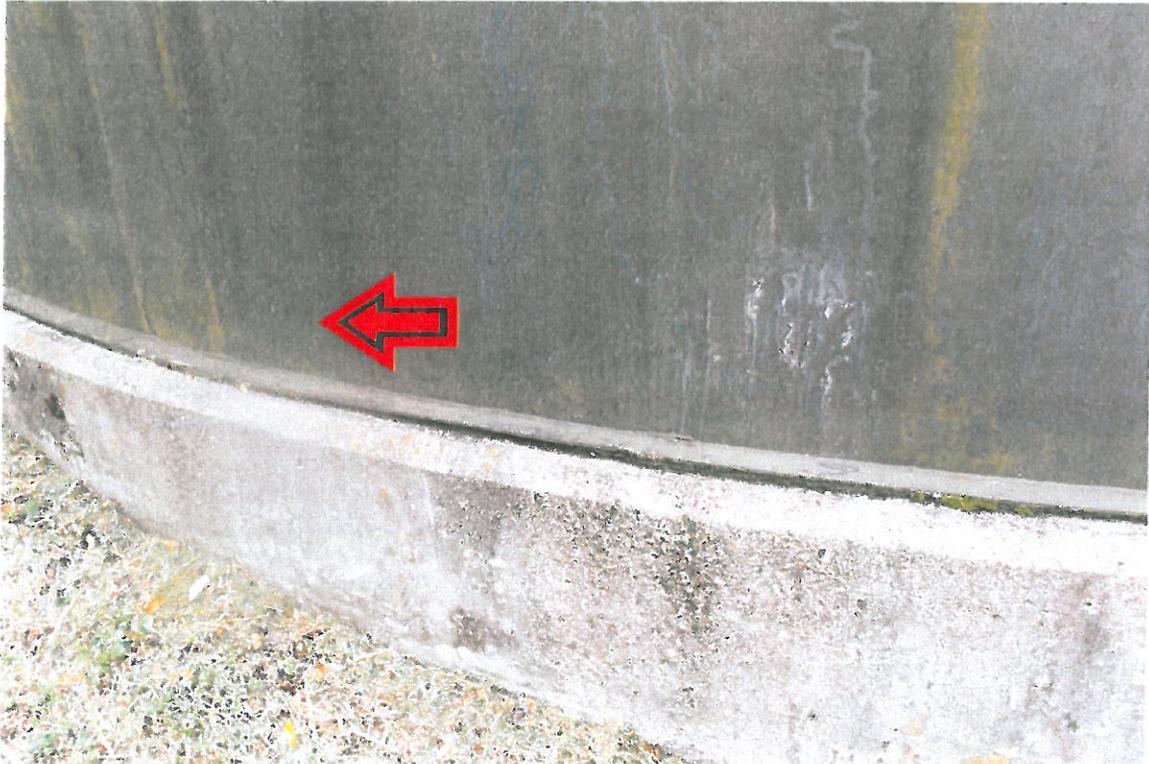
Photo shows the condition of the shell. Currently there is no drain valve. We recommend installing a frost proof drain valve near the shell-to-floor connection, complete with locking device to prevent unauthorized draining of the tank and a splash pad to direct water away from the foundation.

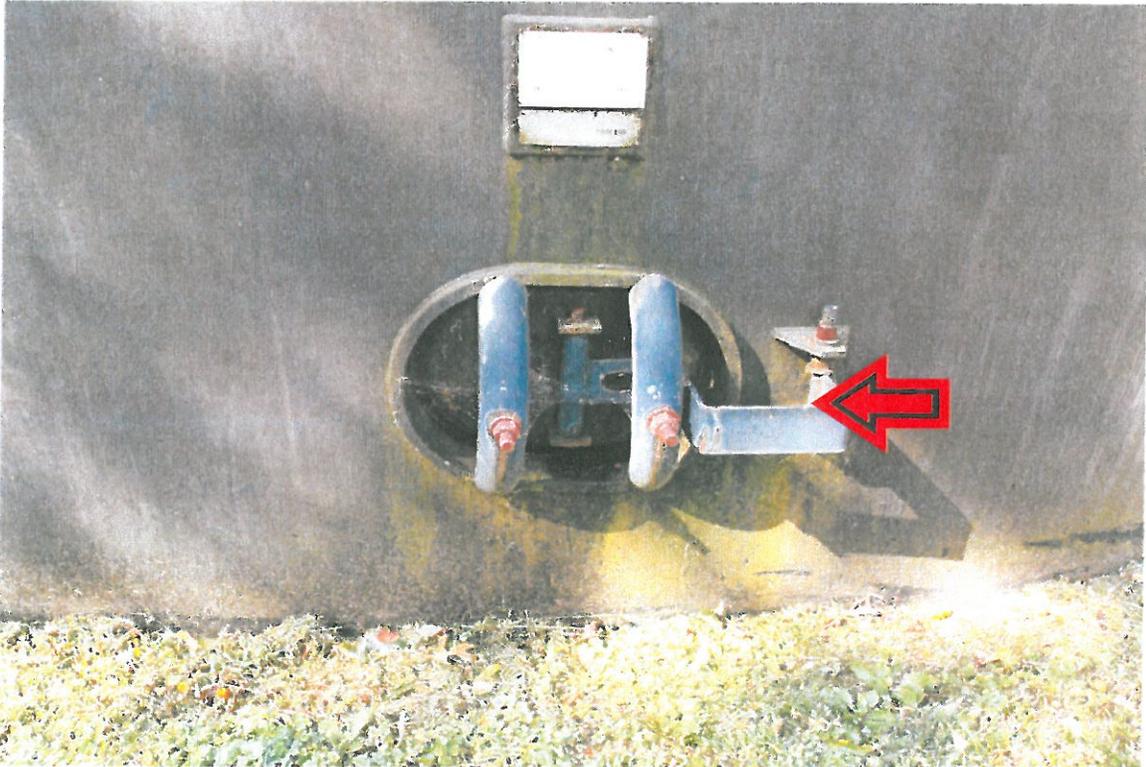
Photo shows the condition of the existing 18" X 24" ' primary shell manway. The manway is in compliance with [AWWA D 100-11 Shell manholes 7.4.4.](#)

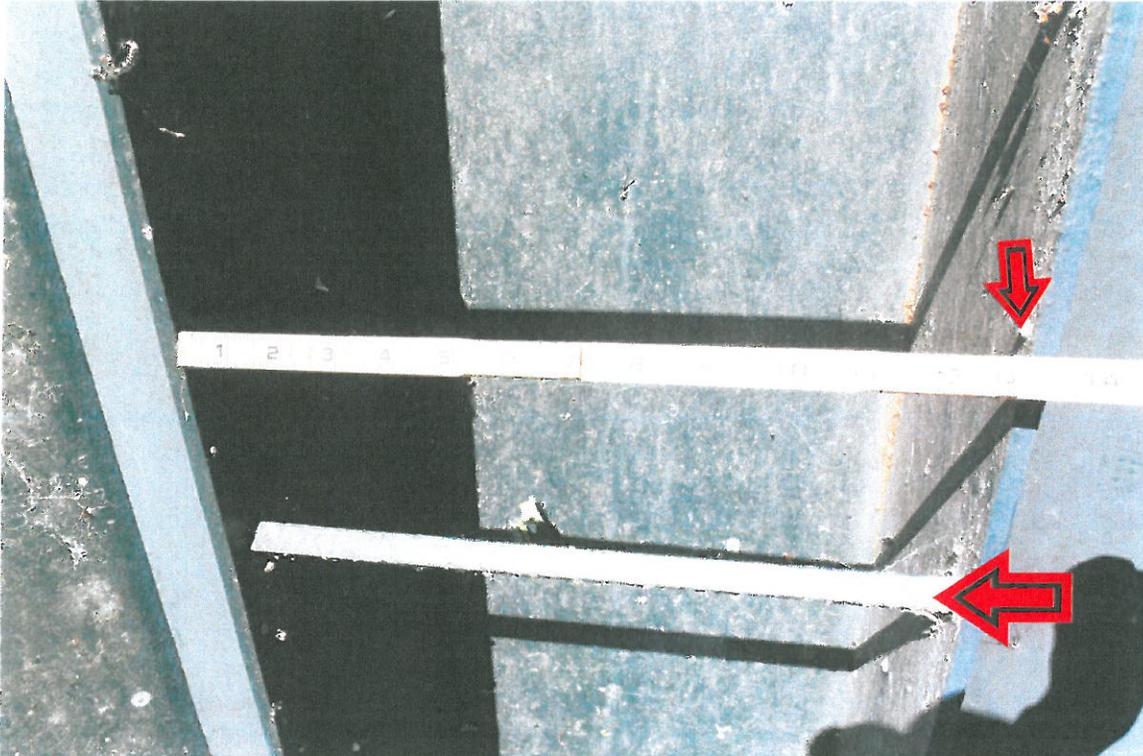
Photos show the tank shell ladder is equipped with anti-skid rungs but is only 13" wide. **OSHA 19.27 Ladders** states: "Minimum clear distance between the sides of individual rung/step ladders and between the side rails of other fixed ladders must be 16 inches (41 cm)." We recommend installing an **OSHA** approved shell access ladder complete with standoffs every 10' on center, a cable type ladder safety device, a lockable ladder guard to prevent unauthorized access and posting a **Fall Protection Required** sign.

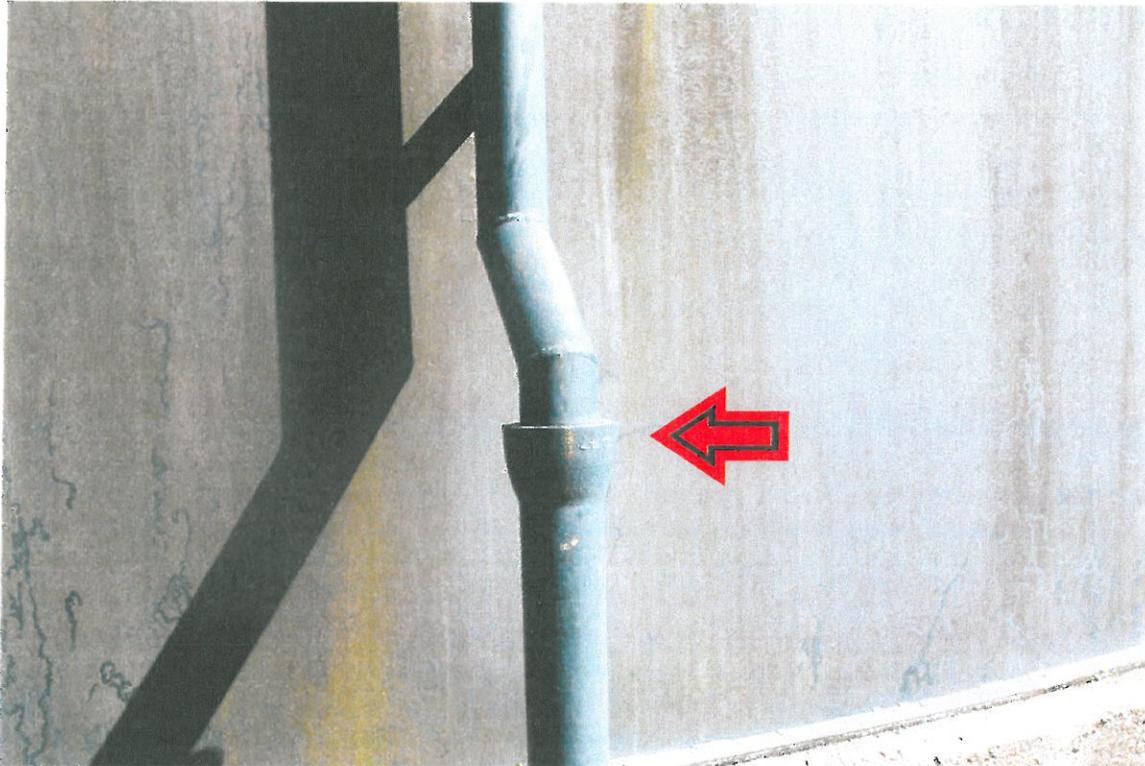
Photo shows the condition of the overflow pipe. We recommend disconnecting the pipe from the underground drain then installing an air break complete with an [AWWA D100-11 7.3: Overflow](#), approved flapper valve and screen to prevent the ingress of contaminants into the water supply.

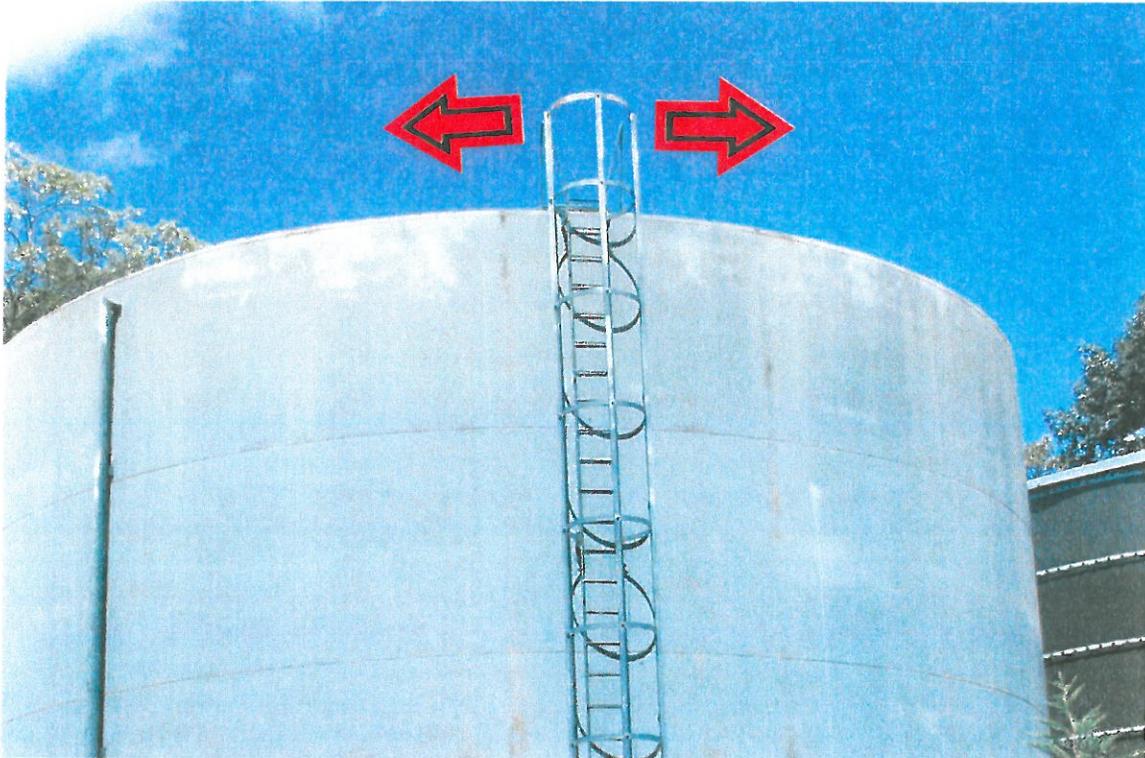
Photo shows the tank roof is not equipped with a required fall protection system. **OSHA 29 CFR 1910.23(a)(1)** requires fall protection on the edges of all walking, working surfaces. **OSHA 1910.23 Subpart c** requires fall protection to encompass all walking, working surfaces. We recommend installing 42" high handrails around the circumference of the tank roof, complete with a toeboard, an intermediate rail and a stainless steel gate chain at the junction of the shell-to-roof access ladder and tank roof.

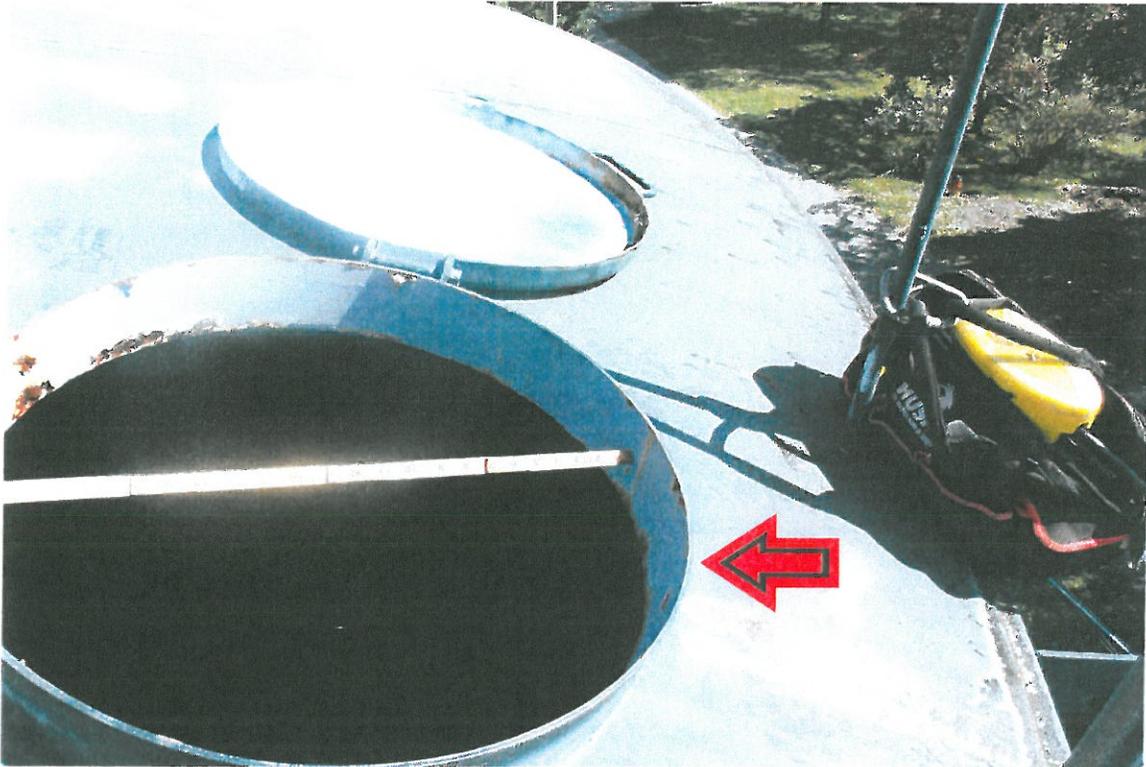
Photo shows the condition of the 24" roof manway. Roof openings on this tank require the following to be in compliance with **TSS 7.0.8.2, AWWA D100-11, 7.4.3: Roof openings.**

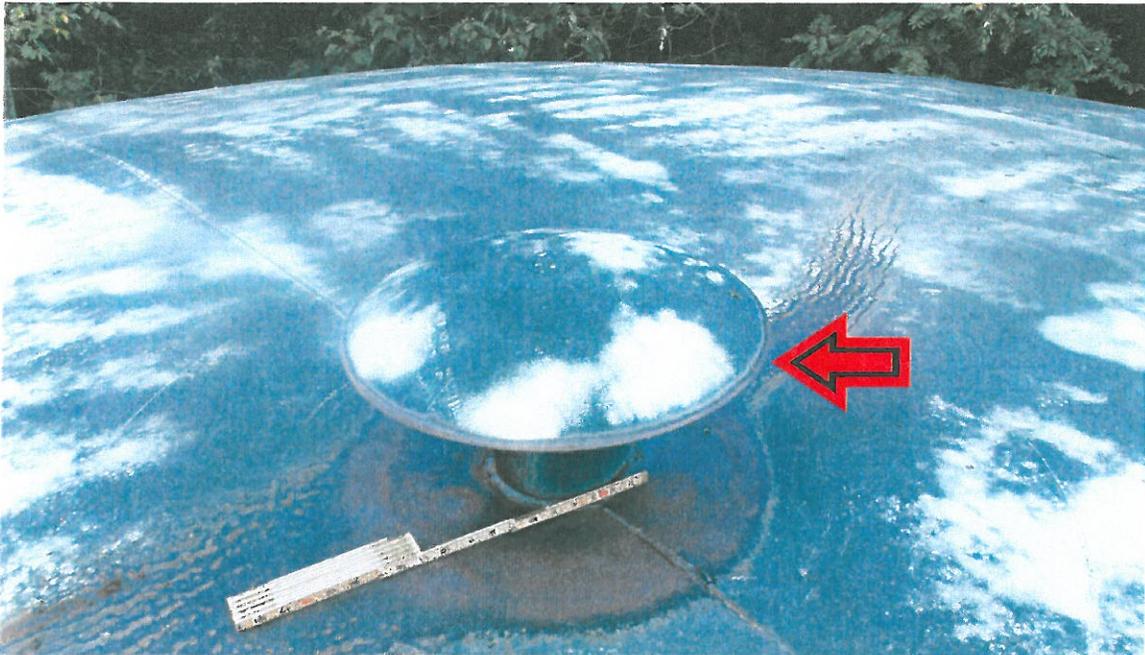
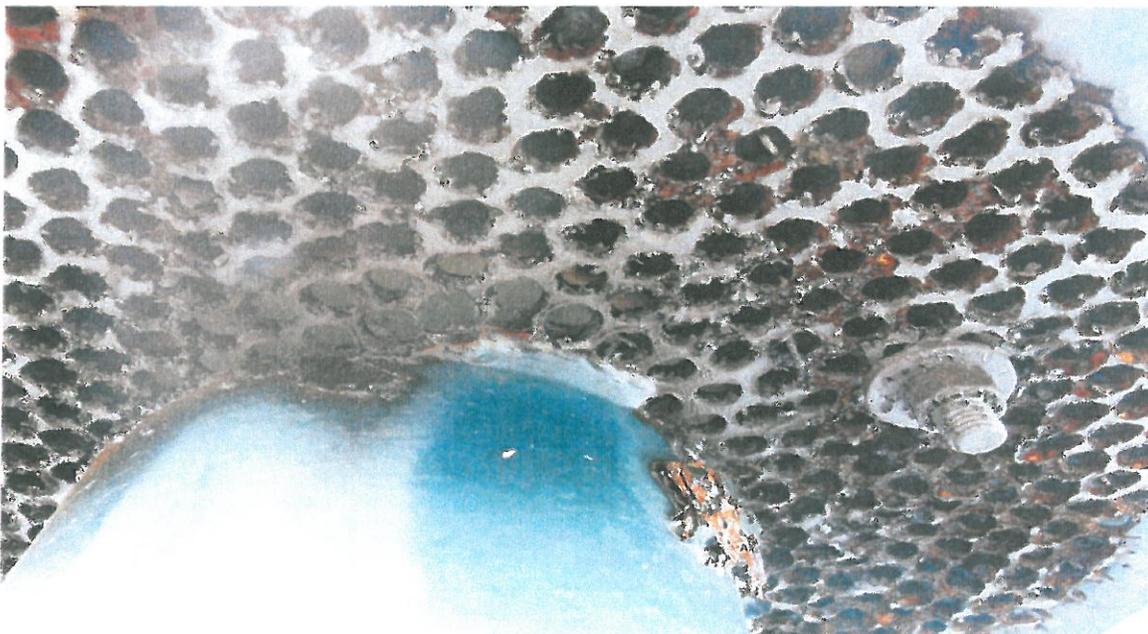
Photos show the condition of the existing roof vent and screen. **AWWA D100-11, 7.5.2** requires a vacuum/pressure device on all vents that require an insect proof screen. This vent is allowing the ingress of rain and wind-borne contaminants into the water system. **An improperly vented tank may cause external pressure to act on the tank which can cause buckling even at low pressure differential.** We recommend replacing the existing roof vent with a vacuum-pressure, frost proof vent and screen.

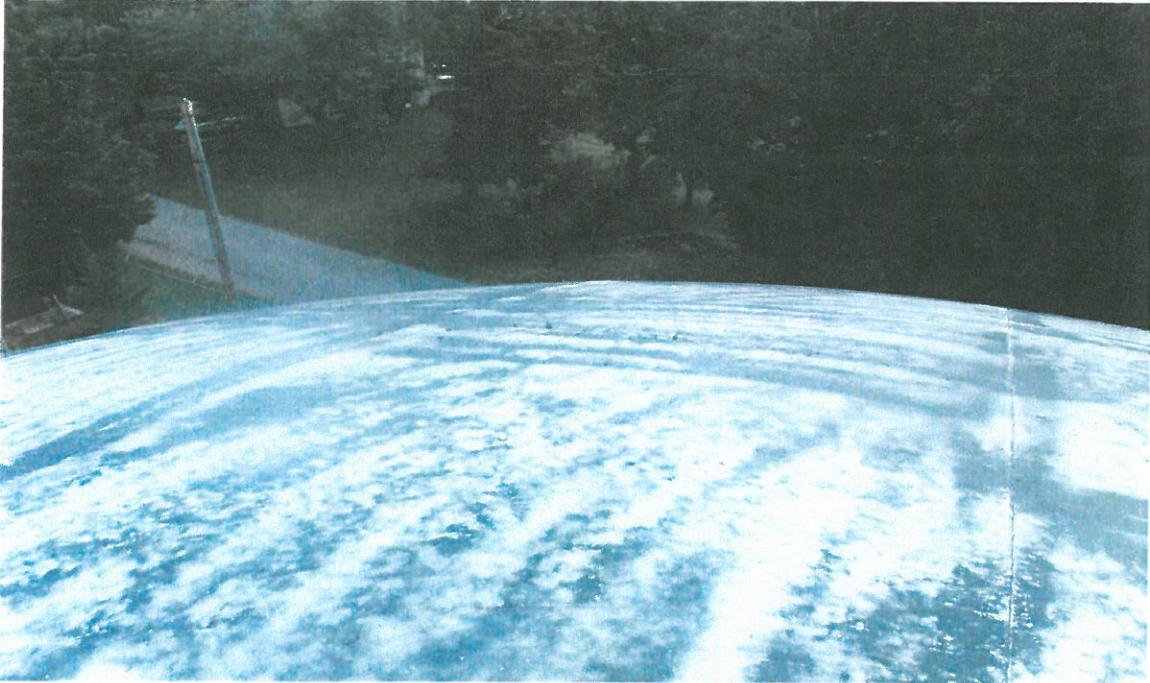
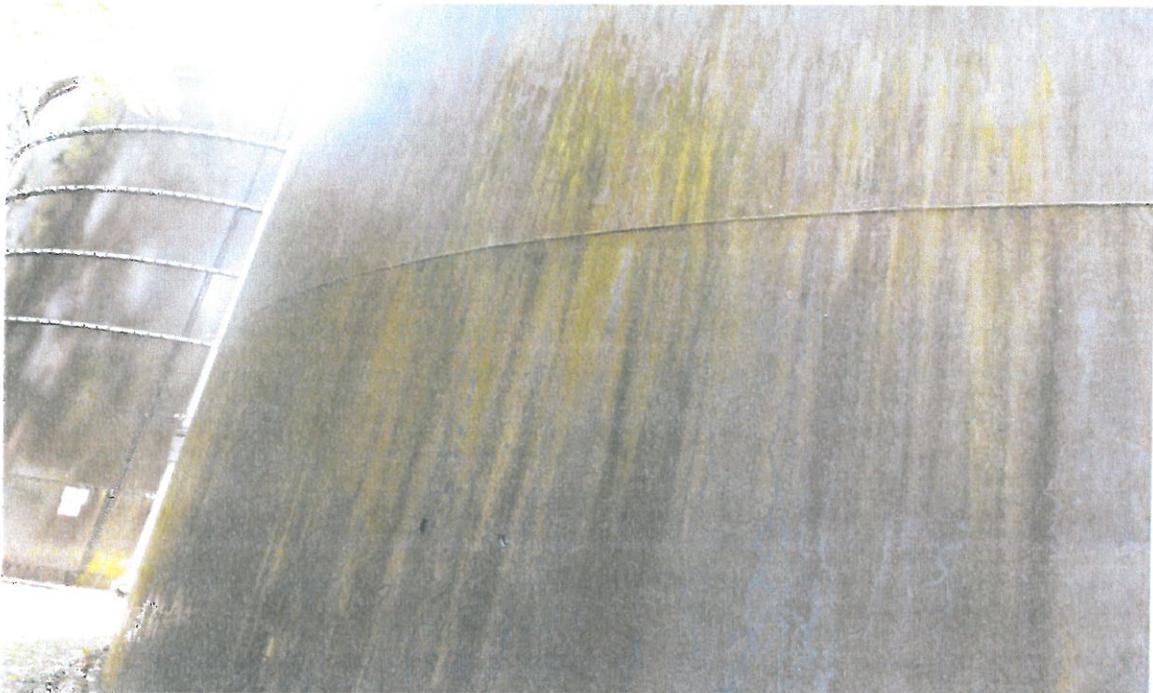
Photos show the tank exterior coating system. We recommend pressure washing the tank exterior with biodegradable detergent injection (minimum 3,500 psi at 3.0 gpm) then remove all loose rust and scale with wire brushes and hand scrapers in accordance with SSPC#2 (hand tool cleaning), spot prime and apply one (1) finish coat of alkyd enamel.

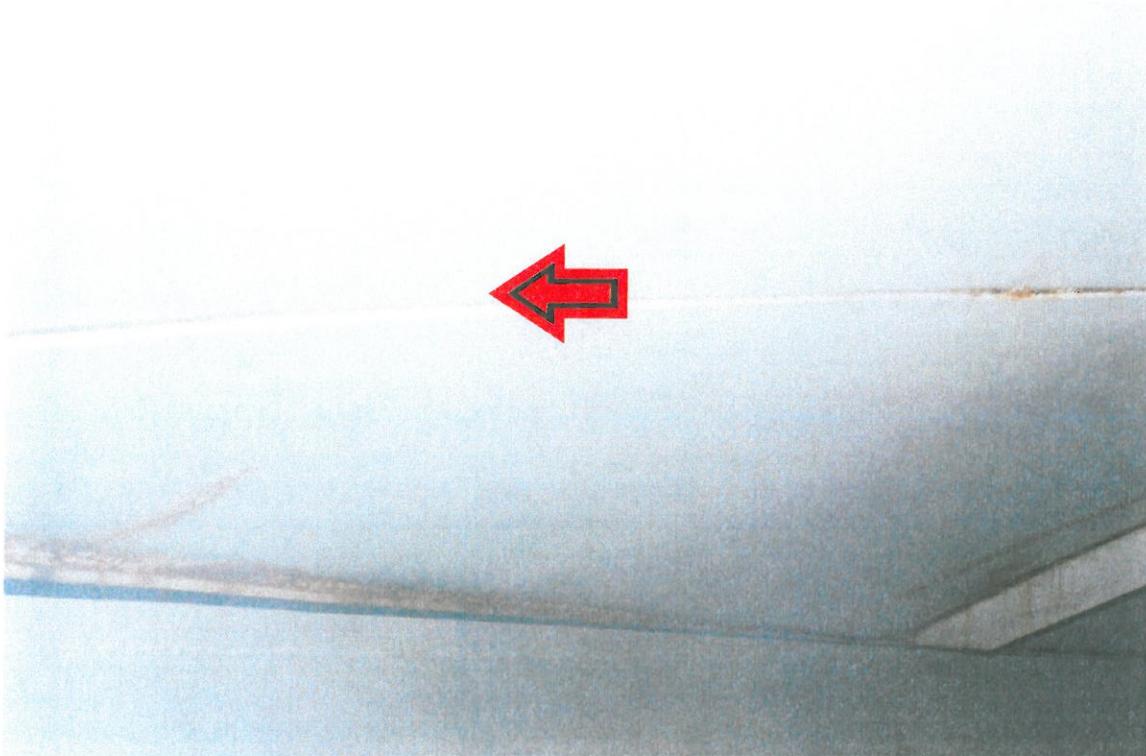
Photo shows the condition of the interior roof. Notice the rust forming at the roof lap seams. We recommend, seam sealing all un-welded interior roof lap seams with Sika-Flex 1A to prevent failure of a new interior liner.

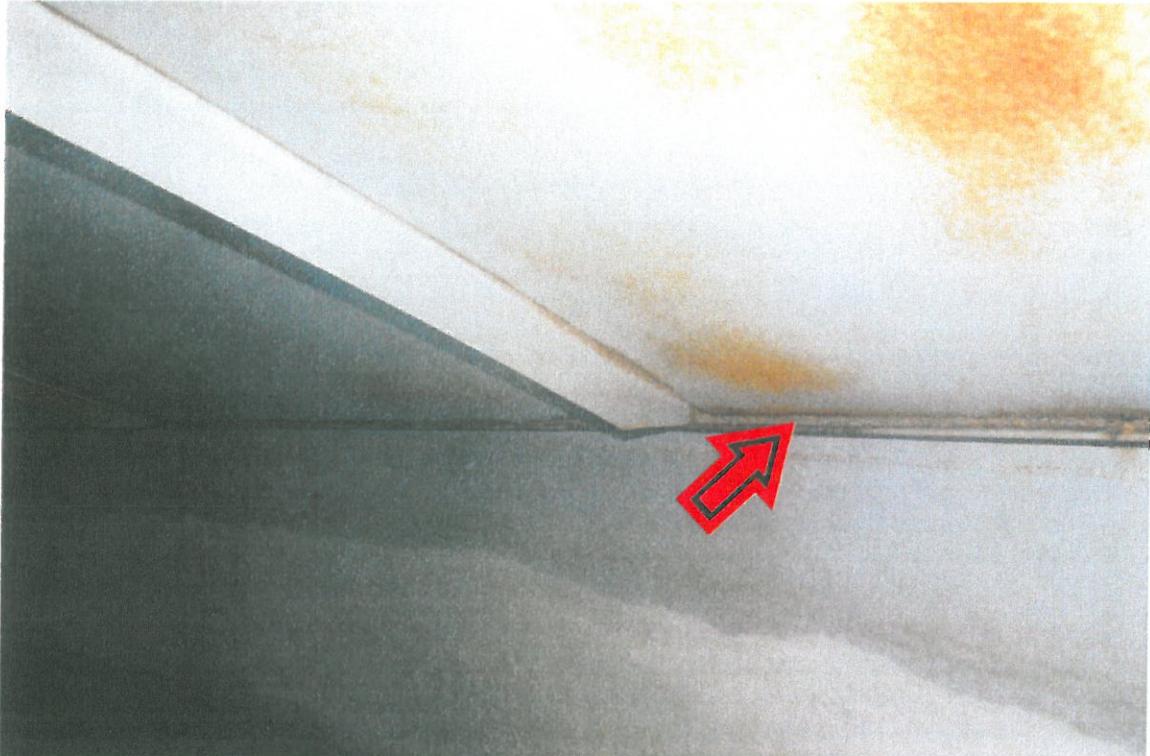
Photo shows the condition of the interior roof-to-rim angle connection. Notice the rust forming in the crevice between the roof and rim angle. We recommend seam sealing the roof to rim angle with Sika-flex 1A to prevent failure of a new interior liner.

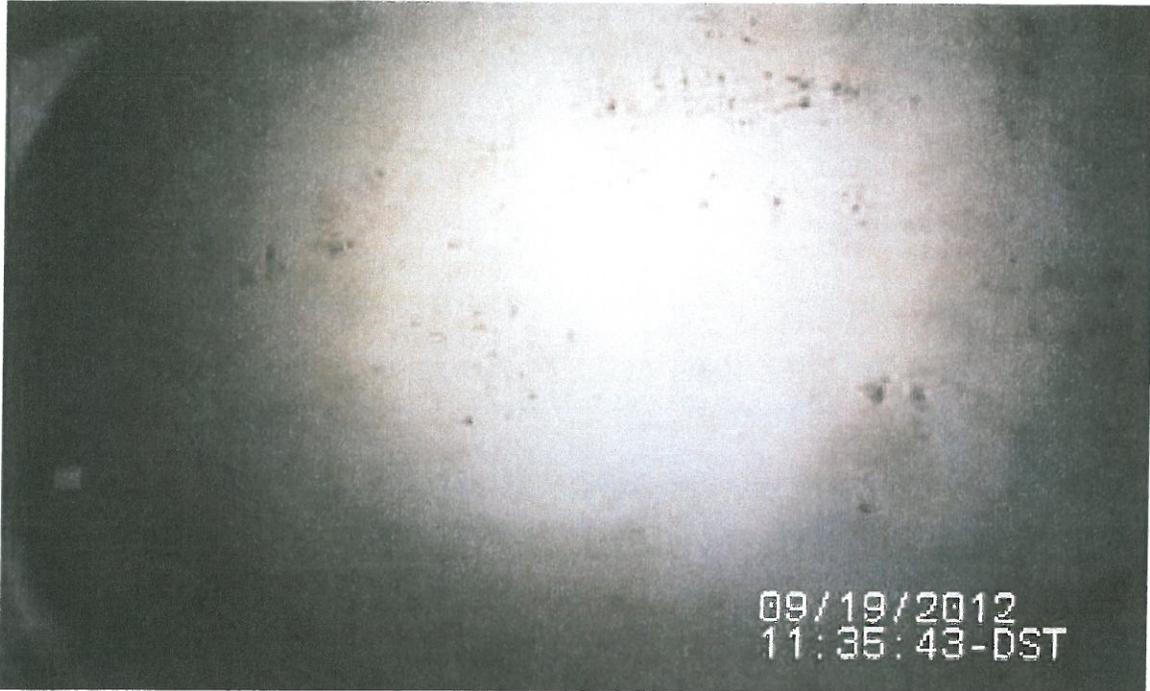
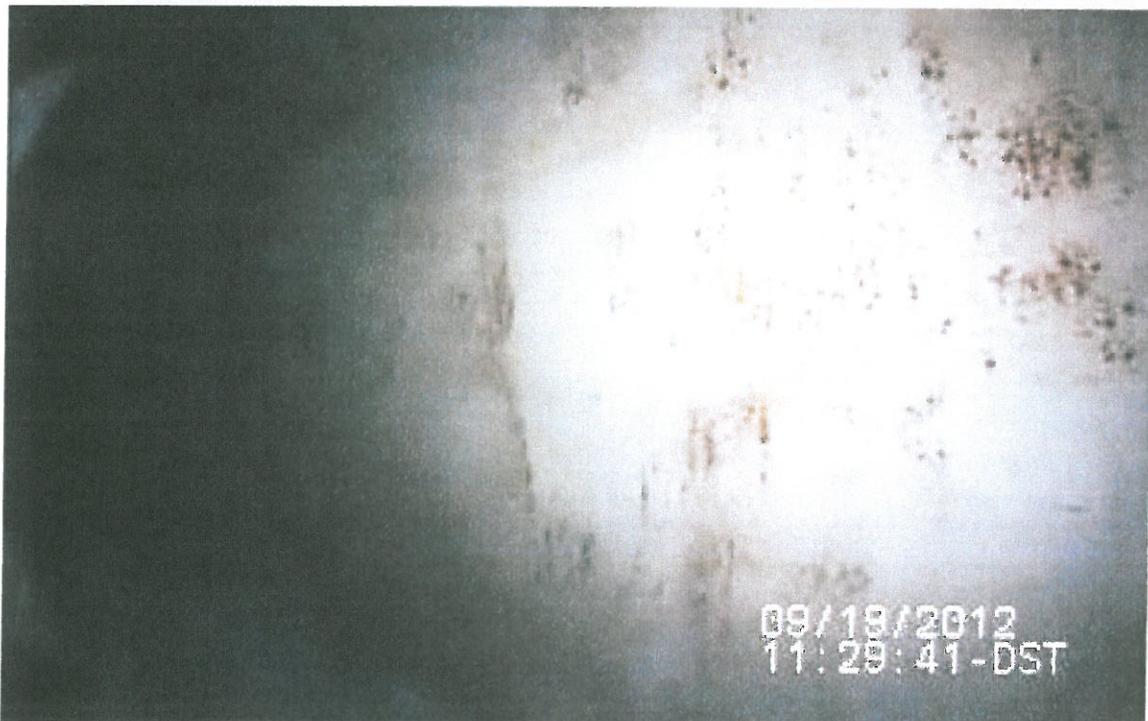
Photos show the condition of the interior liner. We recommend sandblasting all rusted and abraded areas of the tank interior to an SSPC #10 (near white blast) condition, brushblast all remaining areas, stripe coating all seams and welds, then applying an epoxy liner to achieve 8-10 mils of dry film thickness.
