# HILL TOP HOUSE HOTEL

## HISTORIC RESOURCES PLAN

HARPERS FERRY, WV

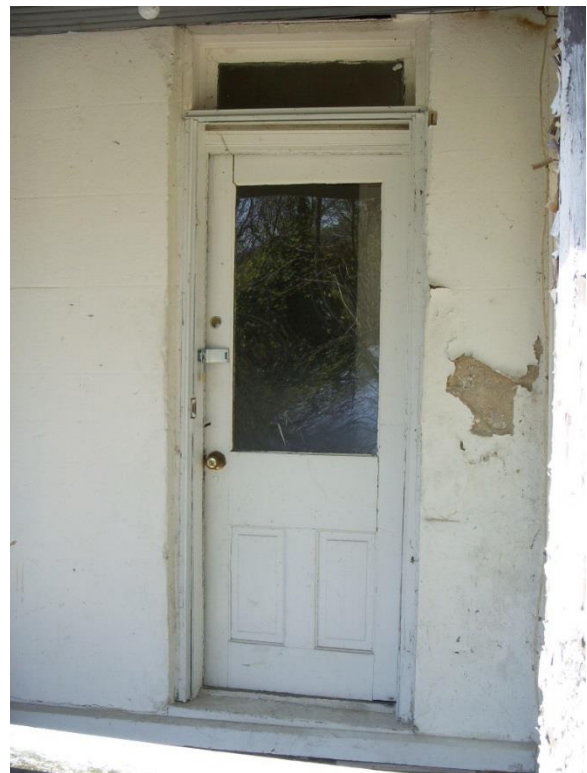
The exterior door on the east elevation (adjacent to the interior stair to the basement) is not original. The wood frame and door details do not match the other three exterior doors. When the modification was made, a wood lintel and masonry arch were installed over the opening. The style of the masonry arch differs from those used in other (original) masonry openings. The masonry arch above this door opening has failed due to poor construction techniques, causing cracking in the masonry wall above. Based on

Existing first floor door at north end of east elevation of main building (Oehrlein & Associates, 2008).

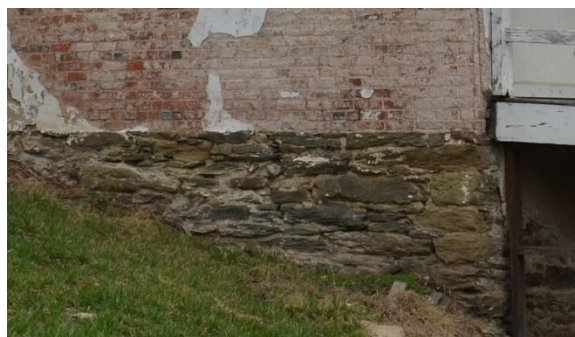
Localized loss of mortar at foundation walls (Mills Group 2018).

- **Foundation:** There has been a failure of the foundation wall in the cellar under the main house at the northwest corner and of the north retaining wall under the porch. The failures are due to the deterioration of the mortar. Since the north wall is buried in the hill, the wall has remained relatively moist causing a more rapid deterioration of the mortar. Without regular repointing, the wall ultimately failed. A localized loss of mortar at the foundation walls was observed in 2018.

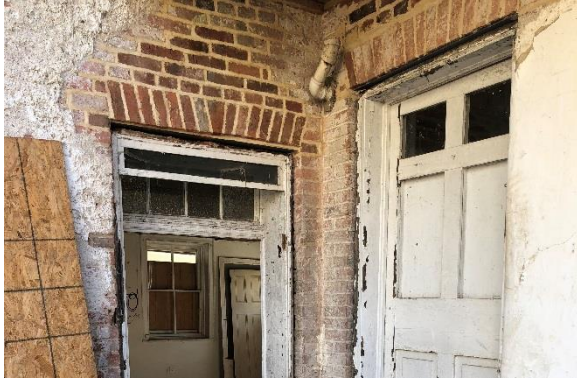
Reconstructed jack arch and adjacent masonry over exterior door opening on north wall (Mills Group 2018).

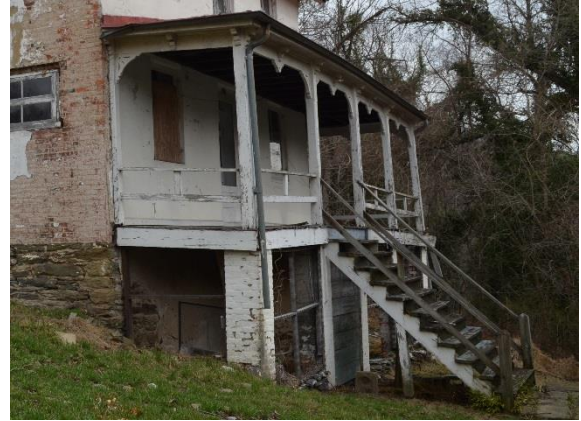
View of south elevation illustrating settlement of masonry porch piers and deterioration of porch framing (Mills Group 2018).

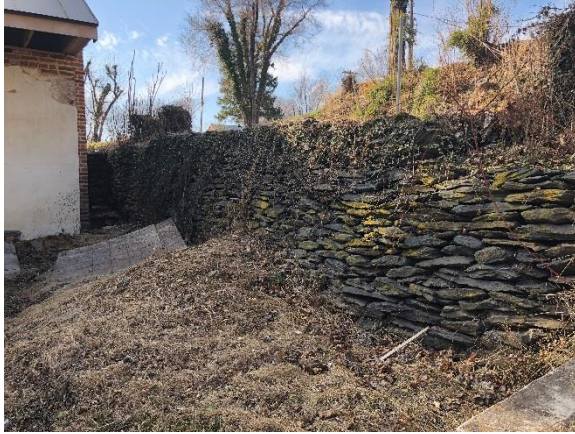
Retaining wall adjacent to rear wing; selectively rebuild with salvaged stone and mortar to match existing (Mills Group 2018).

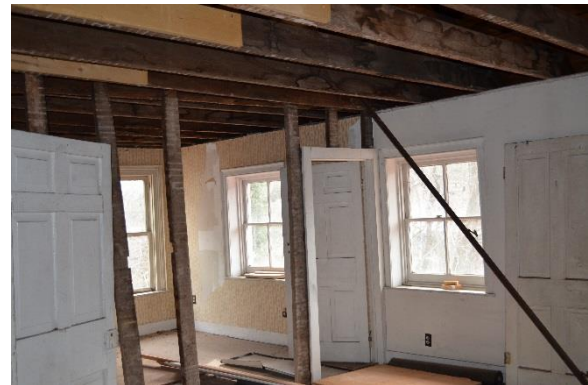
View of interior stud walls with plaster and lath removed; install new interior gypsum board wall finishes and ceilings (Mills Group 2018).

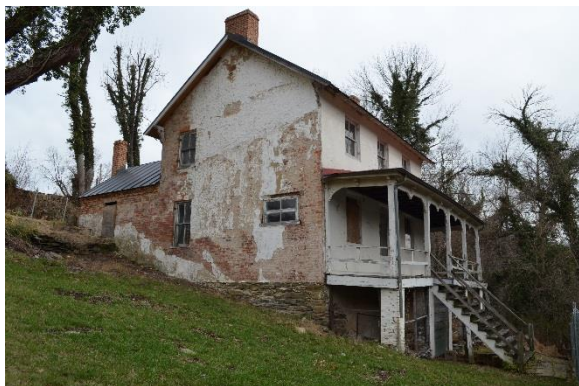
View of deteriorated stucco on west elevation (Mills Group 2018).

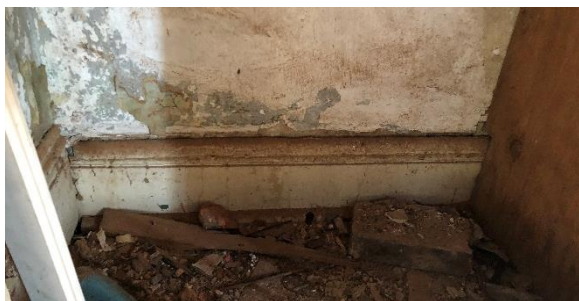
Historic wood baseboard trim to be replicated throughout (Mills Group 2018).

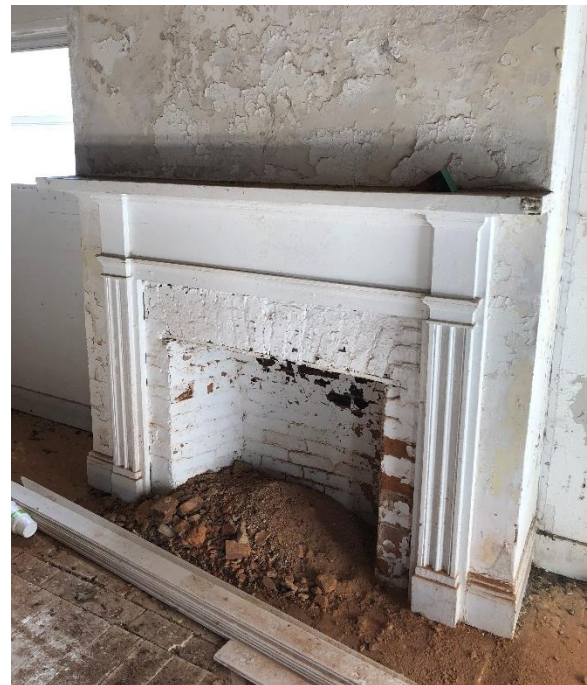
Existing mantle at west fireplace of first floor to be replicated (Mills Group 2018).

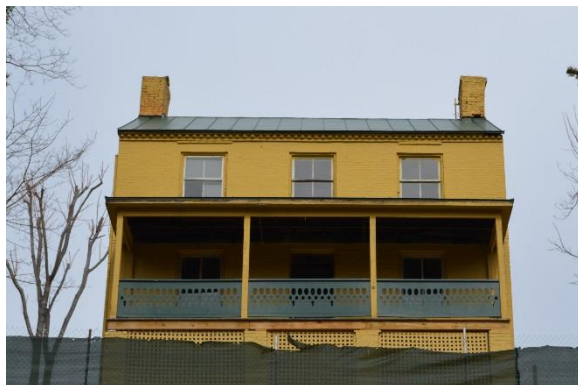
View of out-of-plumb chimneys on main building (Mills Group 2018).

- *Chimney:* The brick chimney at the west end is significantly out of plumb (leaning towards east at the top). Several bricks at the top course of the chimneys are missing or damaged.

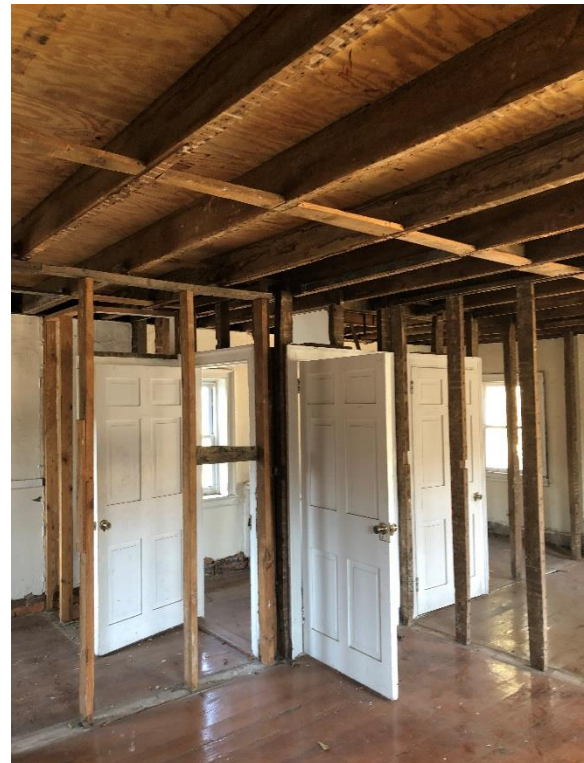
Second floor exposed ceiling/attic floor framing with removed plaster and lath (Mills Group 2018).

- *Interior Missing Plaster Ceiling Finishes:  
Install new plaster or gypsum ceiling  
finishes per NPS Preservation Brief 18.*

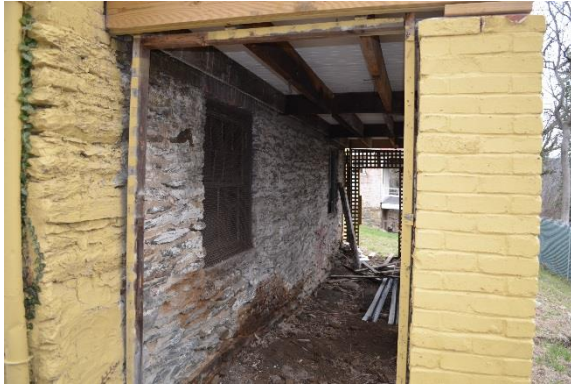
View of porch framing beneath new porch flooring (Mills Group 2018).

exterior of the foundation wall. Between the beams is a mixture of old and new nominal joists. The southeast pier is approximately 3" out-of-plumb, leaning in the southeast direction. A few of the wood framing members are deteriorated slightly. New porch flooring and rim board have been installed over the existing framing.

- Main Building, Level 1: Selectively structurally reinforce first-level joists. Install new header at opening to basement.
- Porch Floor Framing: Selectively structurally reinforce deteriorated porch floor joists.

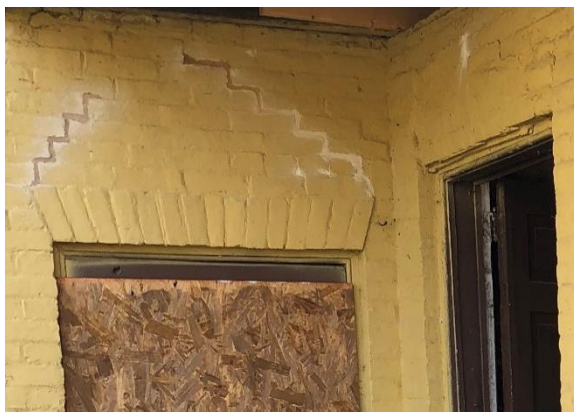
Reconstructed jack arch and adjacent masonry over north exterior door (Mills Group 2018).

- **Exterior Wall Construction:** A few of the brick arches above door and window openings show signs of movement. The arches tend to have very little bearing; therefore, the cracking may be the result of the failing bearing conditions. The cracking may also be exacerbated if shrinkage or deterioration of the wood lintel at the interior has occurred. The jack arch above the door on the east wall of the rear wing has been removed and replaced with random brick. The jack arch above the north door to the main building, along with adjacent masonry, has been rebuilt.

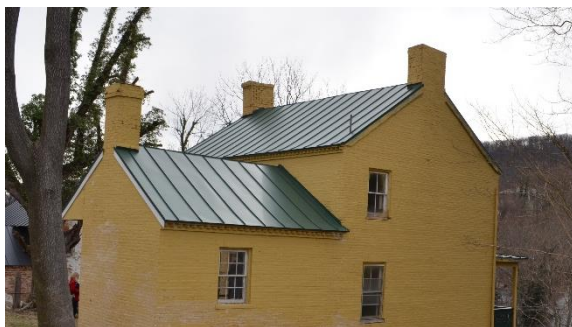
View of new standing-seam metal roof (Mills Group 2018).

- **Main Roof:** The new standing-seam metal roof is in good condition but is missing gutters and downspouts.
- **Porch:** The porch flooring has been replaced,, along with the rim board. The porch ceiling is no longer present.

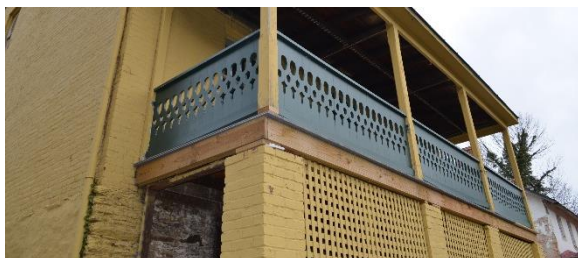
Reconstructed porch railing and rim board (Mills Group 2018).

- **Porch Railing:** The porch railing has been rebuilt using the original balusters as a pattern.
- **Windows:** The wood window sills at the east and west elevations of the main portion of the building are rotten. The wood window sill at the second floor on the west elevation (bathroom) has been replaced by loose brick in-fill. At the south elevation, the window sills at the second floor are in poor condition, while those

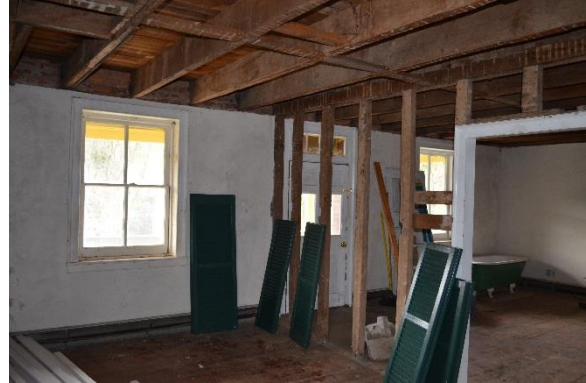
- **Shutters:** Wood window shutters throughout are missing. The remaining shutters are currently located inside the main building.
- **Rear Wing Roof:** The roof of the rear wing has been recently reconstructed and re-sheathed in standing seam metal. The east-facing eave soffit is missing.

Shutters stored inside main building (Mills Group 2018).

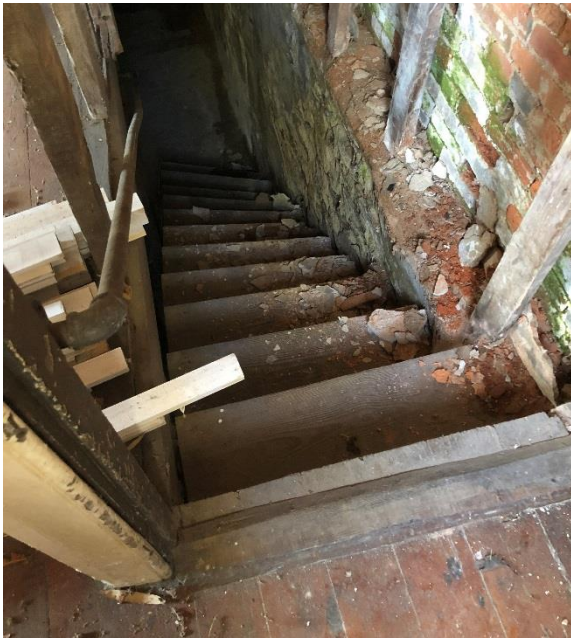
- **Basement Stairs:** The wood stair going down to the basement is unsafe and in poor condition.
- **Trim:** Existing interior wood baseboard trim is inconsistent and not original.

Stairs from first floor to basement level (Mills Group 2018).

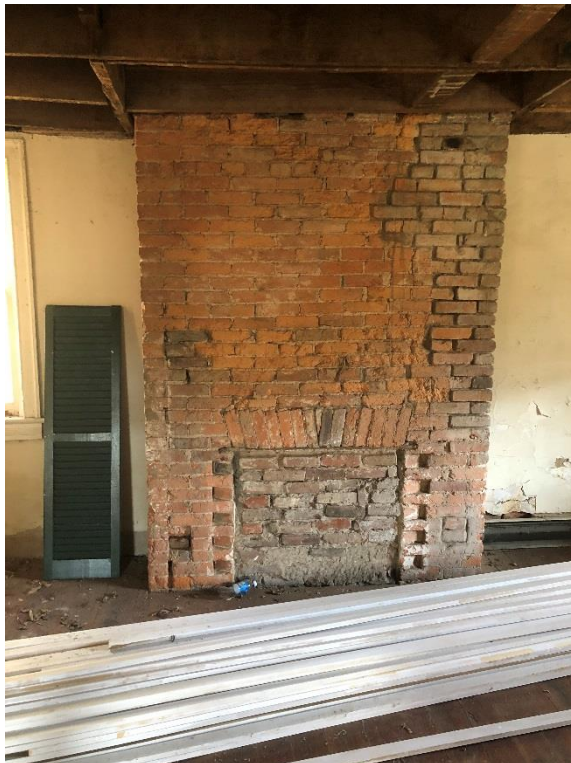
The fireplaces at the first floor are exposed brick. Several repairs have been made to the fireplaces as evidenced by an array of mortar types and colors, all with varying joint profiles. The fireplace opening at the east end has been closed up with brick masonry. The brick hearth

Fireplace, first level east side (Mills Group 2018).

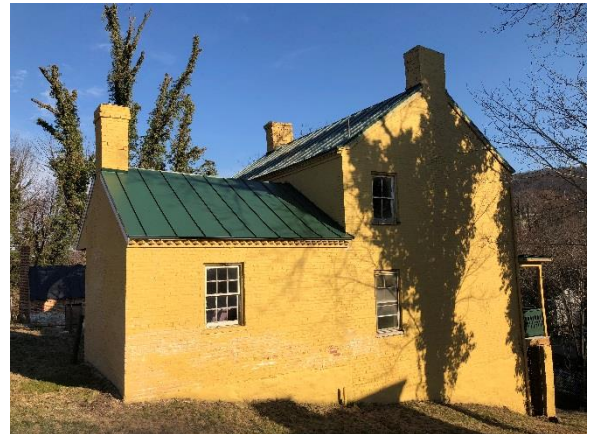
View of new roofing; install new gutters and downspouts for rainwater diversion (Mills Group 2018).

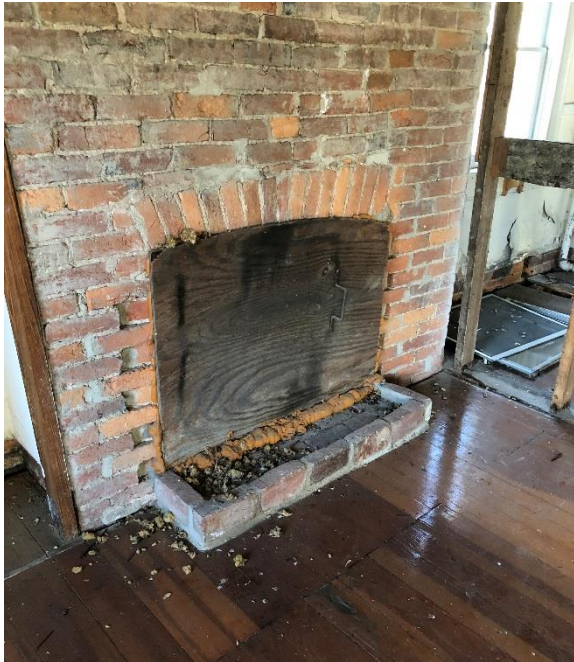
There are two rooms and one full bathroom at the second floor. The fireplace at the east room is completely covered with gypsum board while the fireplace at the west end is exposed brick with the opening covered by a plywood panel set in place with spray foam insulation. The original hearths of both fireplaces have been removed. The hearth in the east room was replaced with wood floorboards. The hearth in the west room was replaced with a smaller raised brick hearth and wood floor in-fill. Closets have been built adjacent to both fireplace projections.

Plywood panel and foam insulation, along with raised brick hearth, at second floor west fireplace (Mills Group 2018).

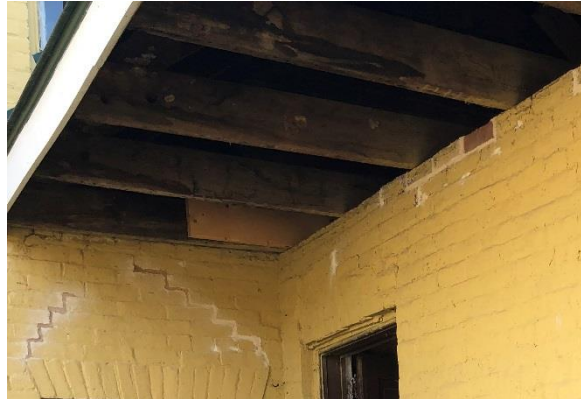
Open rafters on overhanging east side of rear wing roof; replace ceiling/soffit in this area (Mills Group 2018).

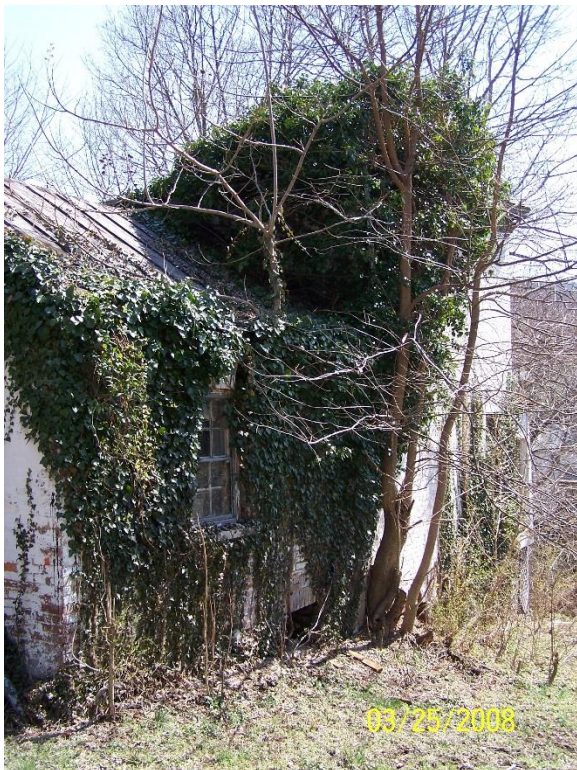
Invasive ivy at west elevation (Oehrlein & Associates, 2008).

vegetation and approximately 60% of the building is enveloped in ivy.

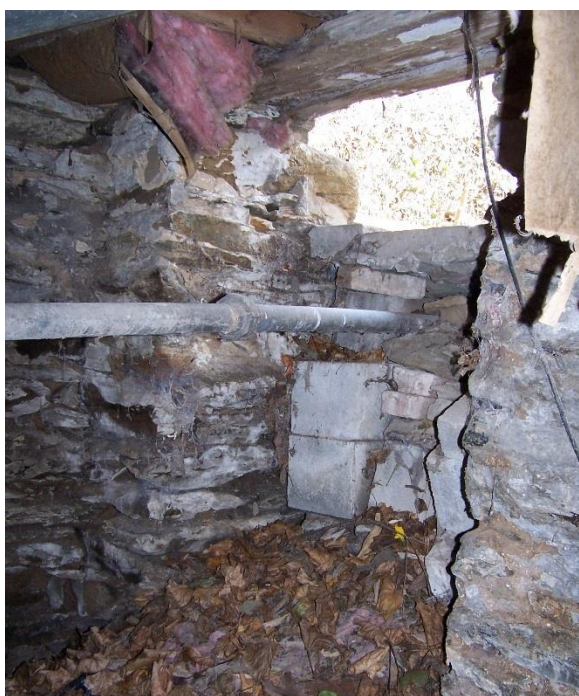
Modified original rear cellar access (east elevation) (Oehrlein & Associates, 2008).

but concrete blocks have been added in the cellar to reduce the height of the opening.

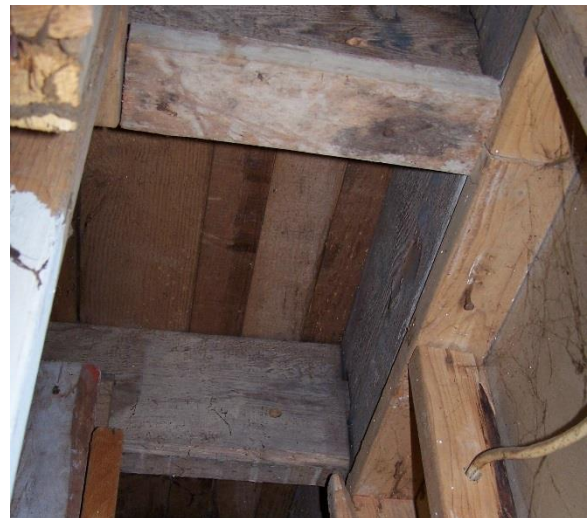
Framing of stair at first floor. Modern framing contrasts with original tenoned floor joists (Oehrlein & Associates, 2008).

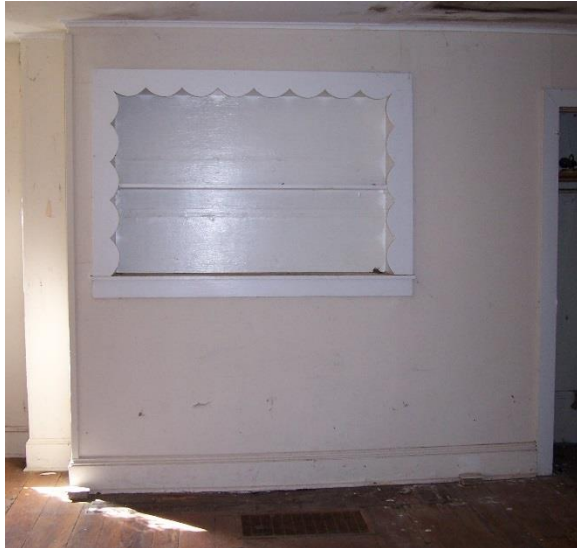
West room fireplace covered with drywall (Oehrlein & Associates, 2008).

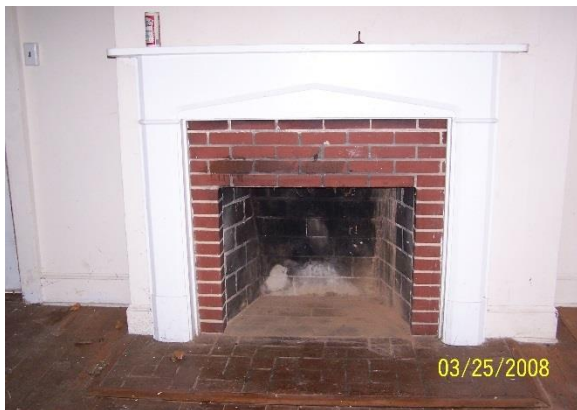
New firebox at east room fireplace, first floor (Oehrlein & Associates, 2008).

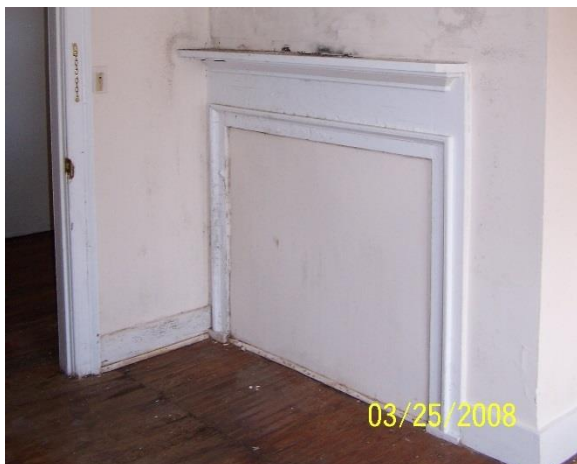
Boarded fireplace in east room, second floor. West room fireplace similar condition. Note brick hearth has been removed at this location and filled with wood flooring (Oehrlein & Associates, 2008).

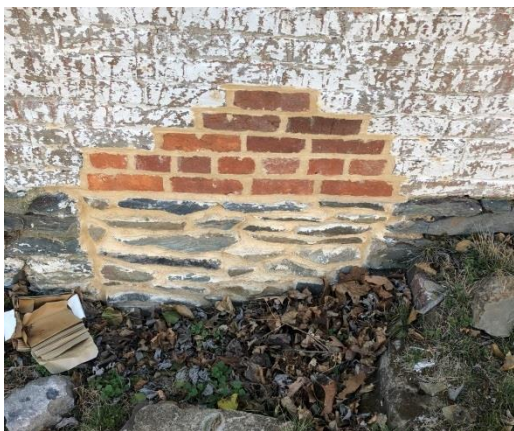
View of brick masonry repair (Mills Group 2018).

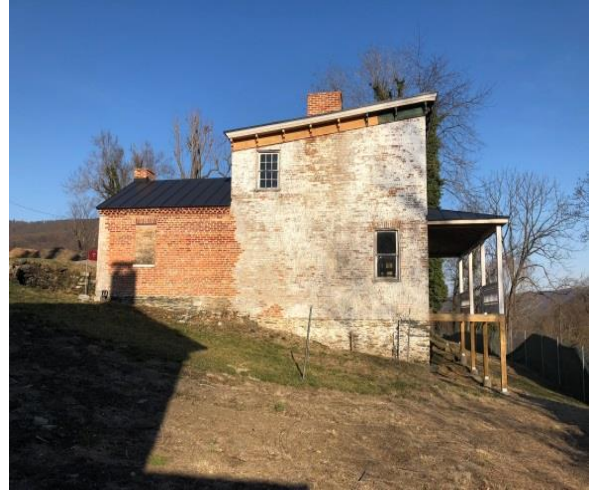
West elevation showing rebuilt rear wing walls (Mills Group 2018).

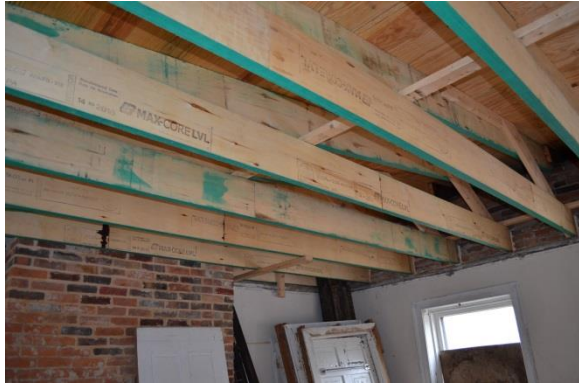
Reconstructed roof framing (Mills Group 2018).

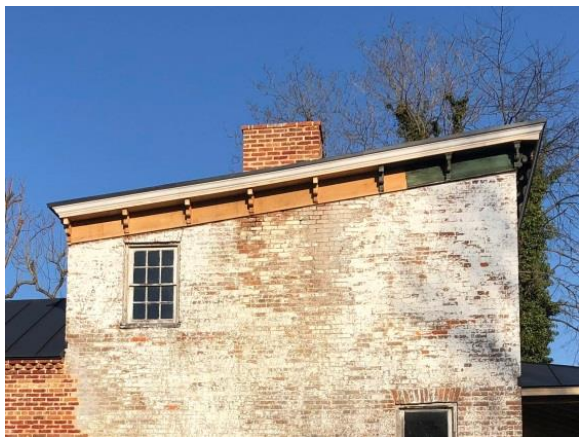
Detail of reconstructed eaves and brackets (Mills Group 2018).

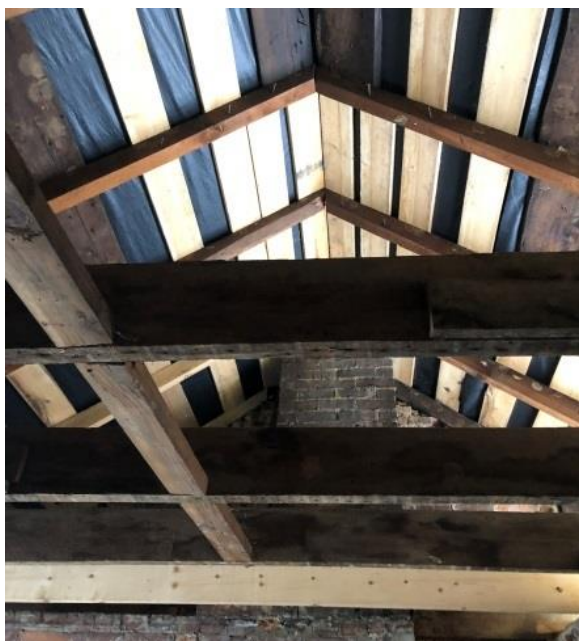
Rehabilitated roof framing over rear wing (Mills Group 2018).

new standing-seam metal roof is supported by a mix of original and new random width wood sheathing. Currently, no soffit is present beneath the east eaves of the rear wing.

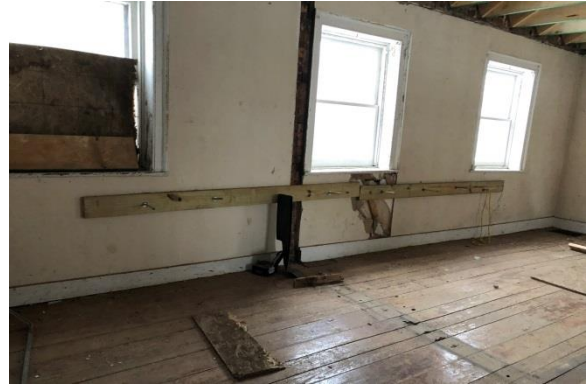
Shoring element on south wall, second level (Mills Group 2018).

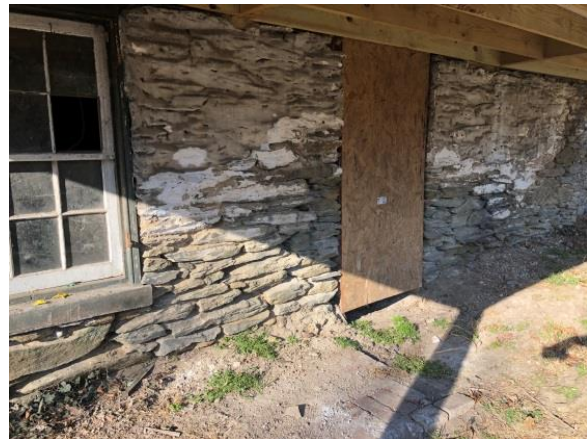
Missing basement access door, south wall (Mills Group 2018).

- *South 3-Panel Wood Door with Top Panel Light and Transom:* Remove glazing and install new wood panels to match existing. Clean and paint per NPS Preservation Brief 47. Clean and oil hardware, and add new storm door.
- *Missing South Basement Access Door:* Fabricate new custom wood door and hardware to match historic profiles. Add new storm door.
- *East Level 1 6-Panel Door:* Clean and paint per NPS Preservation Brief 47. Clean and oil hardware, and add new storm door.
- *Missing North Level 1 Door:* Fabricate new custom wood door and hardware to match historic profiles. Add new storm door.
- *Missing East Door to Rear Wing:* Fabricate new custom wood door and hardware to match historic profiles. Add new storm door.

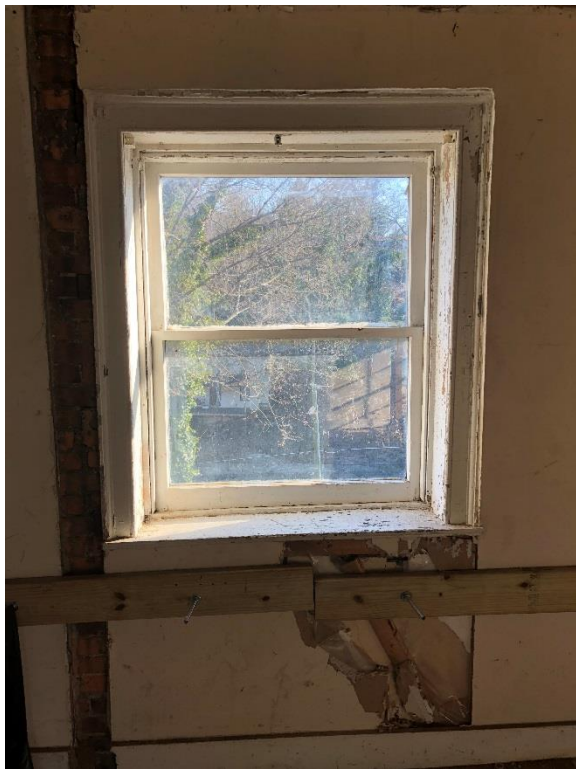
Windows are inconsistent in style, varying between 6-over-6 and 1-over-1 double-hung. The 6-over-6 wood window at the south elevation of the cellar is the best representation of the original window detailing and construction.

Non-original 1-over-1 double-hung wood windows (Mills Group 2018).

- *Wood Double Hung Windows:* Remove existing and replace with new custom wood double-hung divided-light windows. Add new storm windows.
- *Missing Windows, Rear Wing:* Fabricate new custom double-hung divided-light wood windows. Add new storm windows.
- *French Windows, South Elevation:* Clean and paint per NPS Preservation Brief 9. Install new weatherstripping at jambs and meeting rails and new sash hardware. Install new storm windows.

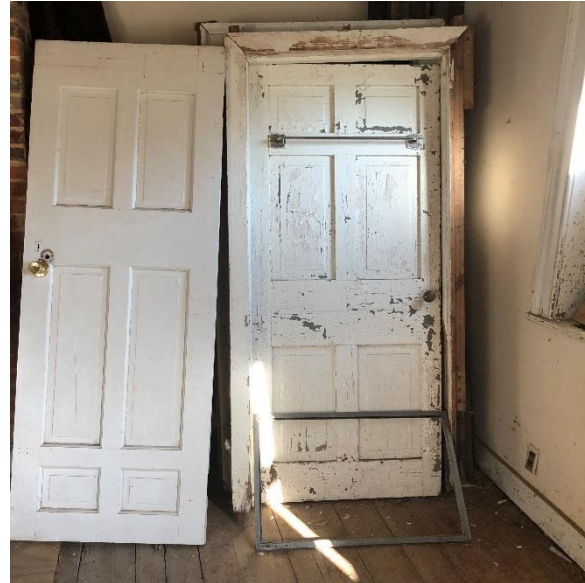
Various interior doors stored in dwelling (Mills Group 2018).

- Replace missing doors with new custom wood doors to match historic profiles. Install new hardware and hinges to match historic precedent.
- Paint existing doors; clean and oil existing hardware per NPS Preservation Brief 18.

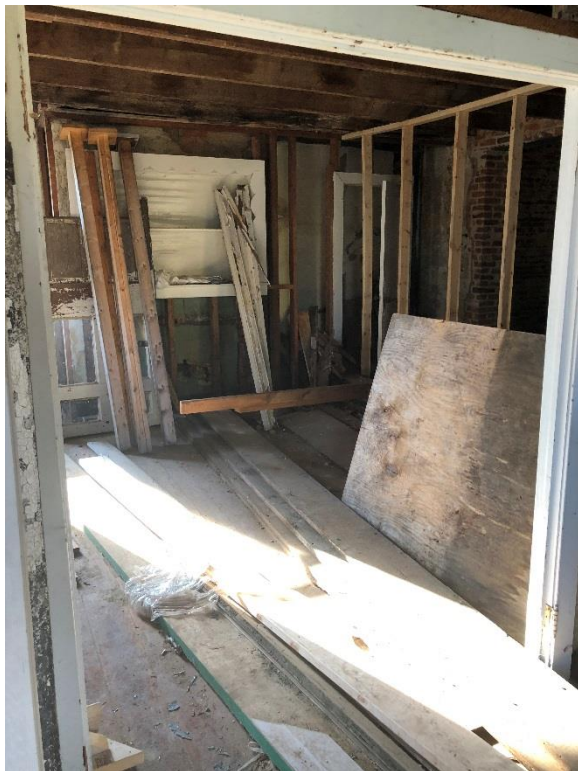
View of enclosed fireplace, first level west side (Mills Group 2018).

- Millwork: Configuration to be determined by architect. Replace any missing elements with new to match historic profiles.
- Fireplace and Mantle, First Level West Side: Configuration to be determined by architect.
- Fireplace and Mantle, First Level East Side: Clean and paint mantle, and adapt fireplace with gas-burning logs.
- Fireplace, Second Level West Side: Adapt with gas-burning logs. Fabricate new wood mantle to match existing.
- Fireplace and Mantle, Second Level East Side: Clean and paint mantle and re-attach. Adapt fireplace with gas-burning logs.

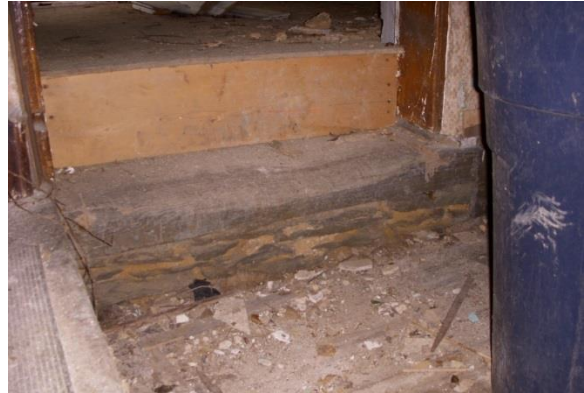
Photograph of modern wood floor framing installed on top of original wood floor in west unit (Oehrlein & Associates, 2008).

- West Unit
  - A modern floor framing system of 2x10 wood joists was constructed over the existing floor and floor framing system in the stone building. Original ceiling joists in this space have been removed (except for one) and replaced with contemporary nominal lumber.
  - An original door opening on the first floor south elevation has been modified to a large picture window. A new door opening has been created to the east of the existing picture window.

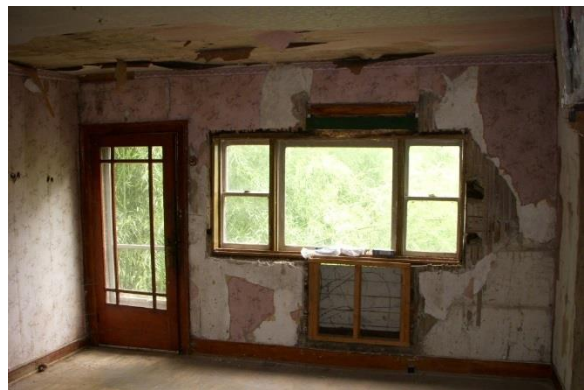
Existing picture window at location of former door opening in west unit (Oehrlein & Associates, 2008).

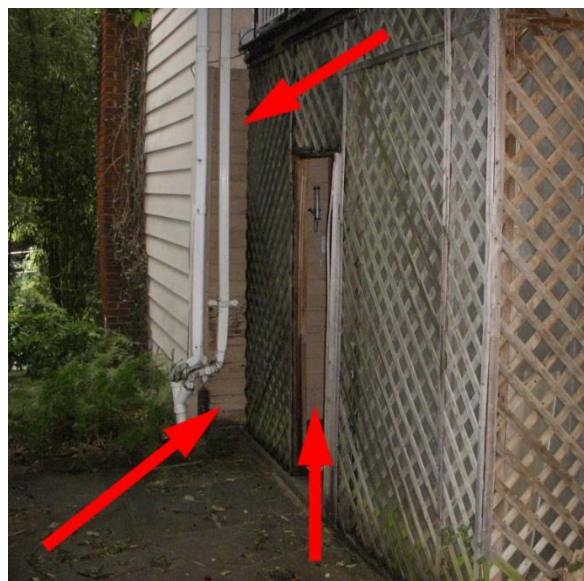
Arrows point to old wood siding on north elevation of east unit log building (Oehrlein & Associates, 2008).

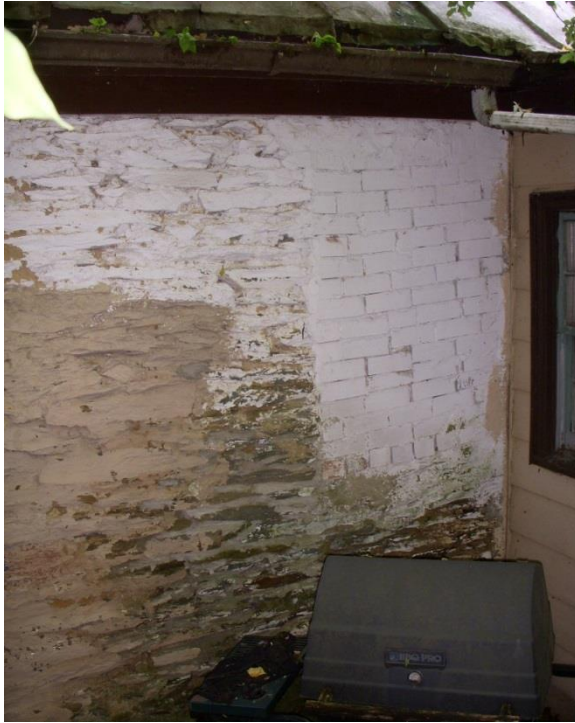
Former window opening in stone wall now filled in with brick masonry (Oehrlein & Associates, 2008).

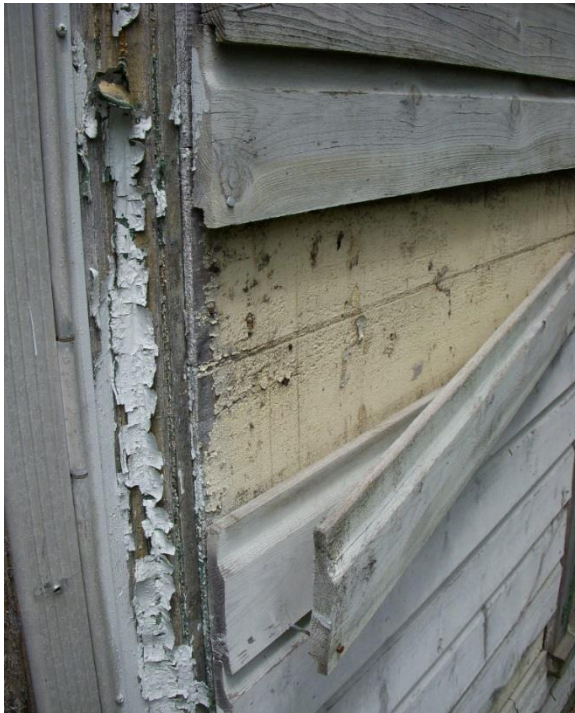
Existing exterior wood siding over older shiplap wood siding on west elevation of west unit log building (Oehrlein & Associates, 2008).

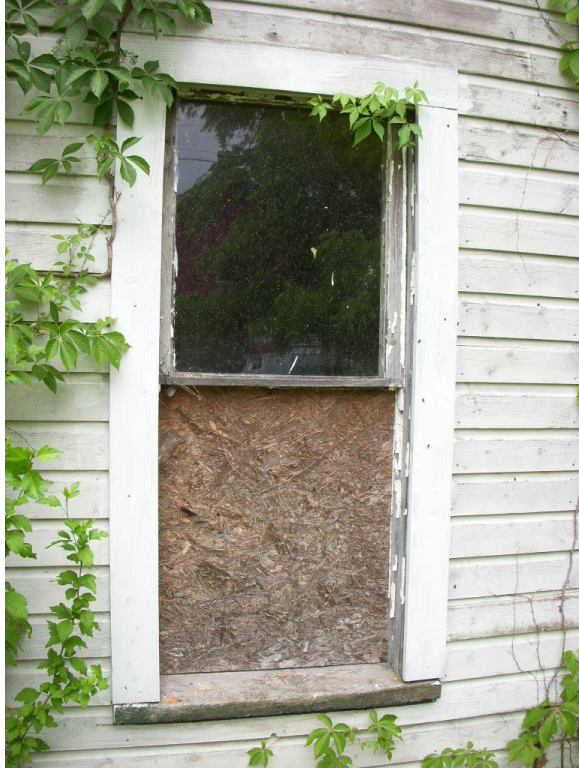
Existing window on west elevation of log building (west unit) with wood top sash having pegged connections (Oehrlein & Associates, 2008).

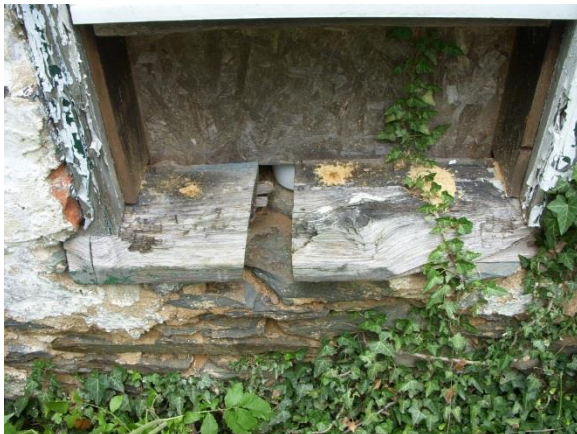
Existing window opening in west elevation of stone building (west unit). Brick masonry on the left side of this opening indicates that the width of the opening may have been modified over time. Also note the portion of wood removed from the wood sill (Oehrlein & Associates,

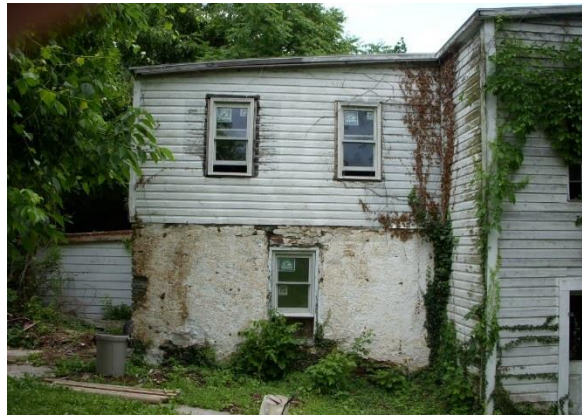
Shadows at the second floor windows of the west unit indicate the former presence of shutters at these windows (Oehrlein & Associates, 2008).

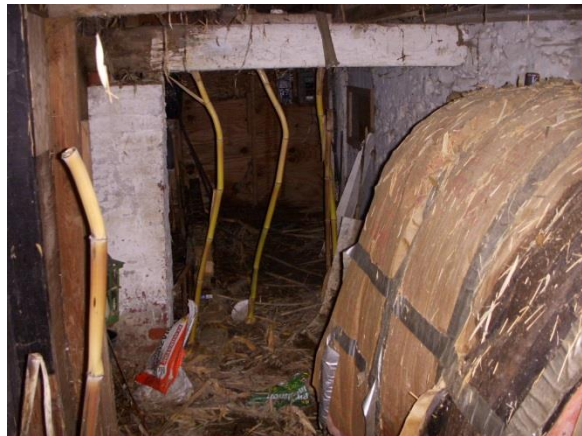
Painted masonry piers under the east unit porch on the south elevation are the only historic element of the porch still remaining (Oehrlein & Associates, 2008).

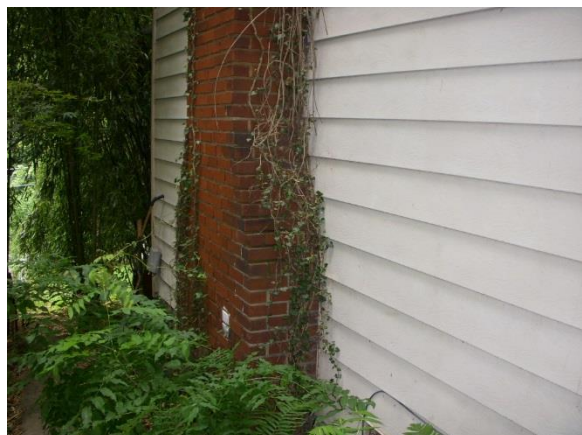
Existing brick masonry chimney on the east elevation of the log building (east unit). This chimney is not original to the building (Oehrlein & Associates, 2008).

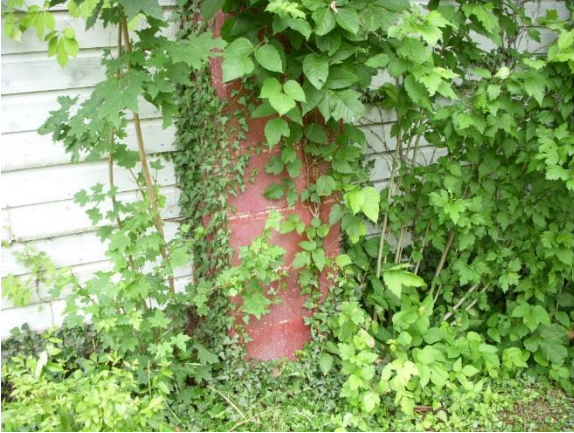
- The chimney on the west elevation, constructed of concrete masonry units, is not original to the duplex.

Existing painted CMU chimney on the west elevation of the log building (west unit). This chimney is not original to the building (Oehrlein & Associates, 2008).

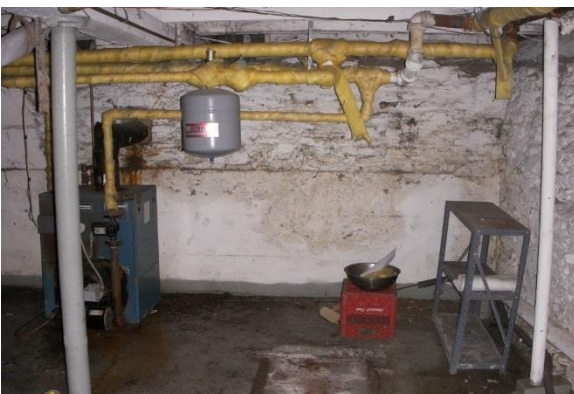
- East Unit
  - Stone foundation walls have been underpinned on the east half of the log building.
  - Supplemental columns, of both steel and wood, have been added in the cellar to support and reinforce the first floor wood framing systems above.
  - The cellar has a concrete floor slab that is a later modification.
  - The stone foundation walls are white-washed.
  - The stairs from cellar to first floor in the east half of the building are not original.
- West Unit
  - Supplemental columns, of both steel and wood, have been added in the cellar to support and reinforce the first floor wood framing systems above.
  - The cellar maintains its original dirt floor.

Existing cellar in east unit of log building. The concrete floor slab is not original to the building. All interior walls are whitewashed. Note the supplemental concrete underpinning at the east foundation wall (beyond) (Oehrlein & Associates, 2008).

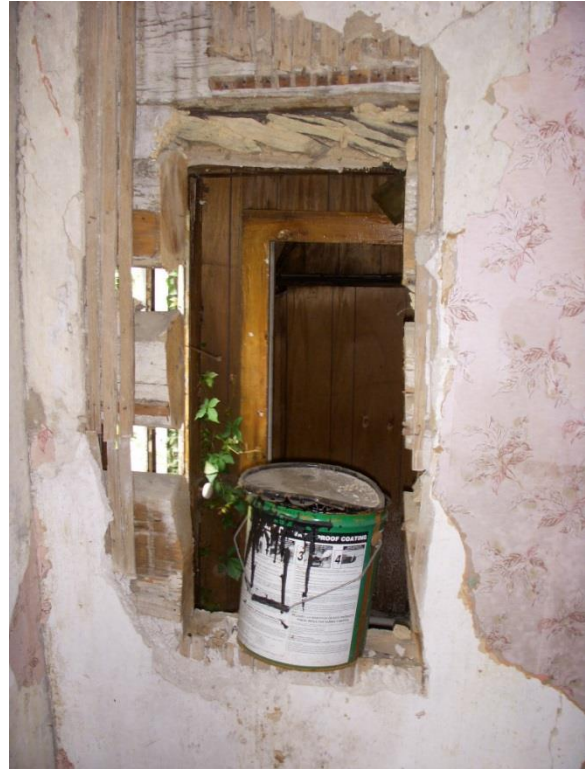
Opening made in north wall of west unit log building (Oehrlein & Associates, 2008).

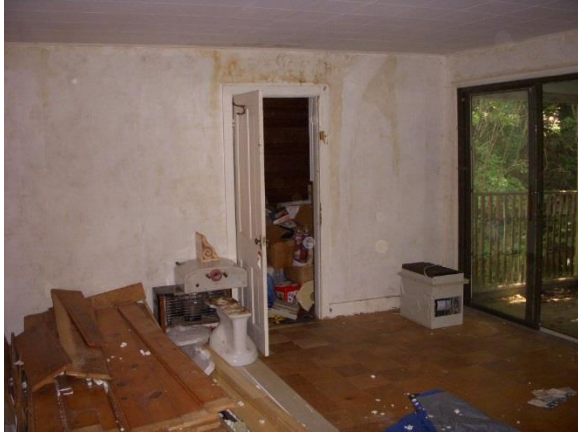
- A sliding glass door has been added to provide access to the two-story covered porch on the east elevation from the space constructed as part of the stone building addition. In this same room, a closet has been added on the west wall. This closet has wood wall paneling and bi-fold doors. Also, 9" square vinyl flooring has been installed over 3-1/2" wood floorboards running in an east-west direction. Note that there is a  $\pm 4\text{-}1/2"$  rise in floor elevation between the second floor level of the main house (at the connecting addition) and the second story addition on the stone building. The floor in this room slopes downward as it moves towards the northeast corner of the space.

Photograph of second floor of stone building in the east unit. The sliding glass door on the right side of the photograph is a later modification to the building (Oehrlein & Associates, 2008).

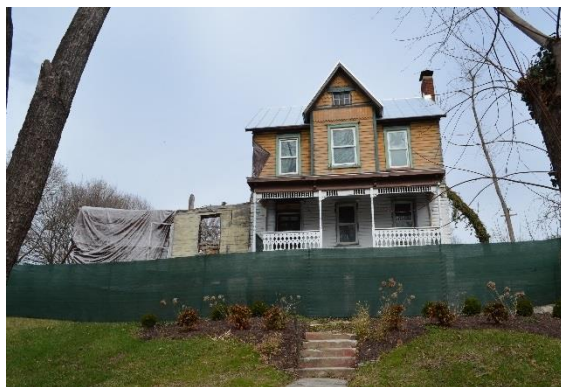
Photograph of south elevation of property illustrating deterioration of west half of duplex (Mills Group, 2018).

The building on Block E, Lot 5 is in fair to poor condition. The second floor level of the west half of the building is missing, as is the connecting addition on the west half of the building. Additionally, the majority of the first floor framing of the west half of the building is missing. A new frame wall with plywood sheathing has been installed on the west side of the connecting addition in the east side of the duplex. For the purposes of this report, the period of significance for the property is defined as c. 1831 – c. 1880.

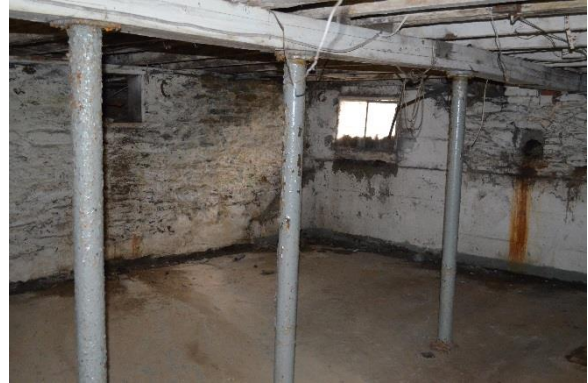
- **Log Building Floor Framing:** In the log building, the joist bearings at the north wall are deteriorated and some have been sistered with newer lumber. The central dropped beam is composed of three plies of wood framing, oriented flat. This beam appears to be a later addition, possibly replacing an original beam. Supporting the beam are four steel columns and one timber post. Marks in the beam suggest an additional column was present near the east wall; however, it appears to have been removed for the installation of a mechanical unit. Around the stair opening, the framing appears meek considering its loading. The first floor in the living room slopes to a low point in the northwest corner.

Photograph of basement level and first floor framing beneath log building, east unit (Mills Group, 2018).

- East Unit Wood Floor Framing, Levels 1 and 2: Selectively structurally reinforce first- and second-level joists.
- West Unit Wood Floor Framing, Level 1: Selectively structurally reinforce joists and rebuild missing floor framing and subfloor.

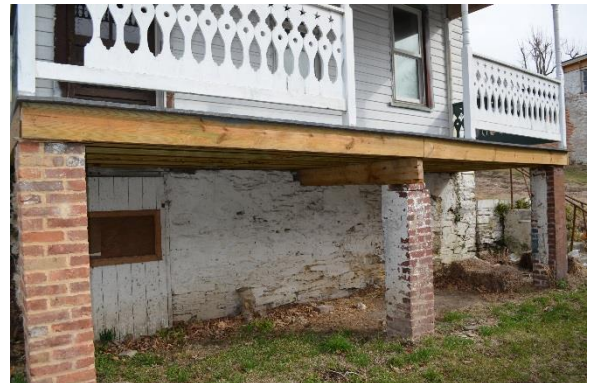
- **Porch Framing:** Porch framing has been entirely rebuilt with new wood joists and

New porch framing, flooring, posts, and balustrade on east unit (Mills Group, 2018).

framing members spanning from the house to the original masonry piers. .

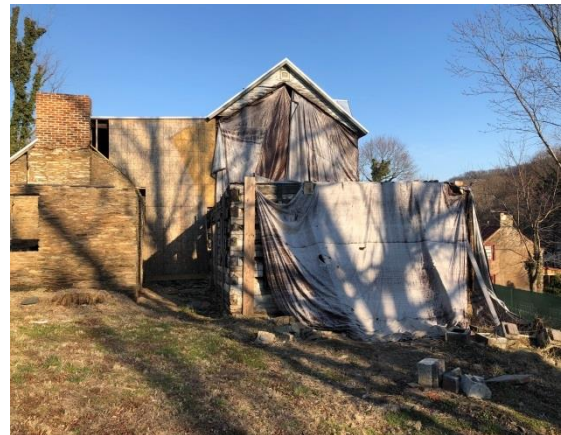
View of west elevation with protective tarp covering (Mills Group, 2018).

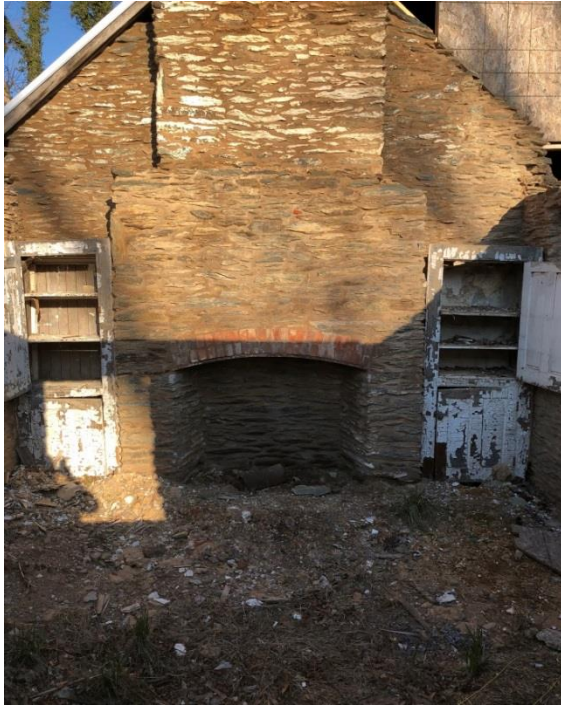
East Unit, stone building fireplace (Mills Group, 2018).

5. Interior Fireplace, Second Level East Side: Mantle removed; servicable condition	Clean and paint, adapt with gas-burning logs; re-attach mantle	No		
	C2010 Stair Construction	Interior Wood Stairs from Level 1 to Level 2: Reconstructed; servicable condition	Architect to review code compliance	No		
	C2020 Stair Finishes	Interior Wood Stairs from Level 1 to Level 2: Servicable condition	Refinish natural wood finish	No		
	C3010 Wall Finishes	Interior Plaster Wall Finishes: Some deterioration due to water damage, mostly along north wall; all other walls servicable condition	Replace missing plaster; clean and paint existing plaster, repair any cracking per NPS Preservation Brief 21	No

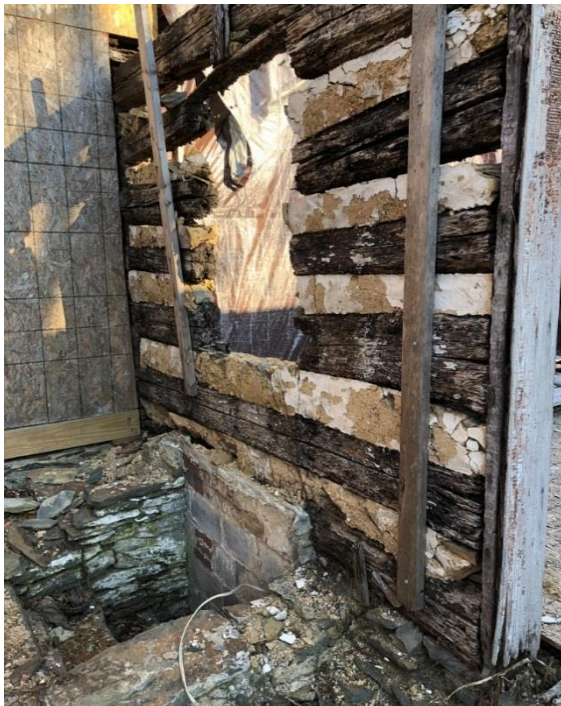
Opening in north wall of West Unit log building (Mills Group, 2018).

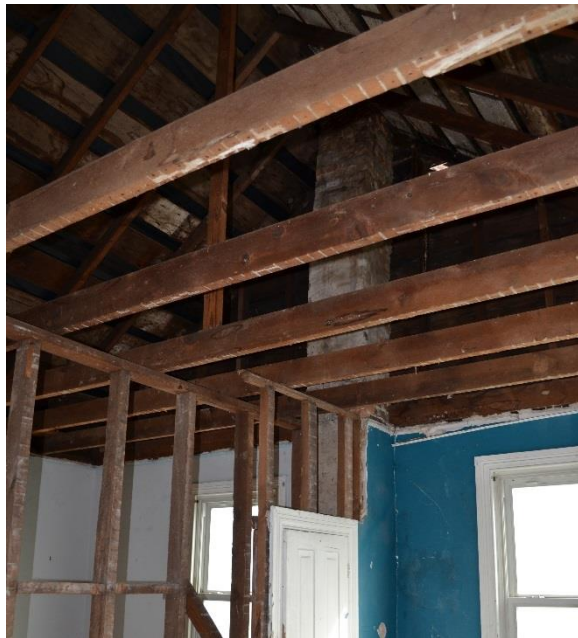
Roof framing over second floor addition to log building, east unit (Mills Group, 2018).

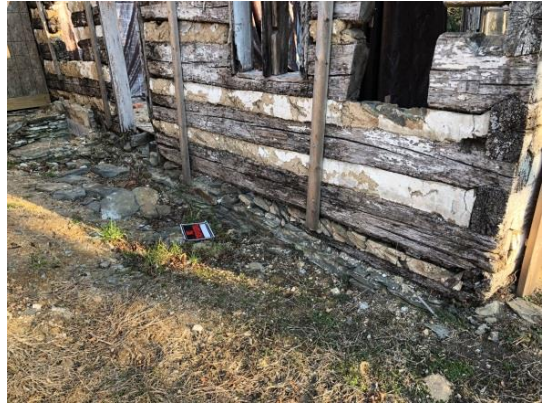
View of deteriorated timber members, West Unit log building (Mills Group, 2018).

5. West Unit, Log Exterior Walls: Partially sheathed with wooden shiplap siding; insect infestation and rot evident in logs and chinking; penetration in north and south walls	Replace damaged timbers and chinking (assume 70% replacement); repair holes in north and south walls; reclad exterior with wood beveled lap siding; paint	Yes	Like kind

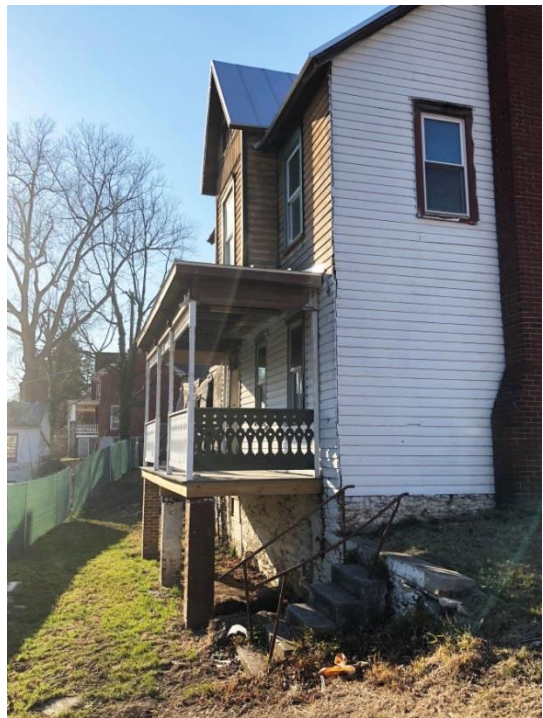
Reconstructed porch floor framing and railings (Mills Group, 2018).

3. East Unit Porch Framing: Recently rebuilt; servicable condition	No action	No		
	B1020 Roof Construction	1. East Unit Main Roof Framing: Servicable condition	No action	Yes
