# HILL TOP HOUSE HOTEL

## HISTORIC RESOURCES PLAN

HARPERS FERRY, WV

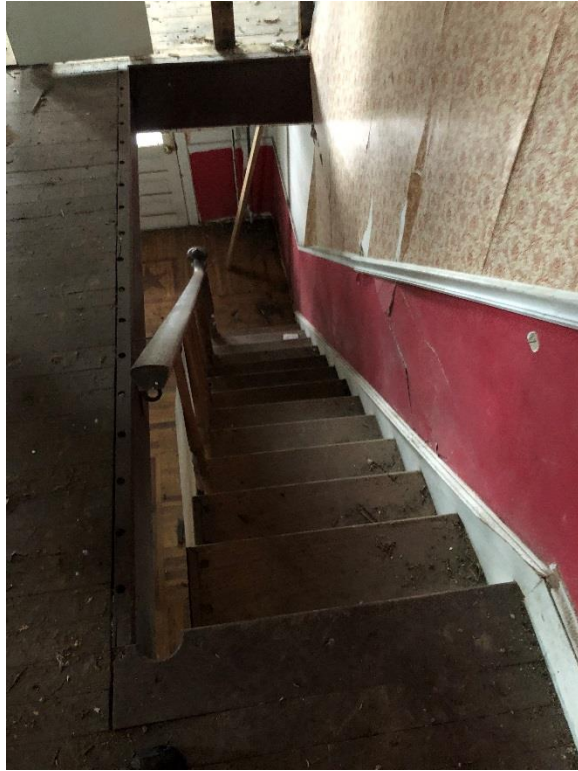
View of settlement of East Unit stairs from level 1 to level 2 (Mills Group 2018).

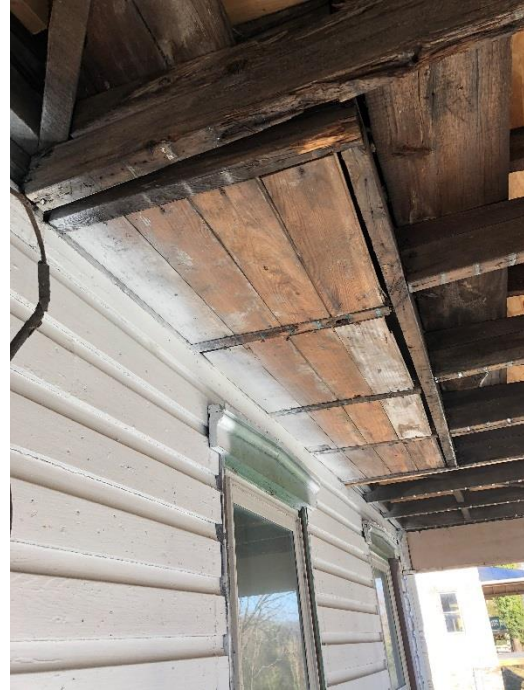
View of floor framing of second level visible from porch (Mills Group 2018).

UNIFORMAT Building Element Classification		Summary of Existing Conditions	Recommendations	Under HLC Purview	Justification	
SHELL	B1010 Floor Construction	1. East Unit Wood Floor Framing, Levels 1 and 2: Sloping due to settlement; some insect damage	Selective structural reinforcement of first- and second-level joists	No

- East Unit Wood Floor Framing, Levels 1 and 2: Selectively structurally reinforce first- and second-level joists.
- West Unit Wood Floor Framing, Level 1: Selectively structurally reinforce joists and rebuild missing floor framing and subfloor.

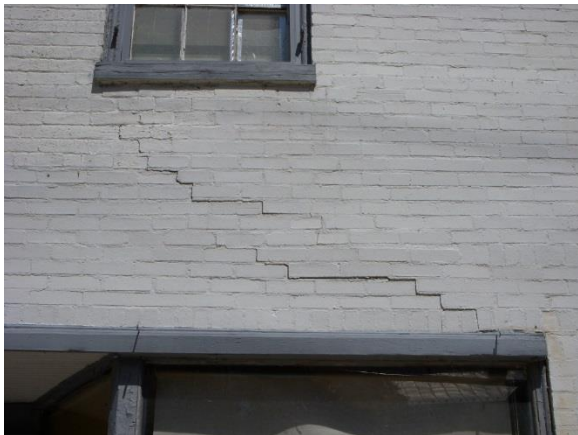
View of crack in masonry wall at south elevation (Oehrlein & Associates, 2008).

- *Brick Masonry Exterior Walls: Repair cracked and bowed south wall. Reinforce/replace structural lintels and jack arches over openings where cracking occurs. Surface cleaning, minor repointing, and repainting/recoating of all other masonry walls per NPS Preservation Briefs 1, 2, and 47. Restore stucco per NPS Preservation Brief 22.*
- *Brick Masonry Exterior Walls with Stucco Sheathing: Restore stucco per NPS Preservation Brief 22, and repaint.*
- *Frame Exterior Walls with Wood Siding, Rear Addition: Replace any deteriorated siding scheduled to remain and repaint.*
- *Frame Exterior Walls with Wood Siding, Basement Access Addition: Remove addition and install new bulkhead door for basement access.*

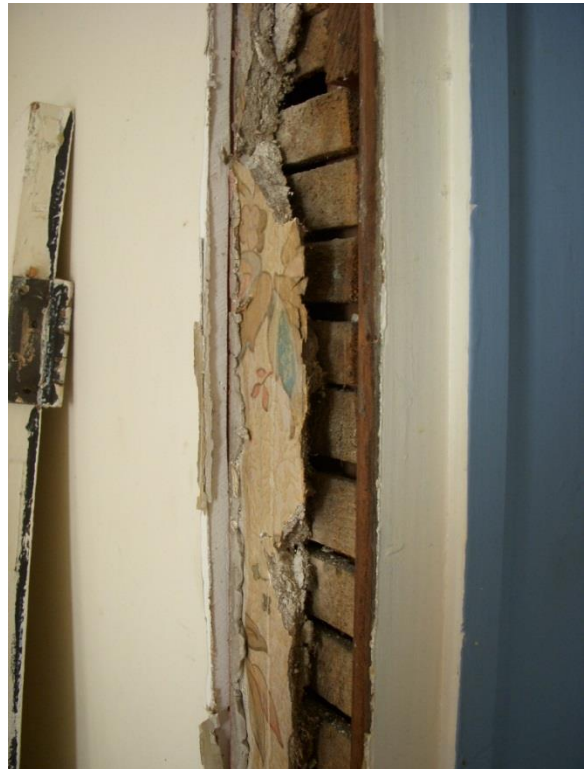
Detailed view of gypsum board installed over historic plaster (and wallpaper) over wood lath (Oehrlein & Associates, 2008).

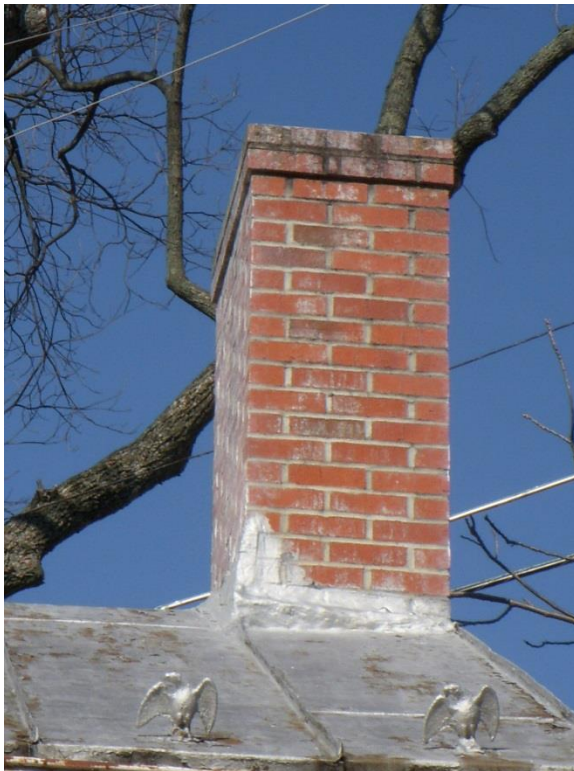
The chimney at the rear wing has recently been rebuilt and is unpainted. The brick used to rebuild this chimney is not the original brick.

Chimney on rear wing that has been recently reconstructed. Note the decorative eagle snow guards (Oehrlein & Associates, 2008).

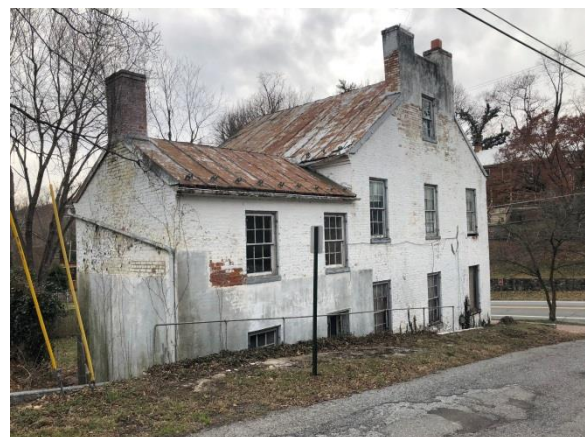
- **Chimneys:** The northern chimney on the west wall is leaning slightly to the east.
- **Roofing:** The existing roof of the building is covered with standing-seam metal. There are decorative eagles at each pan that act as snow guards. Some of these snow guards are missing. The roof is keeping the building mostly dry with only one location in the attic ceiling showing water damage, but is near the end of its useful service life. The roof construction under the standing-seam metal was not accessible for survey.

West elevation showing standing-seam metal roof (Mills Group, 2018).

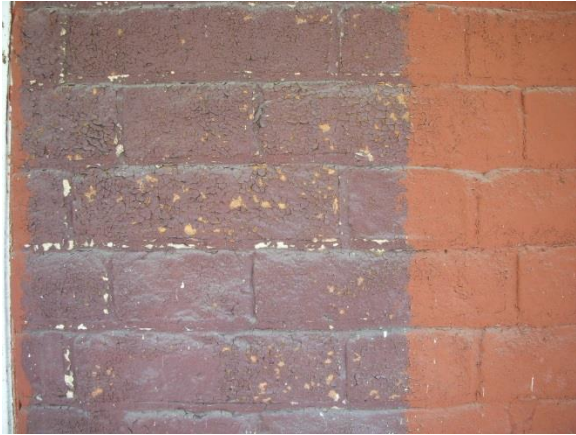
Detailed photograph of painted brick masonry. The red on the right is the most recent color, while the maroon is an earlier paint color. Portions of the original orange brick can be seen in areas of missing paint (Oehrlein & Associates, 2008).

- Brick Masonry Exterior Walls: Surface cleaning, minor repointing, and repainting per NPS Preservation Briefs 1, 2, and 47.
- Frame Exterior Walls with Metal Siding: Surface cleaning and repainting per NPS Preservation Brief 47.
- Porch Railings: Architect to review code compliance. Surface cleaning and repainting per NPS Preservation Brief 47
- Porch Lattice Panels: Surface cleaning and repainting per NPS Preservation Brief 47

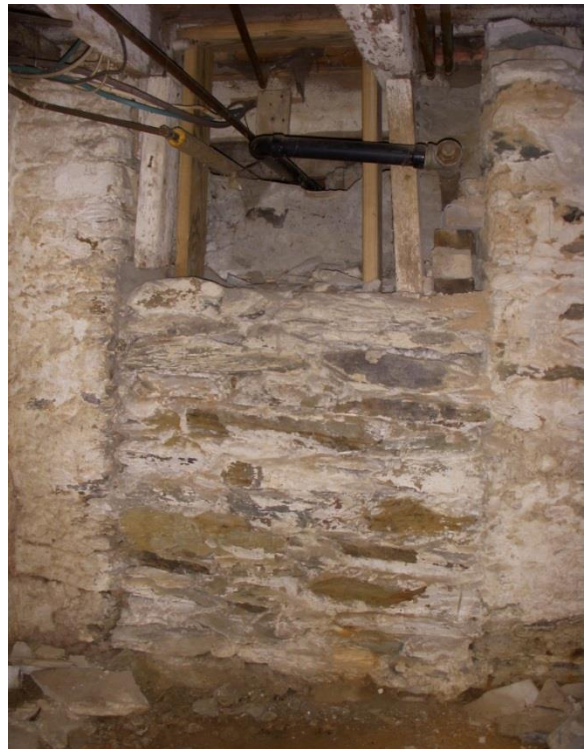
Original opening in east wall of cellar below rear wing, partially filled in with fieldstone. Note the existing floor joists above that are supported by two wood posts (Oehrlein & Associates, 2008).

- **Rear Wing Floor Framing:** First floor framing in the rear wing is 2"x7-1/8" wood joists @ 22" o.c. There are two floor joists that are supported by wood posts in the partially filled original opening for the cellar stair. The bearing condition for these two joists needs immediate attention to prevent a structural failure.

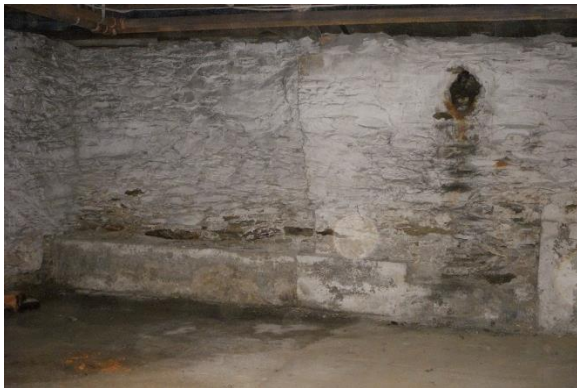
West foundation wall concrete underpinning and concrete ground slab. Note the damp area in the southwest corner where water often collects (Oehrlein & Associates, 2008)

- Excavate full perimeter down to footers. Parge stone foundations above grade and add waterproof membrane to parging. Stabilize and repair foundation walls locally. Add perimeter drainage system tied to stormwater infrastructure.

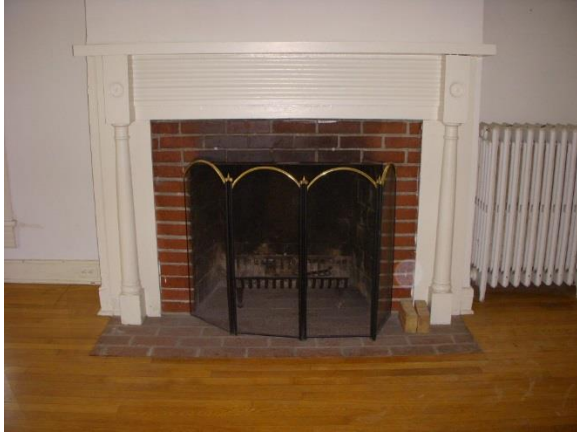
Photograph of the lone remaining fireplace, mantle and brick hearth. Three other fireplaces have been covered over and the mantles and hearths removed (Oehrlein & Associates, 2008).

- *Fireplace and Mantle, First Level West Side: Clean and paint mantle, and adapt fireplace with gas-burning logs.*
- *Interior Abandoned Fireplace, First Level East Side: Configuration to be determined by Architect.*
- *Radiators: Configuration to be determined by Architect.*

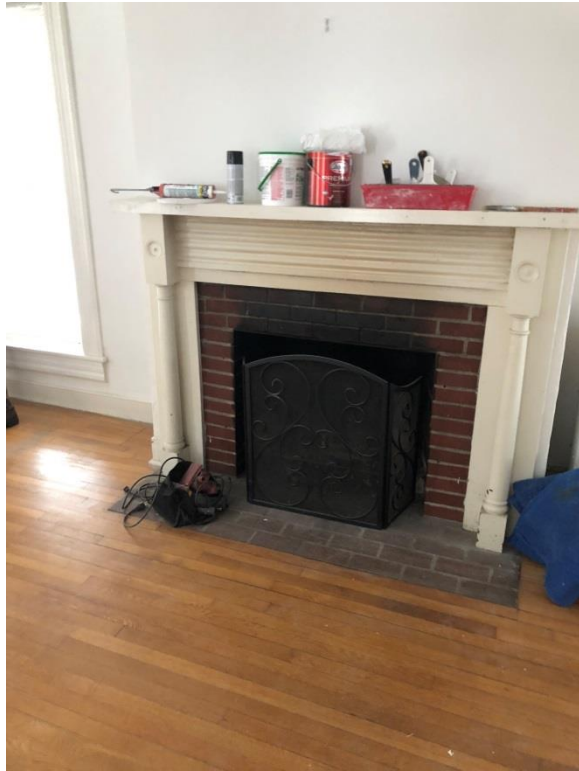
Fireplace, first level west side (Mills Group, 2018).

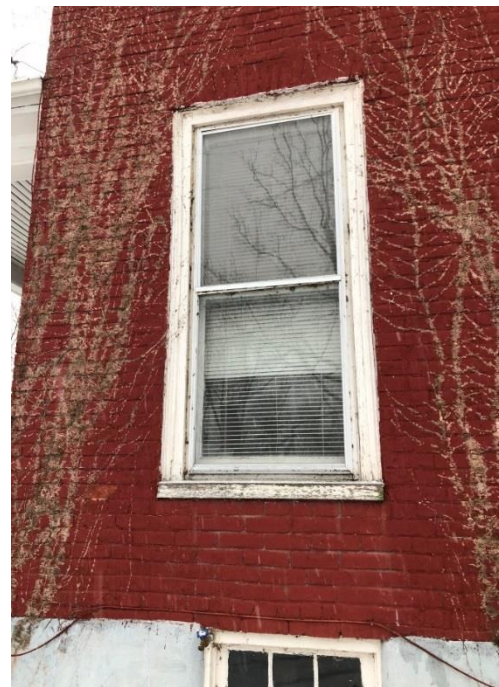
Detail view of exterior storm windows (Mills Group 2018).

2. Aluminum Exterior Storm Windows: Servicable condition	Clean and paint	Yes	Like kind
	B2030 Exterior Doors	1. South 3-Panel Wood Door with Full-Light Top Panel: Outfitted with aluminum screen/storm door, servicable condition	Clean and paint per NPS Preservation Brief 47; add new storm door	Yes	Like kind

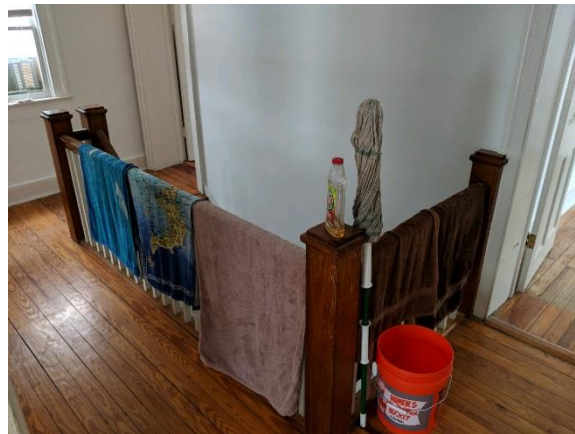
View of second-level stair railing (Mills Group 2018).

2. Interior Wood Stairs from Level 1 to Level 2: Servicable condition	Extend height of second-floor guard rail to 42"; Architect to review code compliance	No

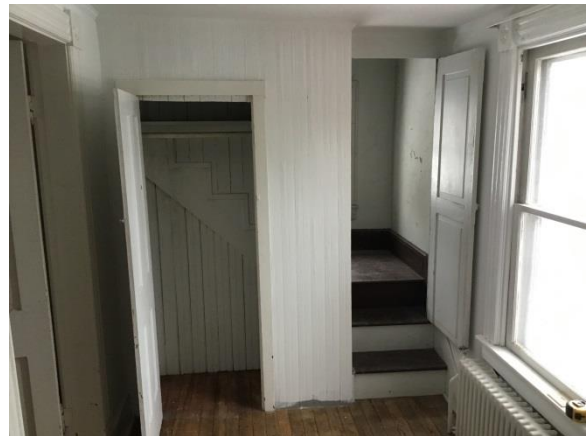
Attic stair entrance and adjacent closet showing stair carriage (Mills Group 2018).

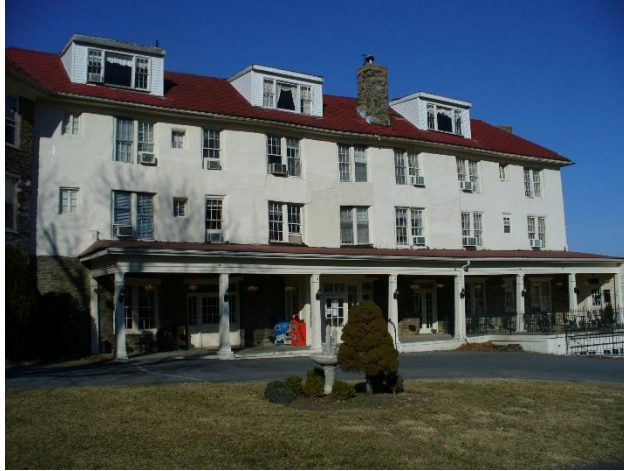
Area 1 south elevation stone wall now covered with stucco. The left portion may be from the 1920 reconstruction or earlier; the right three bays have been recently reconstructed. The frame dormers and the majority of the porch construction are late 20<sup>th</sup> century.

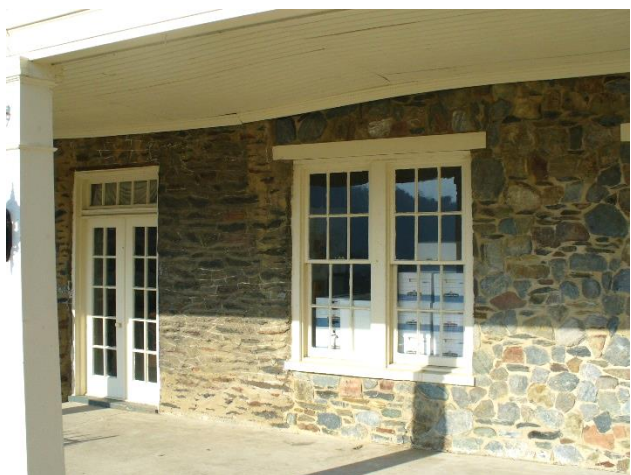
ABOVE: South Elevation under the porch showing the change the stone construction. The stone to the left in the photo is typical of the character seen in the 1920's photographs. The stone at the right in the photo has been reconstructed. The full height of the wall has been rebuilt but is covered with stucco above the porch roof.

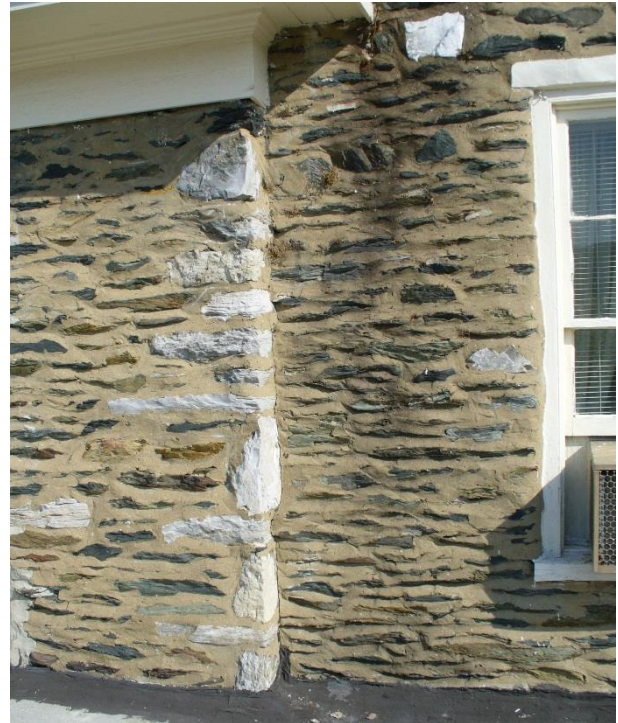
Construction joint between Area 1 (right) and 2 indicates that Area 2 was constructed prior to Area 1. Much of the stonework of Area 1, however, appears to have been more recently rebuilt.

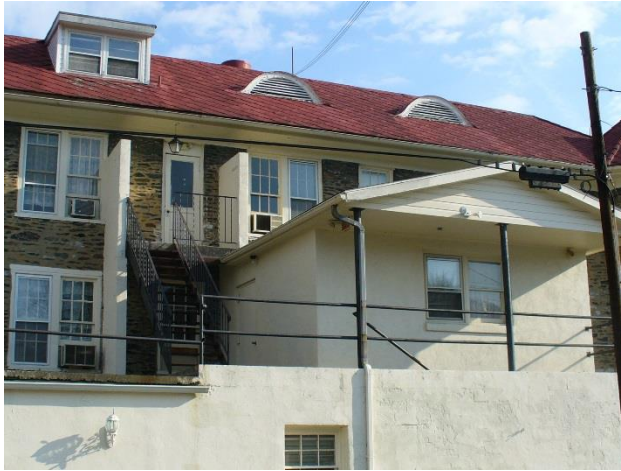
Existing Area 3c porch is at the approximate location of the 1920 two story open porch. The current "porch" is recent concrete, concrete block, stucco and steel post construction.

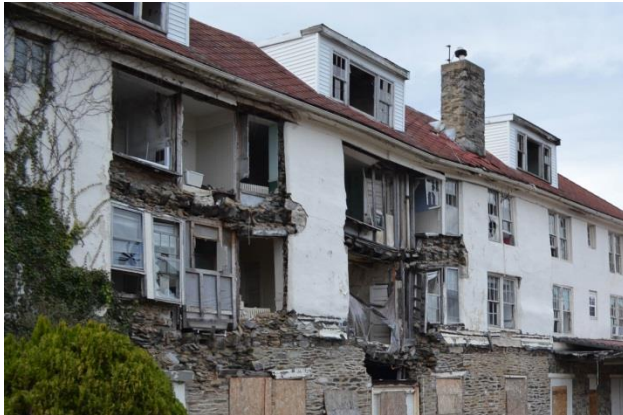
The stone wall of the east elevation of Area 1 is generally in very poor condition. The upper two levels of the southern portion of this wall have collapsed and are missing, likely at least partially due to insufficient window headers. Severe bulging and outward movement of the wall exists at all levels. As a result of the outward movement, there is severe cracking in the stonework at the first floor level. At the interior of this same area the stone wall is separated from the interior finishes upwards of 2".

Vertically, the wall also shows varying relative displacements. At the location of the former entrance vestibule, for example, the wall is leaning inward above the first floor level and is bulging outward above the first floor doors. The lintel above the main door, which was previously rotated and deteriorated as the result of a saturated wall condition, is completely absent. There is currently a large section of stonework missing from the wall above the former entry door, which has been boarded up. The transom and side lights which originally flanked this door are also missing. The southern half of the porch (Area 1a) which once spanned the east facade is now absent, along with the frame entry vestibule which once surrounded the entry door.

Deterioration along east elevation (Mills Group, 2018).

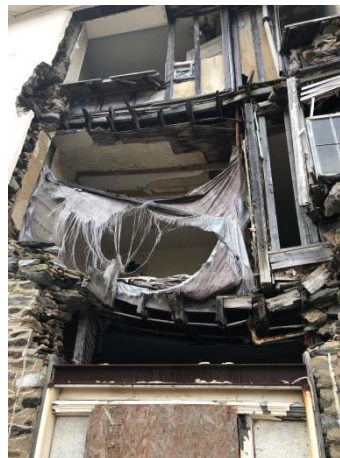
Detail of deterioration (Mills Group, 2018).

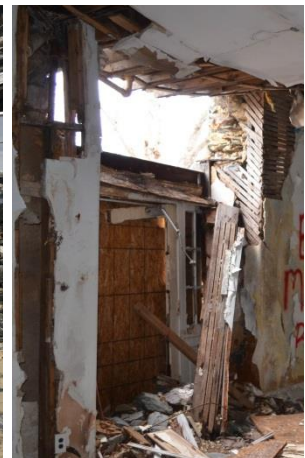
Interior view of deterioration of east wall (Mills Group, 2018).

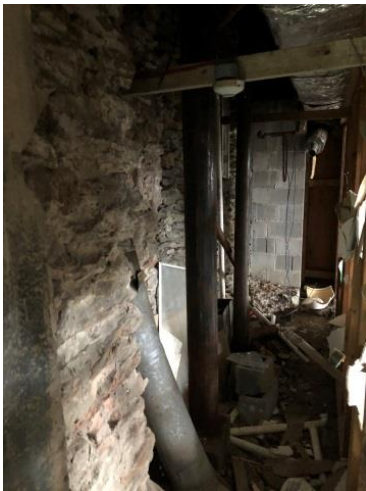
One of the key observations in the basement was of lintel and wall distress similar to that present at the first and second floors of the east wall. A wood lintel over what was once an opening in an exterior foundation wall for Area 2 has significant deflections and rotations with masonry cracking and bulging at the supports.

At an adjacent wall opening, the inner and outer faces (wythes) of the stone have separated and the lintel above has rotated, similar to the phenomenon observed at the east façade. Once a portion of the wall has started to rotate, the uneven application of vertical load from above causes further rotation, aggravating the problem. In this instance, the problem was partially mitigated by building a series of concrete block buttresses to support the wall laterally. This was possible due to the location of these walls below grade; however, this type of reinforcement is obviously not viable at the east façade.

Detail of basement foundation walls (Mills Group, 2018).

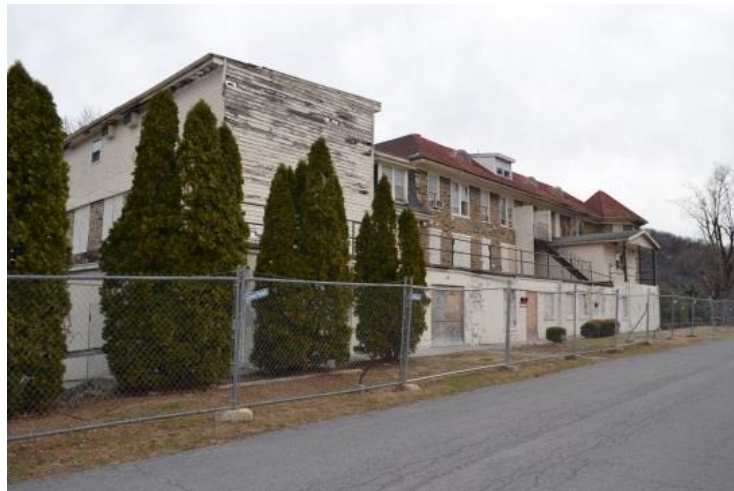
Overview of south wall of hotel (Mills Group, 2018).

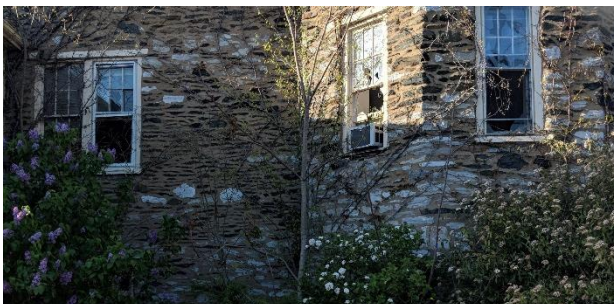
Detail view of stone wall and turret connection, south elevation (Mills Group, 2018).

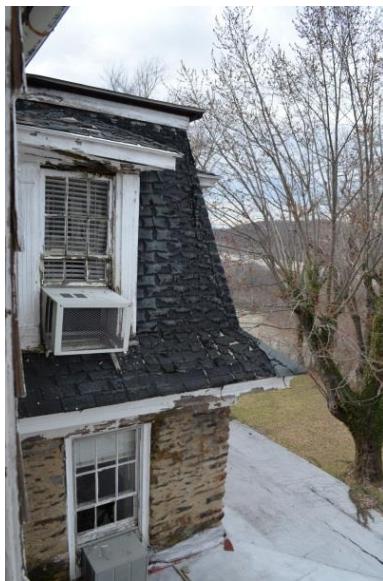
The roof coverings of the hotel are a combination of asbestos shingle, asphalt shingles, corrugated metal, standing and flat seam metal, roll roofing, and membrane roofing. The perimeter metal gutters and downspouts are galvanized steel and aluminum; most are missing. All roofing materials are in poor condition.

Asphalt shingle roofing (Mills Group, 2018).

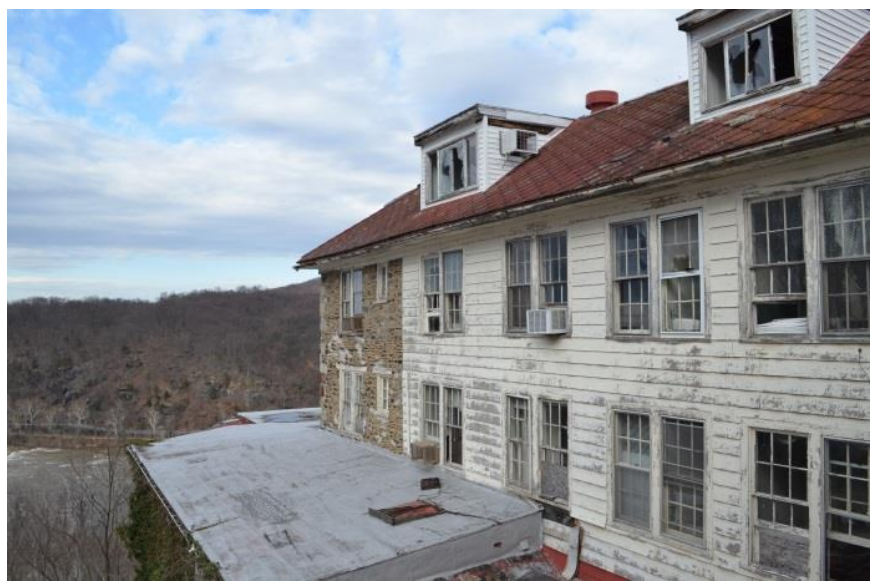
The Area 1 roof is covered with diamond shaped asbestos shingles, flat seam sheet metal, and sheet metal flashing that has been painted red. Both shingles and metal are in poor condition. The roof valley at the northwest side of the roof ends in a chimney, meaning that water, snow and ice accumulates in this area. The wood eave is significantly damaged and the roofing has biological growth and deterioration. It is likely that the wood roof framing at this area is deteriorated as well.

Asbestos shingle roofing (above) and flat seam metal roofing (below) (Mills Group, 2018).

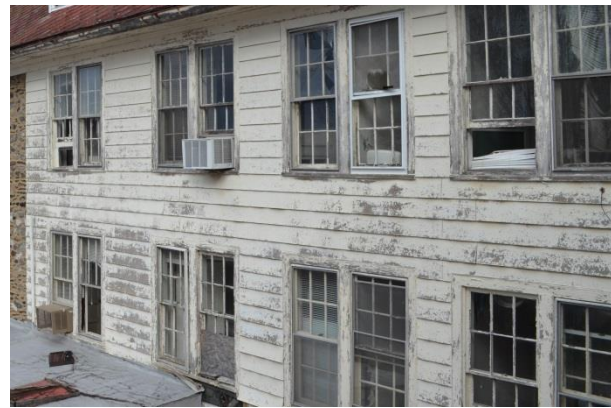
The exterior windows and doors of the oldest portions of the building, Areas 1 and 2, are wood. Most of these wood windows are covered with aluminum or steel storm windows, and several at the second floor level have been boarded up or are missing entirely. Several wood doors are also missing or have been boarded up. Remaining wood windows and doors are in poor condition, evidenced by rotting observed at sills, missing glazing, and frames out of plumb. Additionally, given the age of these features, they likely contain lead paint and possibly other hazardous materials. At the newer portions of the building, the windows and doors are a combination of wood, aluminum and steel. The glazing in many of these windows, particularly in Areas 5 and 6, is shattered, allowing for additional water and plant infiltration. The trim at all portions of the building is in poor condition. Leaking roofs and gutters and uncontrolled storm water have resulted in deterioration of much of the wood trim.

Wood windows and missing windows at stone and frame walls (Mills Group, 2018).

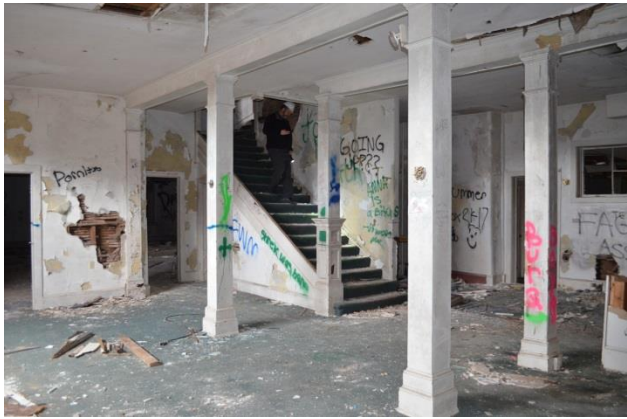
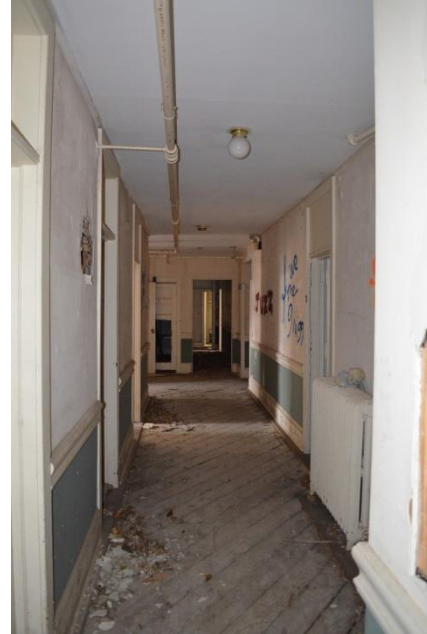
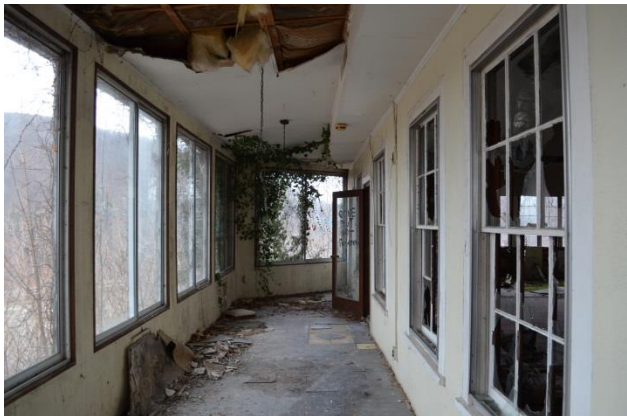
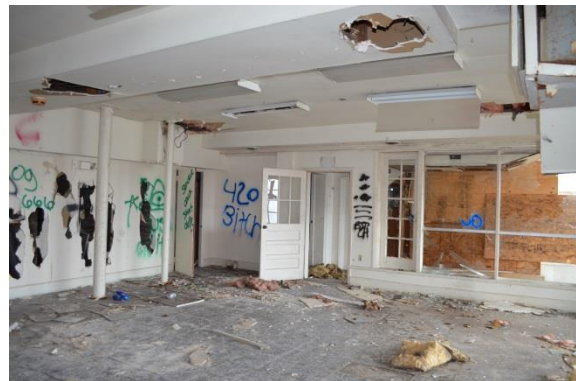
The condition of the interior finishes of the public spaces and guest rooms is uniformly very poor. Wall coverings are peeling, carpets are worn and deteriorated due to water infiltration, and painted ceilings and trim are chipped and peeling. Many interior frame walls are punctuated with large holes where copper wiring was removed by vandals. In many areas, vegetation has begun to enter the building through window openings, while other areas are overgrown with moss due to water infiltration. Floors are sagging and warped; walls, ceilings and tile is cracked, and doors and windows do not close due to the extreme settlement of the building. Bathroom finishes and fixtures are also in poor condition throughout.

Current interior conditions of Hill Top Hotel building (Mills Group, 2018).

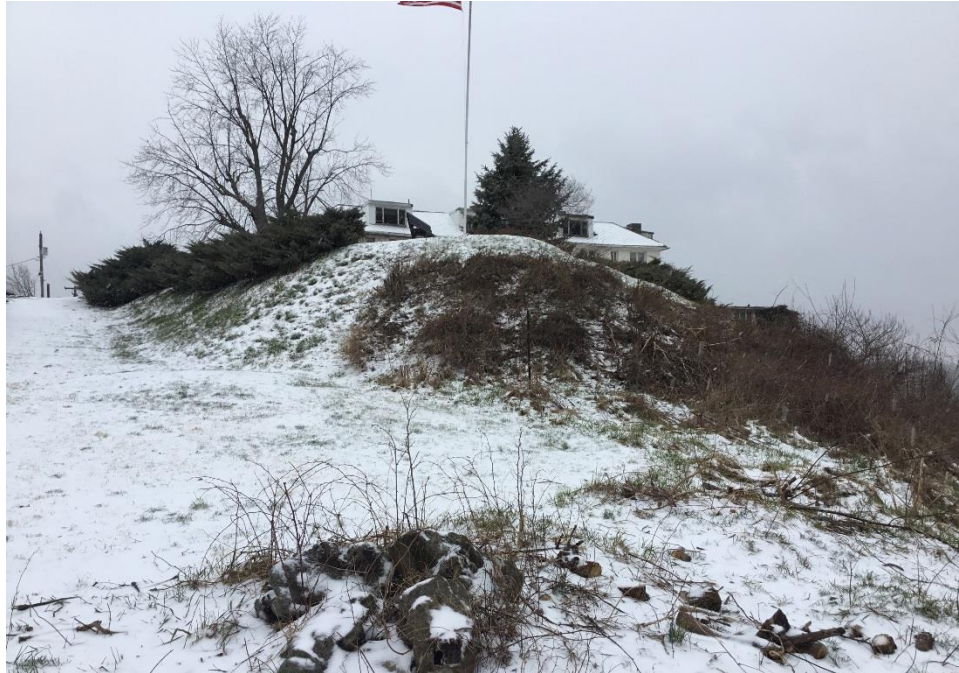
Figure 3. Photograph of overlook from below (Mills Group 2018).

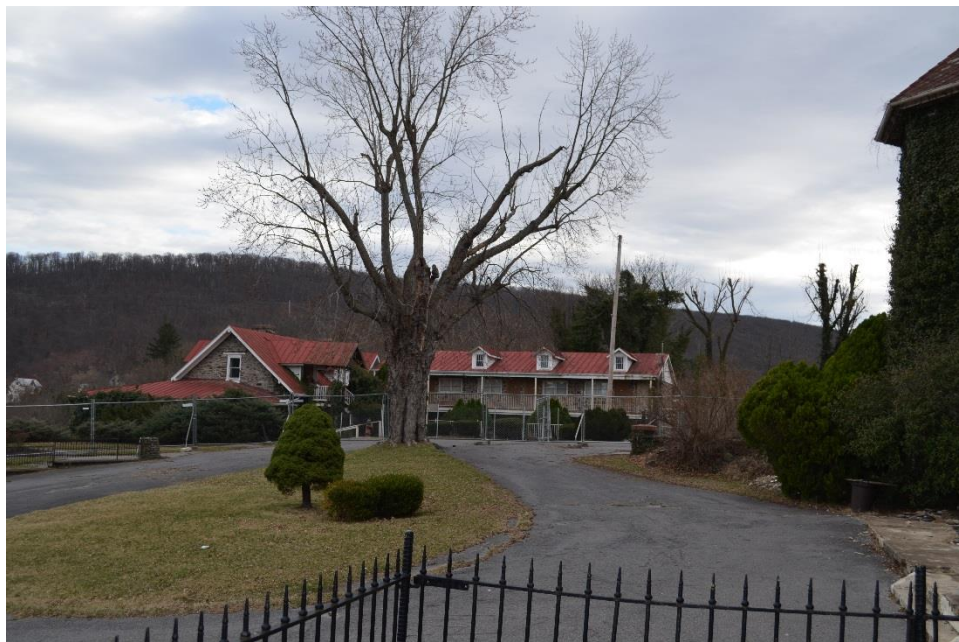
Figure 4. Photograph of circular drive (Mills Group 2018).

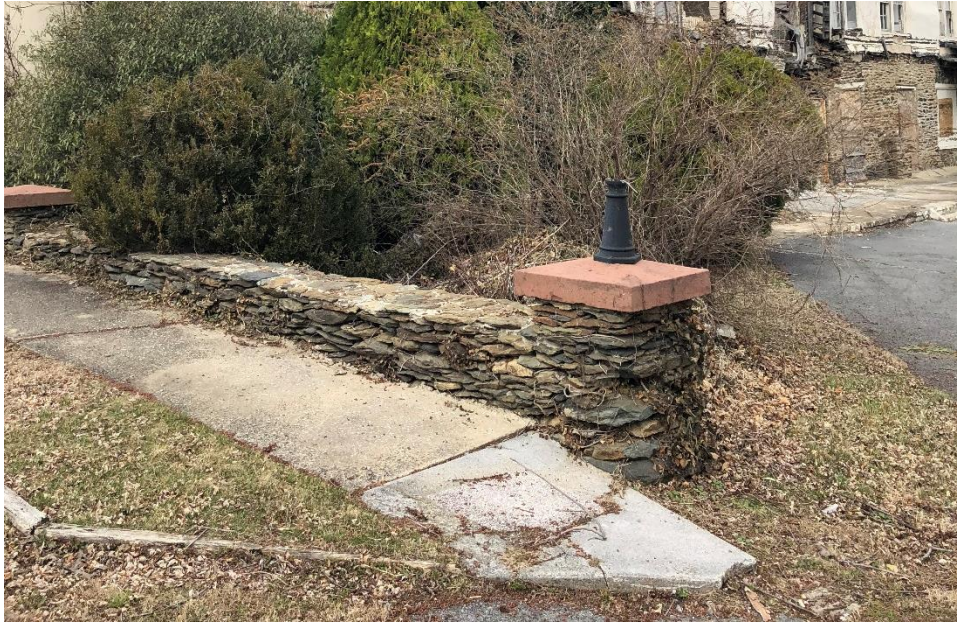
beds, fencing, a stone wall, and paved auto circulation routes and parking areas (Figure 2-Figure 5). Historic photographs and postcards indicate that the majority of these features are modern incursions, with the oldest features consisting of the circular drive and stone wall. The stone wall, which is thought to feature fence caps that were salvaged from the nearby armory, appears in historic photographs as early as 1919 (see Chapter 2, Historic Background). Historic aerial photographs indicate the presence of the circular driveway, as well as the adjacent parking area, as early as 1955, and indicate the development of the paved overlook at the end of Ridge Street by 1965 (Figure 6, Figure 7). The remaining non-historic landscape features are typical of most hotel grounds and do not, in and of themselves, warrant individual distinction.

Figure 5. Photograph of historic stone wall adjacent to sidewalk at south side of hotel building (Mills Group 2018).

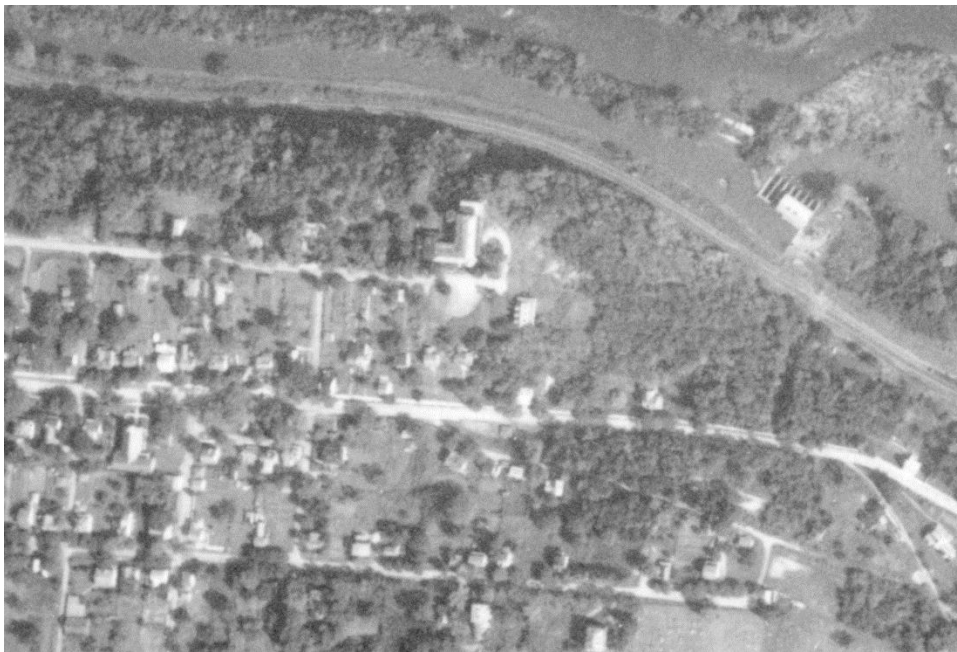
Figure 6. 1955 aerial photograph of Hill Top Hotel property showing circular drive and parking area (Image courtesy United States Geological Survey).

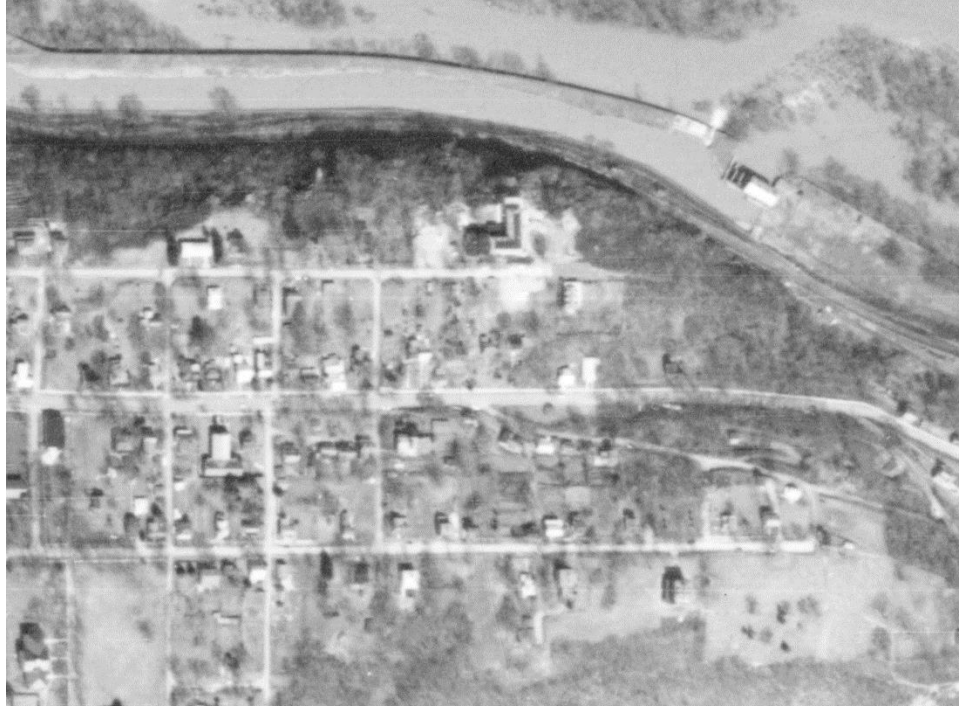
Figure 7. 1965 aerial photograph of Hill Top Hotel property showing beginning of development of overlook area (Image courtesy United States Geological Survey).

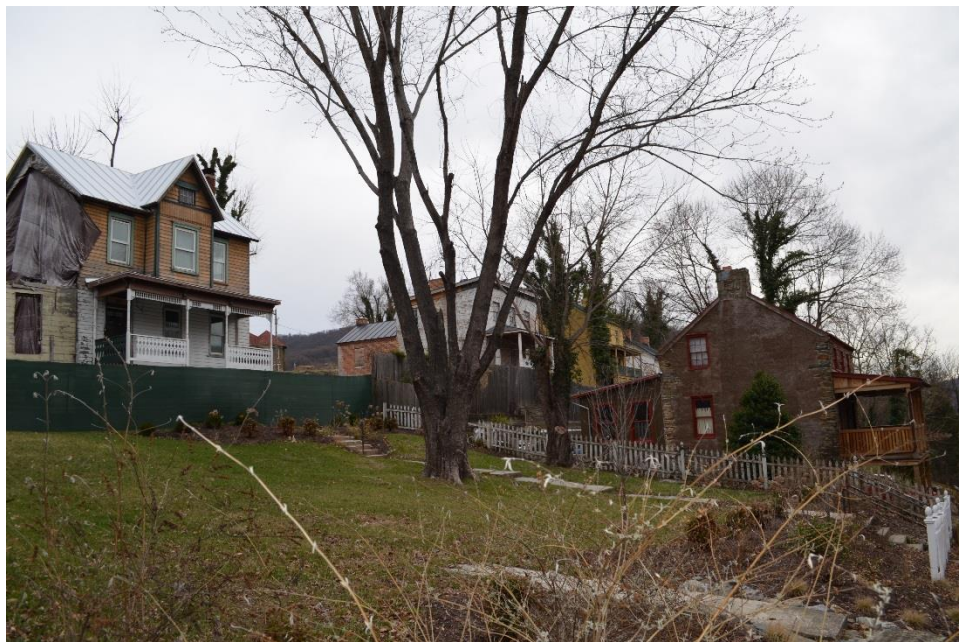
The Armory Dwellings and Barbershop also feature landscape elements such as retaining walls, walkways, and staircases (Figure 8, Figure 9). The exact construction date of these features is unknown; however, they appear to be largely modern incursions that may have replaced original features.

Figure 8. Overview of landscaping, stairs, walkway, and fencing in front of armory dwelling (Mills Group 2018).

- Repoint, or rebuild if necessary, deteriorated retaining walls with salvaged stone and mortar to match existing.
- Create new storm drainage system.
- Remove non-original site features, along with non-functioning utility lines, conduits, and meters.
- New landscape features may be installed as needed for reprogramming of buildings. This may include exterior lighting, pavers, walkways, site circulation amenities, or plantings.

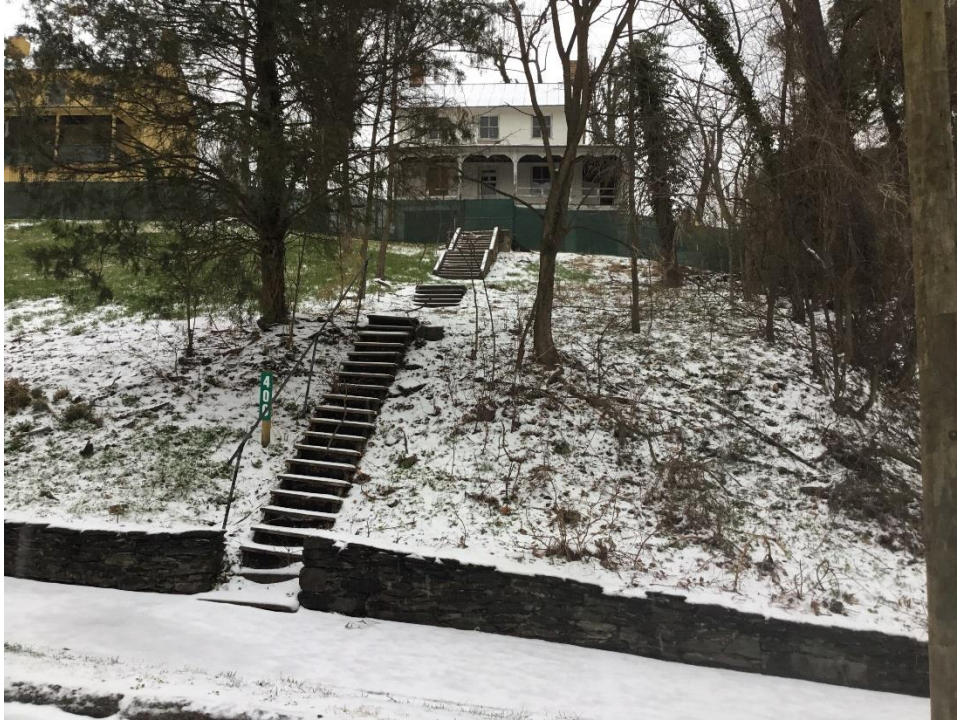
Figure 9. Overview of stairs and walkway in front of armory dwelling (Mills Group 2018).
