HARPERS FERRY WATER WORKS

EVALUATION AND FEASIBILITY STUDY

**WATER TREATMENT FACILITY AND
DISTRIBUTION SYSTEM UPGRADES**

NOVEMBER 2013

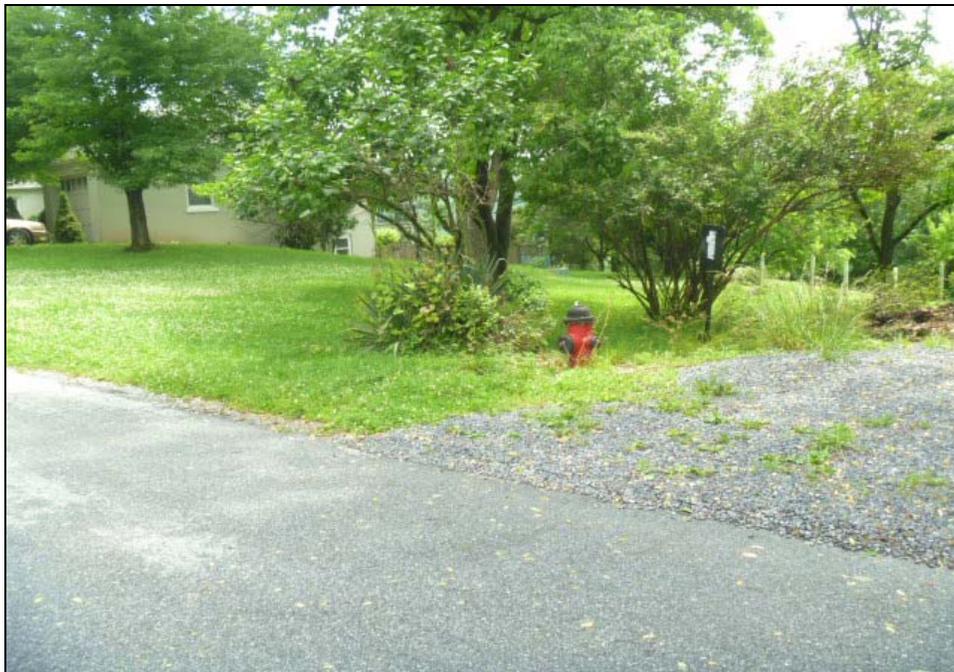
Photo 15 - Proposed Location of New Booster Pump Station along Prospect Avenue (Near Tanks)

The new booster pump station should be installed along Prospect Avenue in the area shown in the photograph below. This building should consist of a concrete foundation with CMU walls and a wood truss/shingled roof similar to that of the proposed intake building. The proposed building will house the inline booster pumps, valves, piping, electrical components and variable frequency drives. A new telemetry system will enable control of the booster pumps from the water treatment facility.

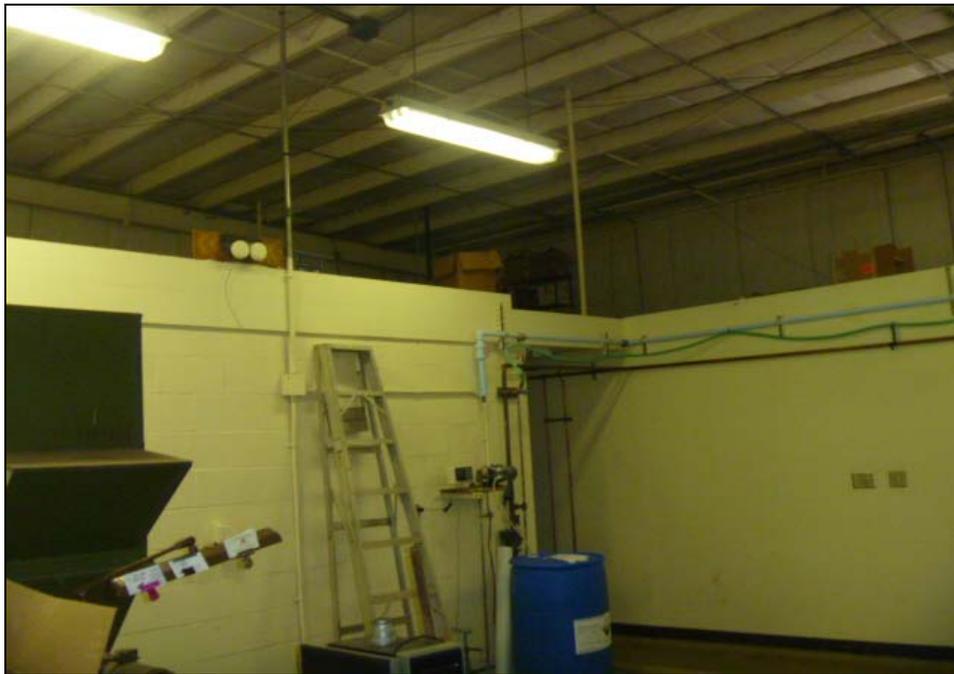
Renovating the Existing Facility - The existing treatment facility was constructed of insulated metal wall panels and structural steel in 1985. The interior walls are constructed of concrete masonry units (CMU) and there is an existing wooden storage platform located above the existing laboratory/office. Some of the wall and ceiling insulation is exposed and peeling and there are various places of surface corrosion on the metal building liner panels.

Photo 18 - Overview of Mezzanine Level

It appears that the existing mezzanine sub-floor (bracing, flooring, joists, etc.) is adequate for the addition of the rooms listed above. However, the average clear space from the existing mezzanine floor to the steel roof support structure is 6'-6" at the lowest end. The mezzanine option will require stairs, relocation of vent piping and results in very low ceiling heights. Furthermore, the rooms will in no way be handicap accessible which may cause issues with code reviewers/inspectors. Further structural investigations are necessary if this option is selected.

It is recommended that the Town construct an office, break and conference room on the first floor level between the existing laboratory and chlorine room. This would be a Phase II project that could be performed following installation and successful start-up of the new filter system. It would require demolition of at least one (1) package filter and piping and reconstruction of the concrete floor.
